STATE OF UTAH MSE WALL INSPECTION FORM

Compiled As Part of Research By The Utah Department of Transportation

Region	2	Identifying Road/Intersection 12300 S., I-15, SLC

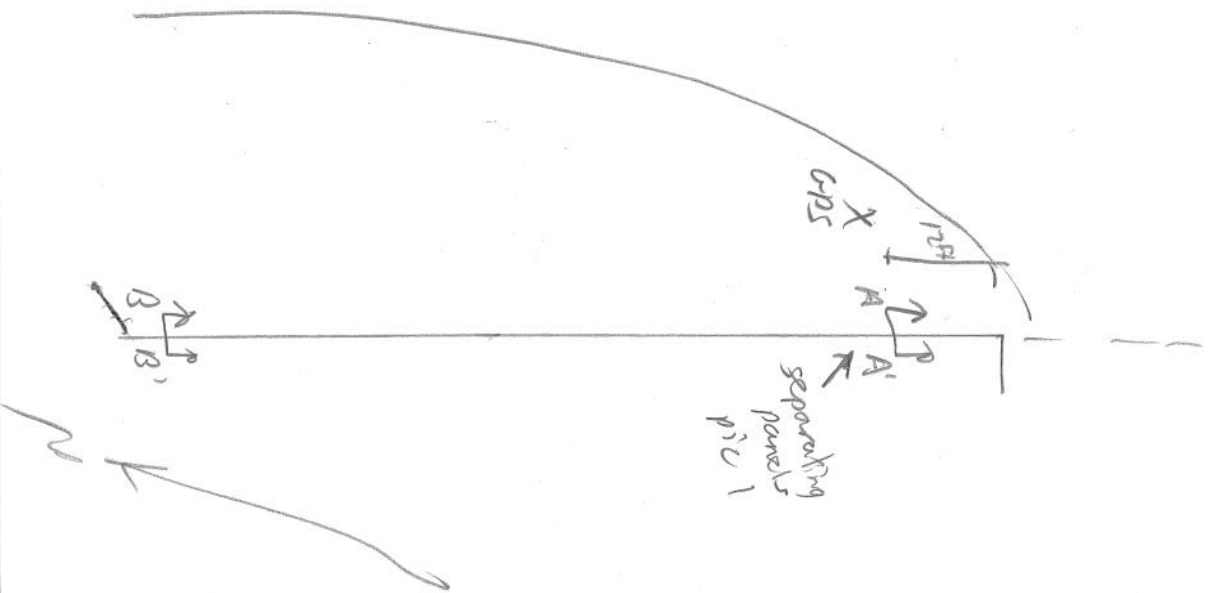
Plan View/Drainage:

gapping in panel joints near abutment
