STATE OF UTAH MSE WALL INSPECTION FORM

Compiled As Part of Research By The Utah Department of Transportation

Inspection Date	8/1/2007	Names Of Inspectors	Howell: RYAN
Region		Identifying Road/Intersection	12300 (SR. 71) - RAILROAD

MSE Wall at Bridge	(Y) N	Bridge Number if applicable:	RAILROAD	Wall Number	R-412
Surrounding Structures	UPRR - UNION PACIFIC RAILROAD		Maximum Height of Wall (ft)	17'	
Distance to Each Structure	0' FT. ON TOP OF		One Stage, Two Stage or Block Wall	Block	
State Route Number	SR-71		Estimated Max Length of Wall Abutment:	220 ft.	
Approximate Mile Marker	4.9		Max Slope of Ground in front of wall:	0	
GPS Datum	WGS/84 NAD/83, or NAD/27		Max Height of wall burial line above surrounding level ground:	0	
MSE Wall GPS Coordinates (Location of Measurement shown on plan view)	N 40° 31.597'		Please draw rough layout of panel with approximate dimensions in space provided below:		
	W 111° 54.345'				
If known, Panel or System Manufacturer	TENSAR?		<div style="display: flex; flex-direction: column; align-items: center;"> <div style="margin-bottom: 20px;"> <p>top row</p> </div> <div> <p>lower rows</p> </div> </div>

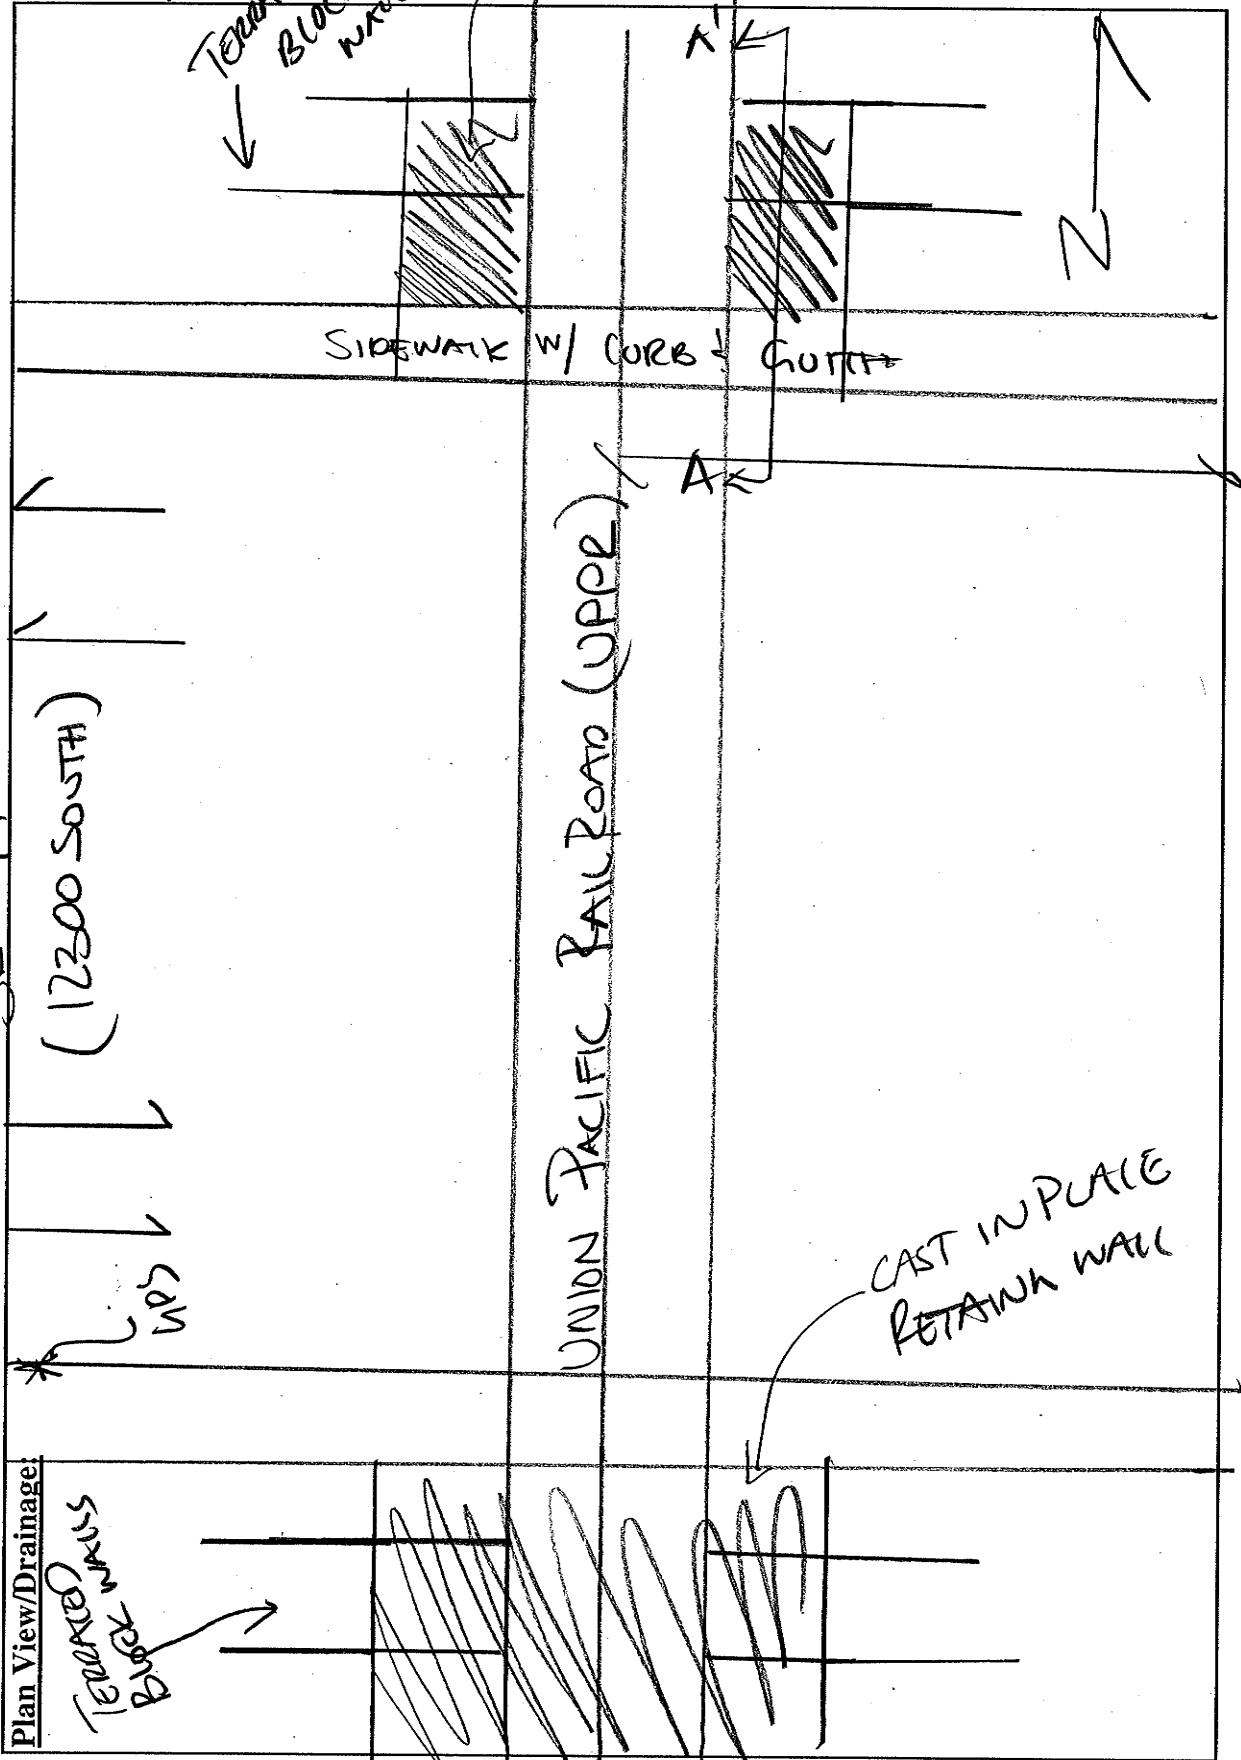
Plan View/Drainage

□ NEW WALL VERY LITTLE PROBLEMS
