STATE OF UTAH MSE WALL INSPECTION FORM

Compiled As Part of Research By The Utah Department of Transportation

Region	3	Identifying Road/Intersection	Provo Canyon, Riverside
---------------	---	--------------------------------------	-------------------------

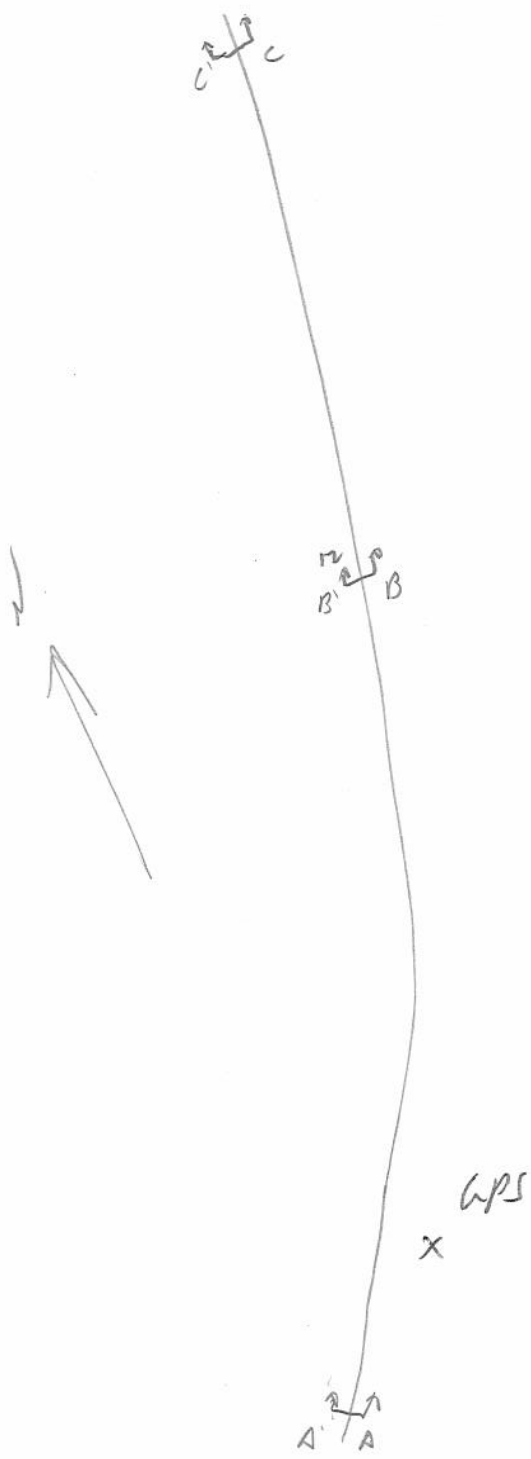
Plan View/Drainage:

wall in good shape
