STATE OF UTAH MSE WALL INSPECTION FORM

Compiled As Part of Research By The Utah Department of Transportation

Inspection Date	11/10/07	Names Of Inspectors	Ryan maw, Holly Griffin
Region	2	Identifying Road/Intersection	Pam sh lane (south wall)

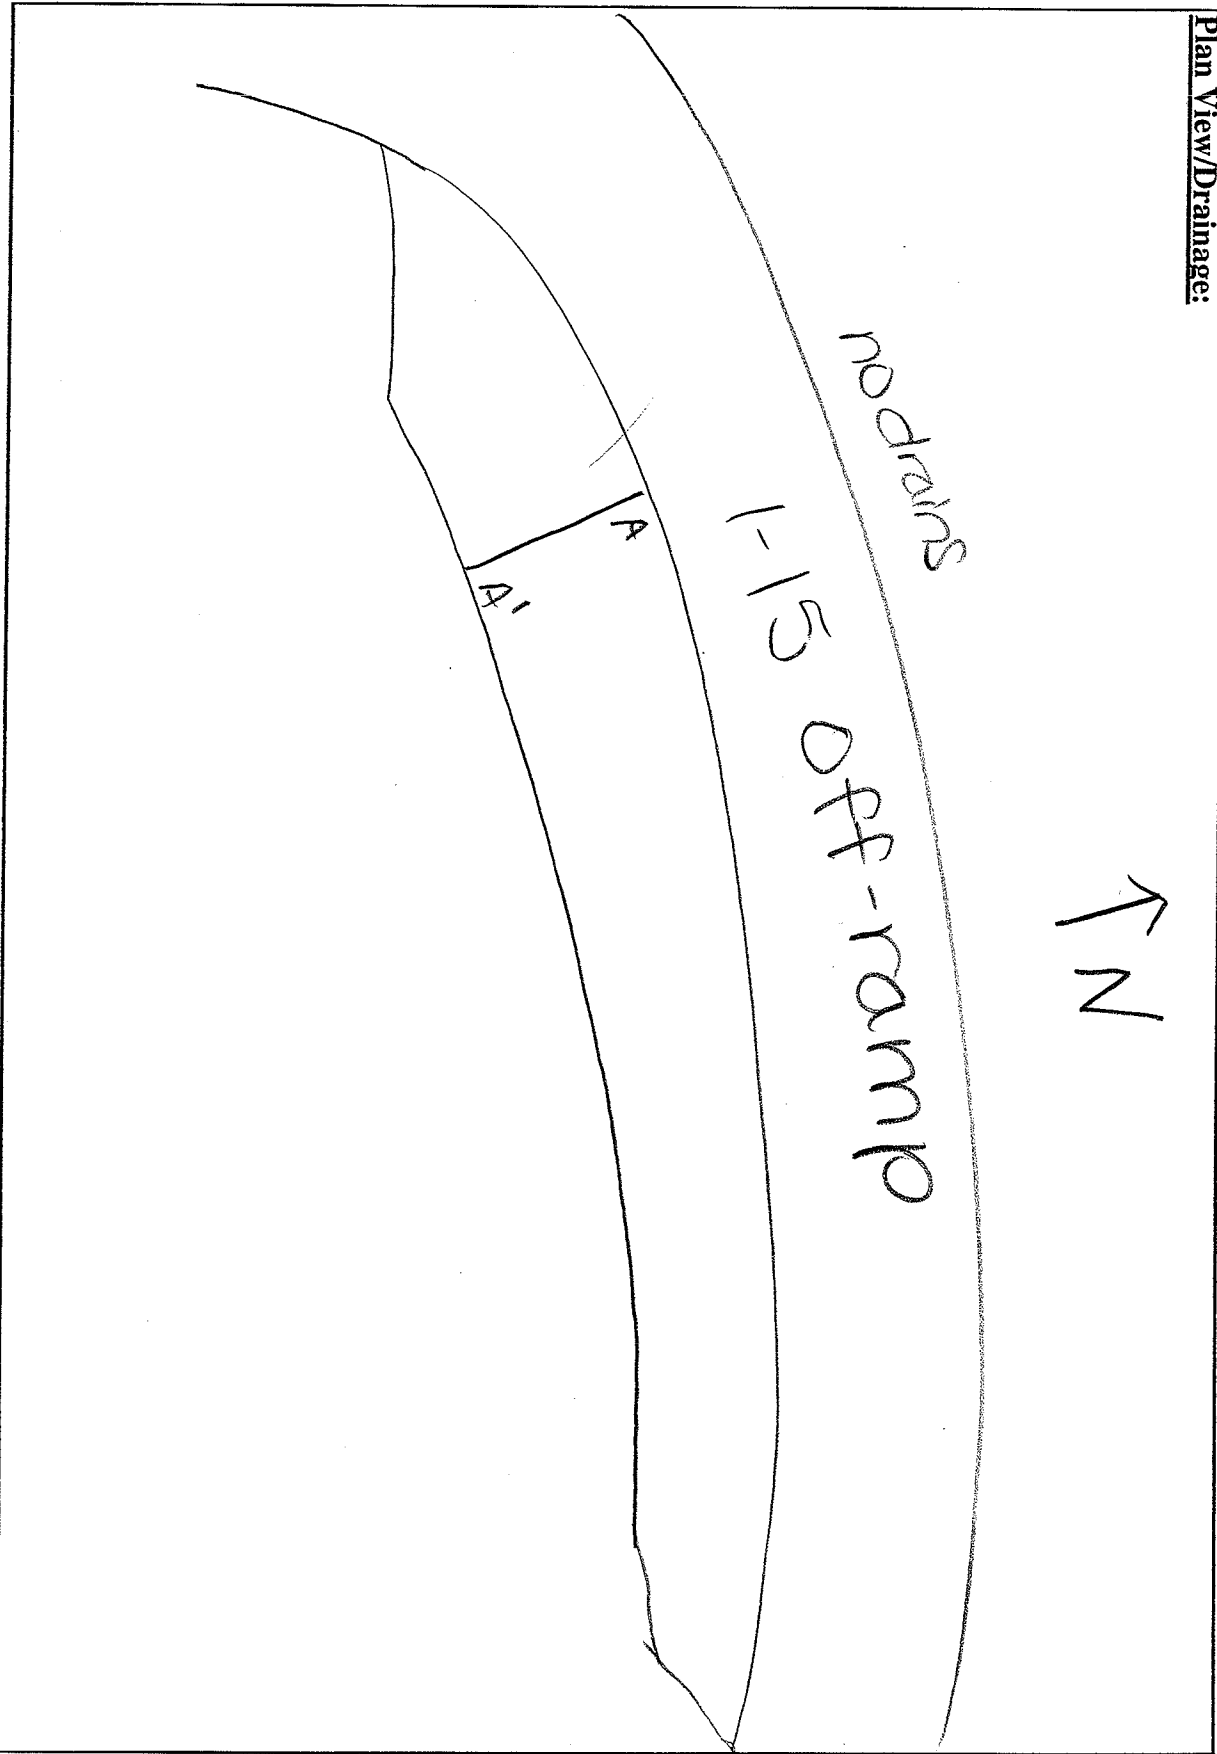
Plan View/Drainage:

no drains
