STATE OF UTAH MSE WALL INSPECTION FORM

Compiled As Part of Research By The Utah Department of Transportation

Inspection Date	11/10/2007	Names Of Inspectors	RM #112
Region	2	Identifying Road/Intersection	5300 SOUTH & UPRR / LIGHT RAIL

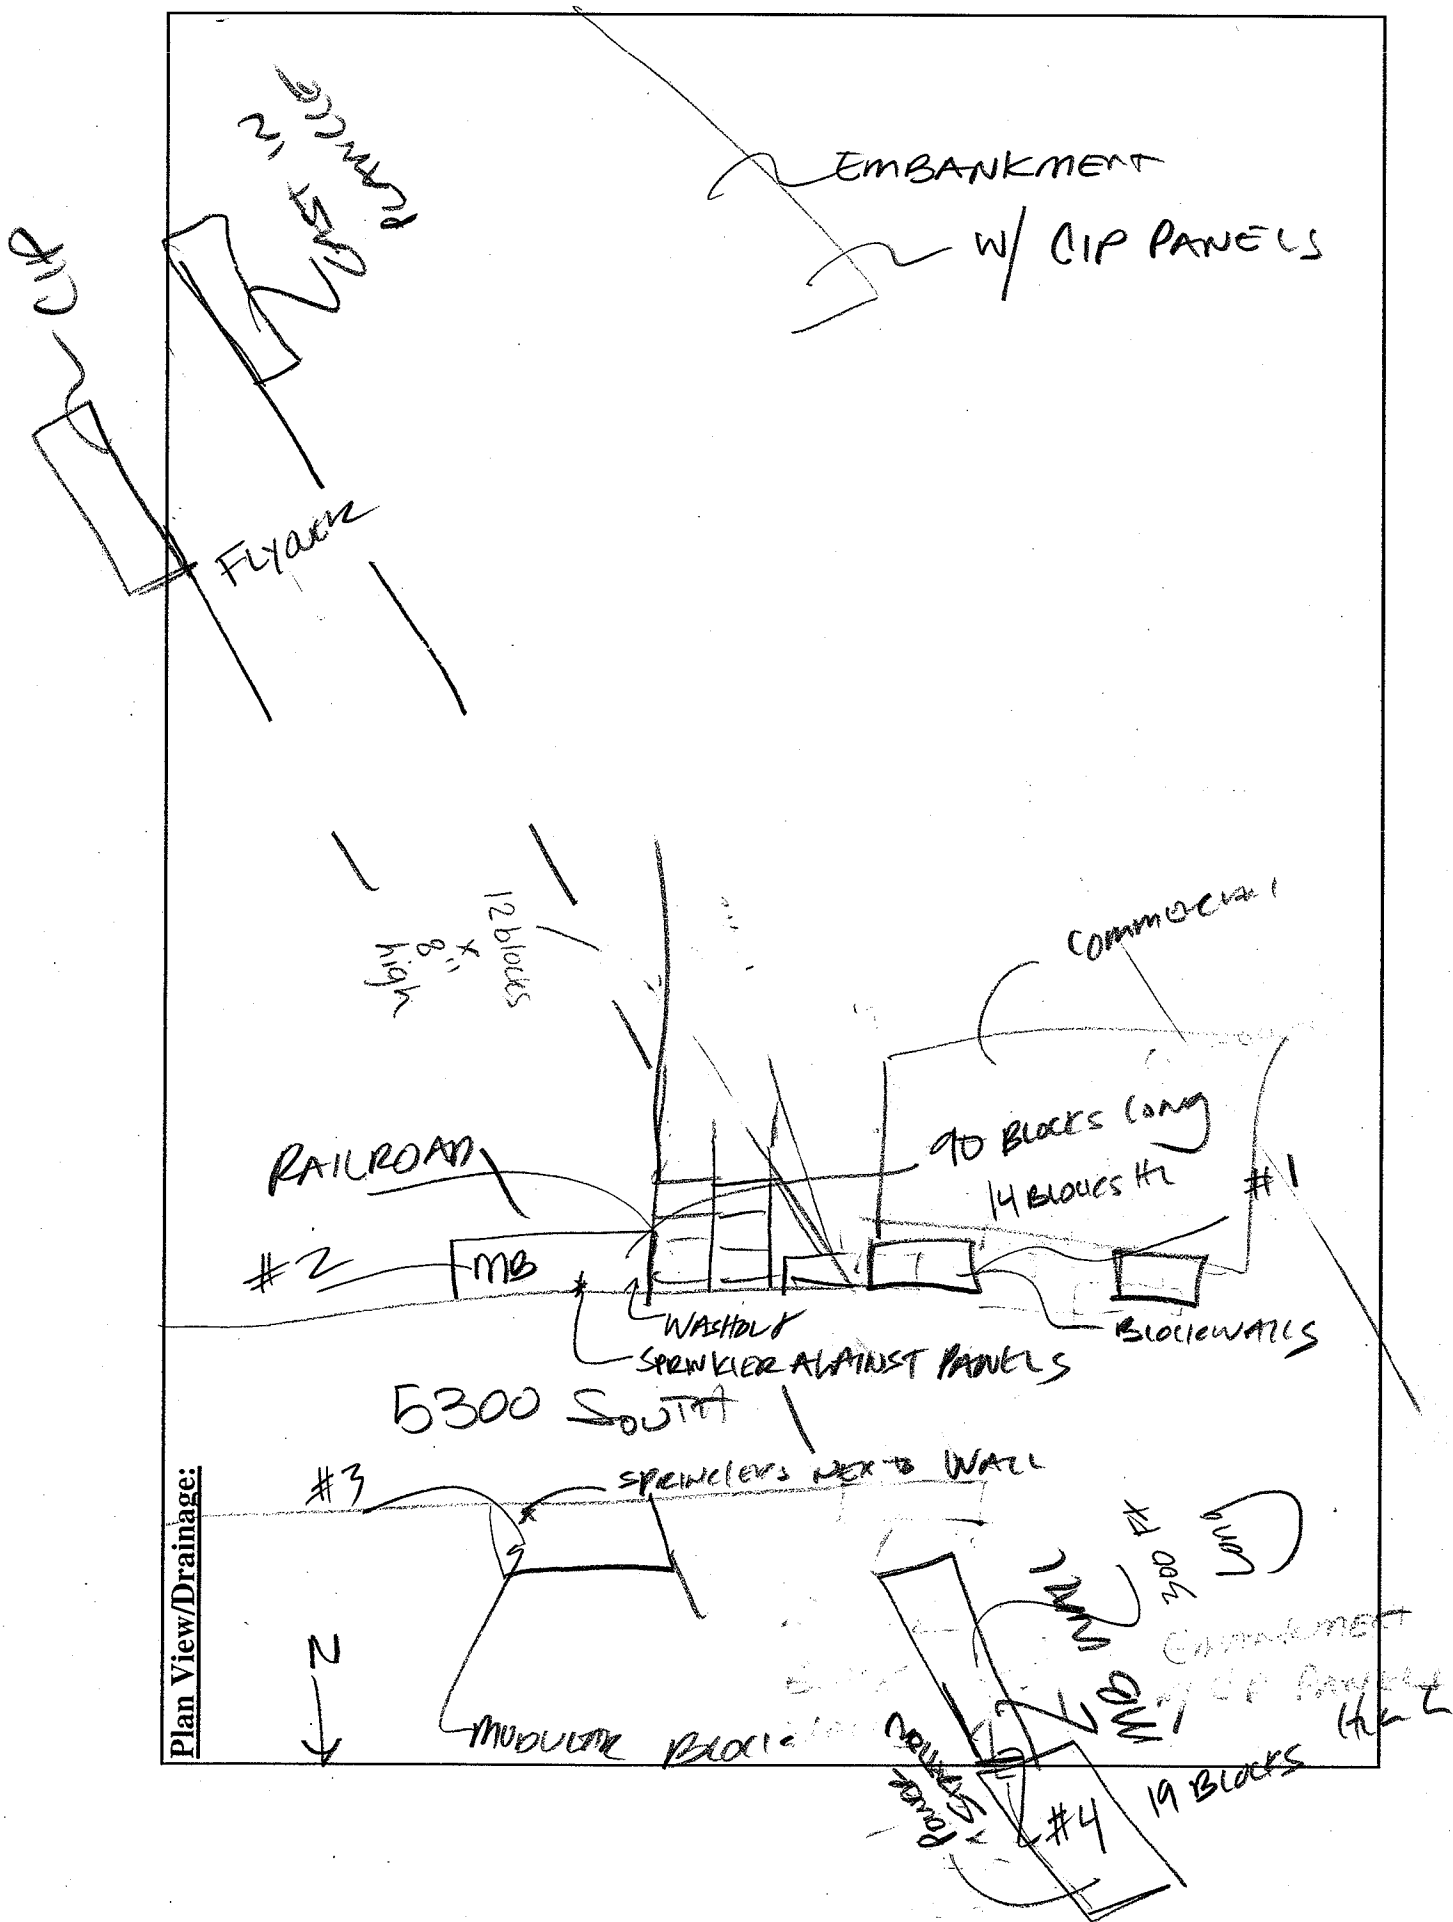
Plan View/Drainage:

NO ACCESS - SECURITY FENCES & RAILROAD LIMIT ANY ACCESS TO SITE.

LANDSCAPED BLOCK WALLS LOCATED NEAR 5300 SOUTH & NEAR POWER SUBSTATION BY BRIDGE
