STATE OF UTAH MSE WALL INSPECTION FORM

Compiled As Part of Research By The Utah Department of Transportation

Region	4	Identifying Road/Intersection	Hwy 6 between Helper & Sol. Summit
---------------	---	--------------------------------------	------------------------------------

MSE Wall at Bridge	Y	(N)	Bridge Number if applicable:	Wall Number	R-428
Surrounding Structures				Maximum Height of Wall (ft)	13 ft
Distance to Each Structure				One Stage, Two Stage or Block Wall	Block
State Route Number				Estimated Max Length of Wall Abutment:	270 ft
Approximate Mile Marker				Max Slope of Ground in front of wall:	0
GPS Datum	WGS/84, NAD/83, or NAD/27			Max Height of wall burial line above surrounding level ground:	10 ft
MSE Wall GPS Coordinates (Location of Measurement shown on plan view)	39 45 49.24		110 53 54.05		Please draw rough layout of panel with approximate dimensions in space provided below:
If known, Panel or System Manufacturer	<div style="border: 1px solid black; width: 200px; height: 100px; margin: 0 auto; position: relative;"> 18' 8' </div>

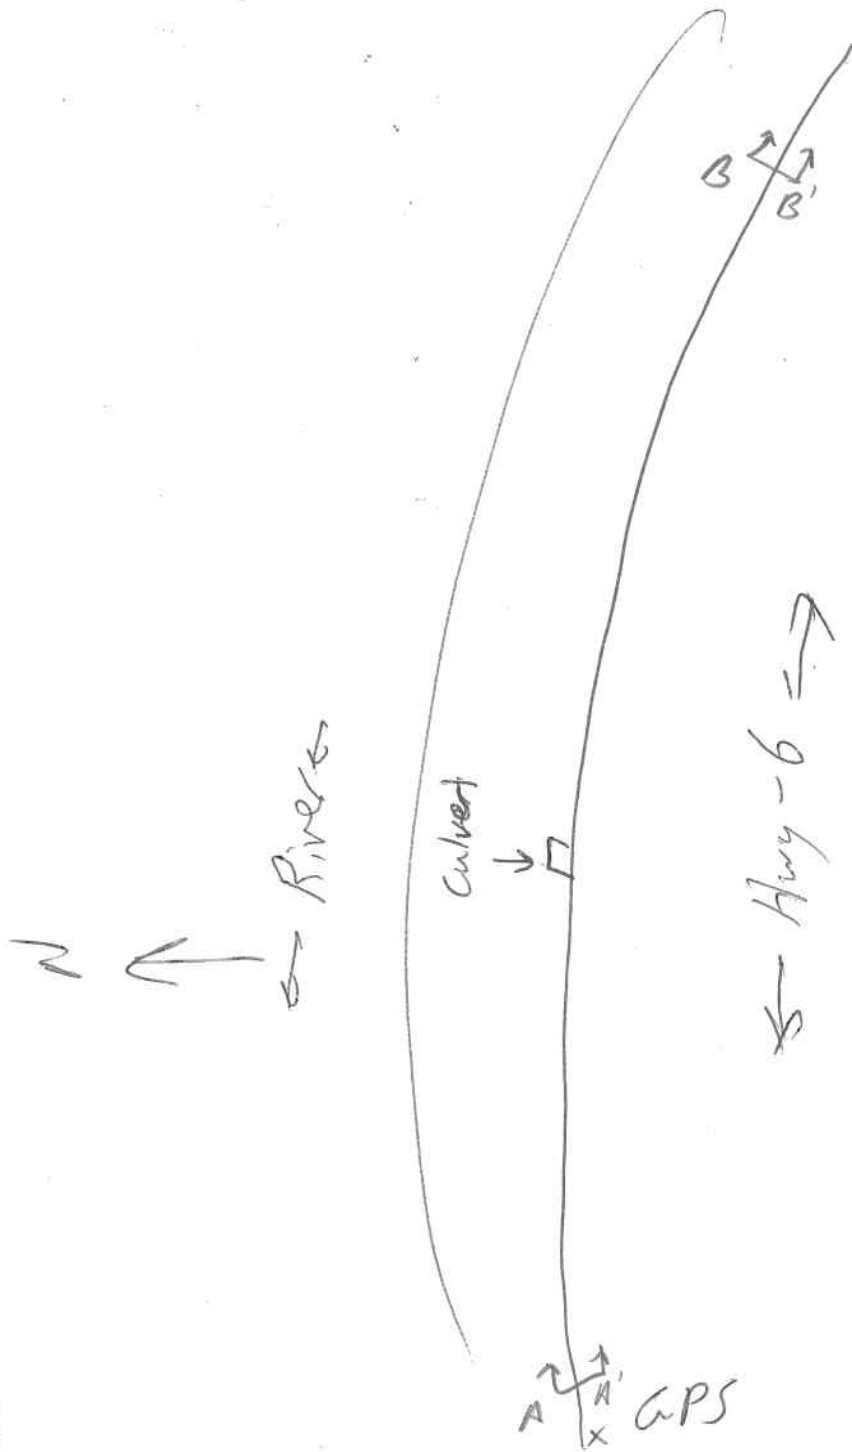
Plan View/Drainage:

spring Flood may be a problem
