# STATE OF UTAH MSE WALL INSPECTION FORM

Compiled As Part of Research By The Utah Department of Transportation

<b>Region</b>	3	<b>Identifying Road/Intersection</b>	US-6 and APRR W of Sorkogwin
---------------	---	--------------------------------------	------------------------------

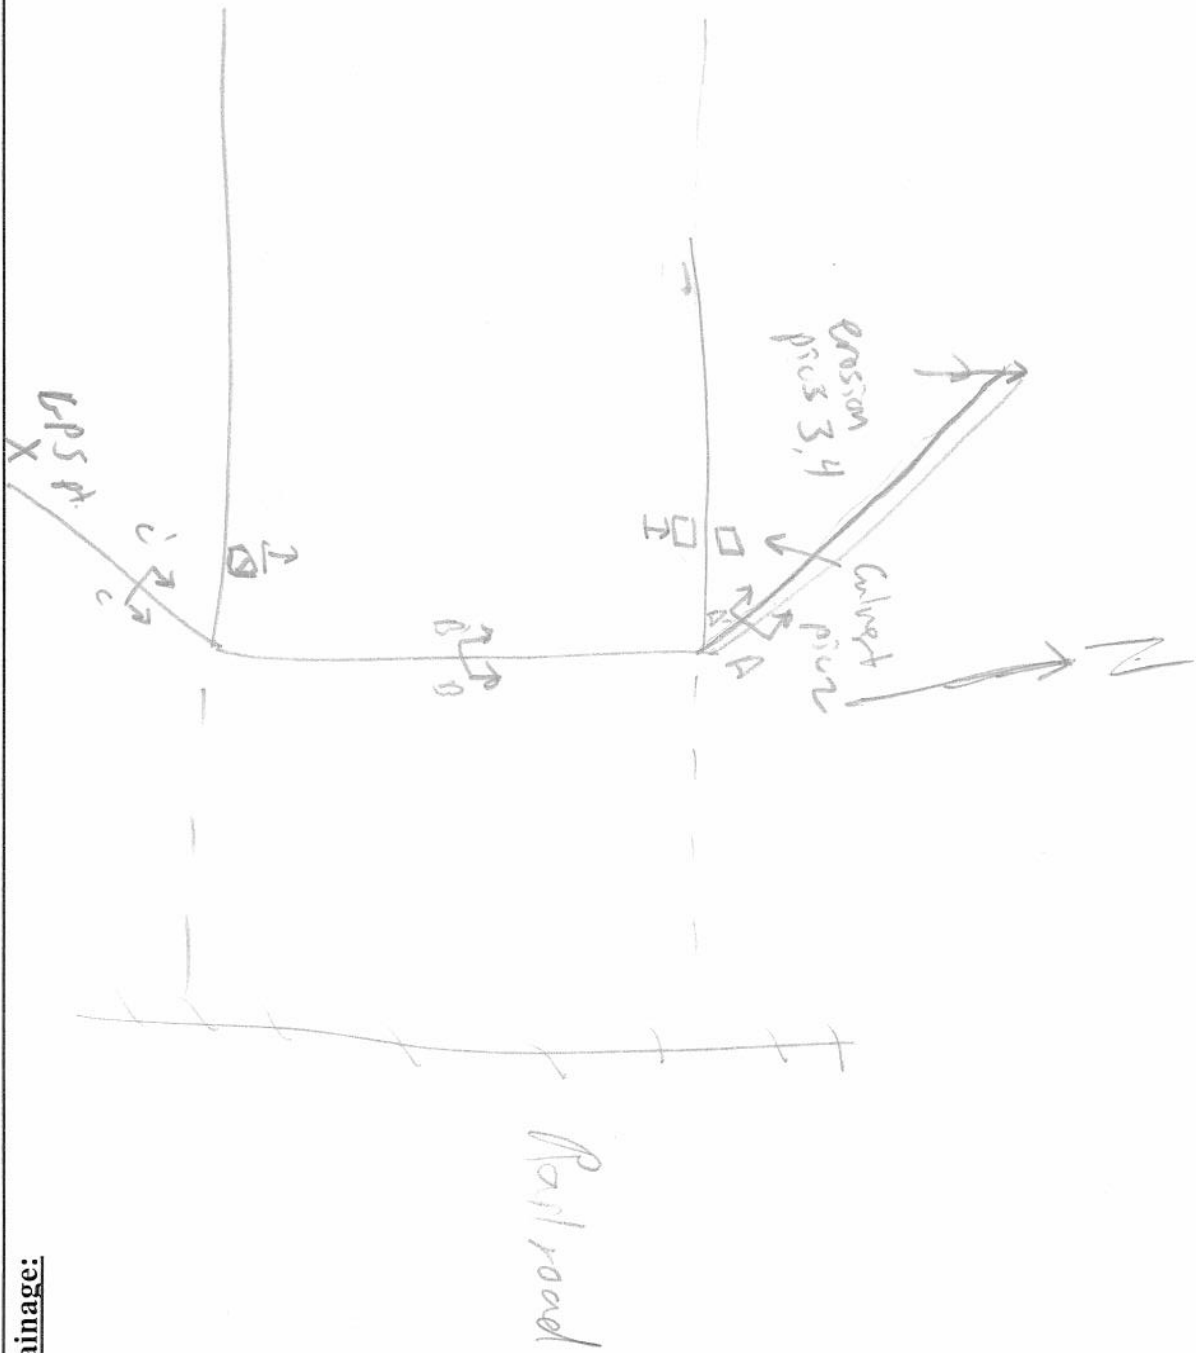
Plan View/Drainage:

over all good  
erosion on north end just past wingwall
