STATE OF UTAH MSE WALL INSPECTION FORM

Compiled As Part of Research By The Utah Department of Transportation

Inspection Date	11/10/2007	Names Of Inspectors	RM & JL
Region	2	Identifying Road/Intersection	201 & BEAUMONT

MSE Wall at Bridge	(Y) N	Bridge Number if applicable:	N/A	Wall Number	R-444
Surrounding Structures	NONE			Maximum Height of Wall (ft)	25'
Distance to Each Structure	N/A			One Stage, Two Stage or Block Wall	TWO
State Route Number	201			Estimated Max Length of Wall Abutment:	400'
Approximate Mile Marker	15.9			Max Slope of Ground in front of wall:	0 - TERRAISED LANDSCAPING
GPS Datum	WGS/84	NAD/83, or NAD/27		Max Height of wall burial line above surrounding level ground:	25'
MSE Wall GPS Coordinates (Location of Measurement shown on plan view)	N 40° 43.463		Please draw rough layout of panel with approximate dimensions in space provided below:		
	N 111° 56.304		<div style="border: 1px solid black; padding: 10px; text-align: center;"> </div>		
If known, Panel or System Manufacturer	VSL? HANSEN WORTH COMPANY

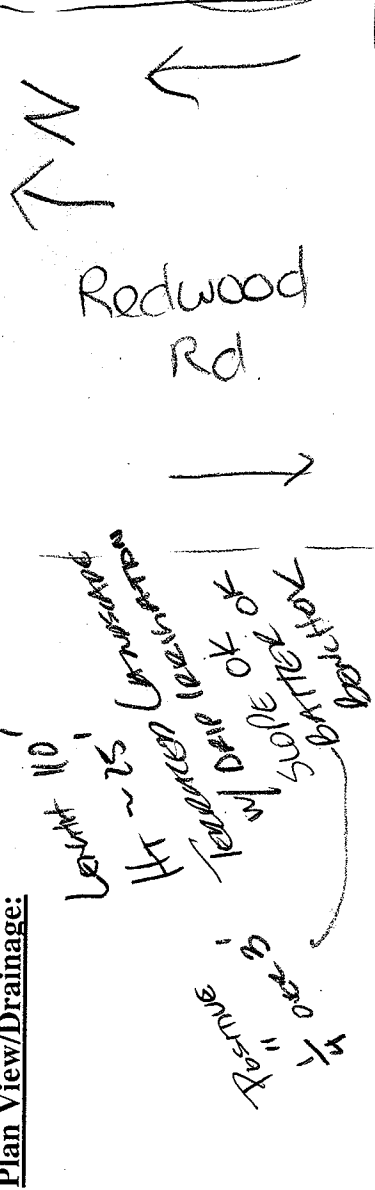
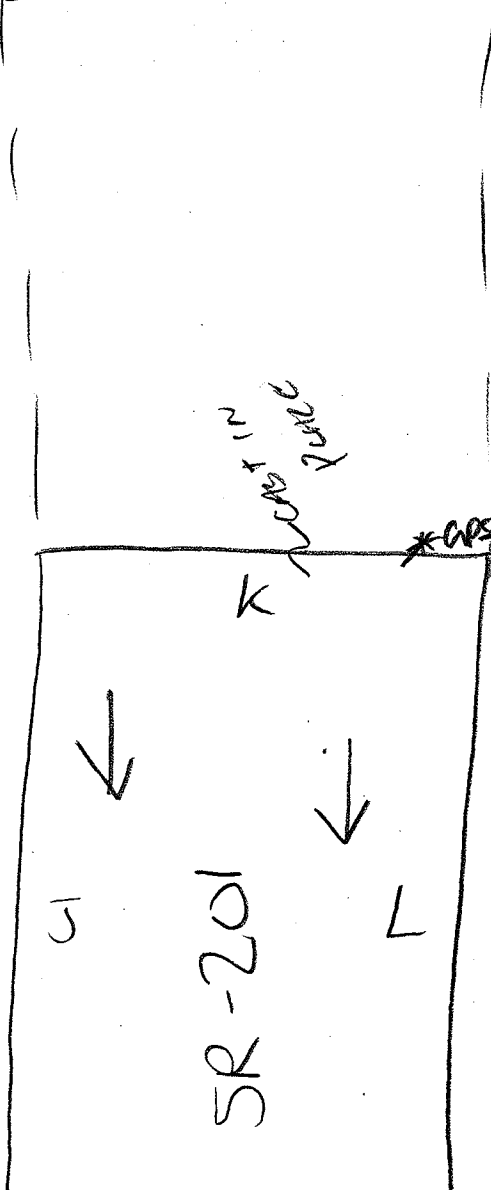
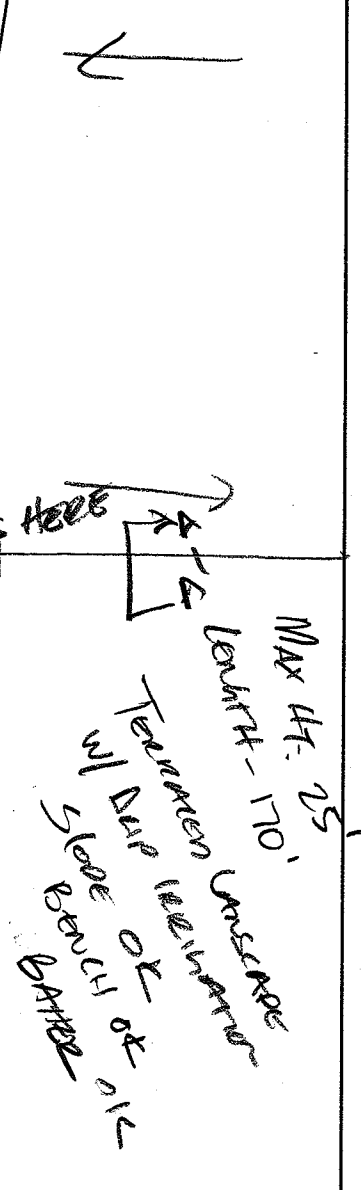
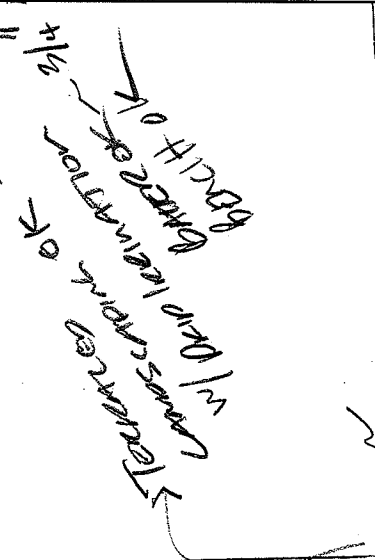
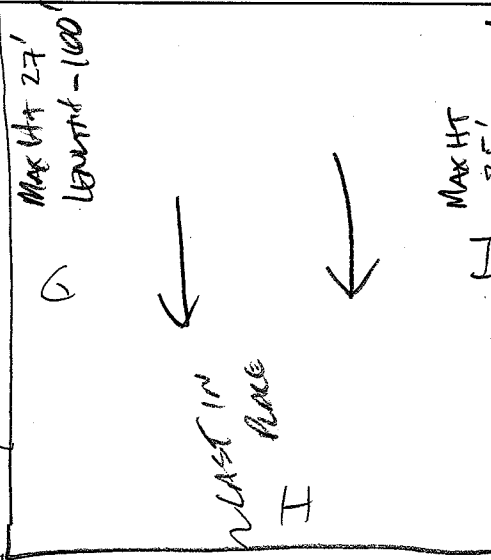
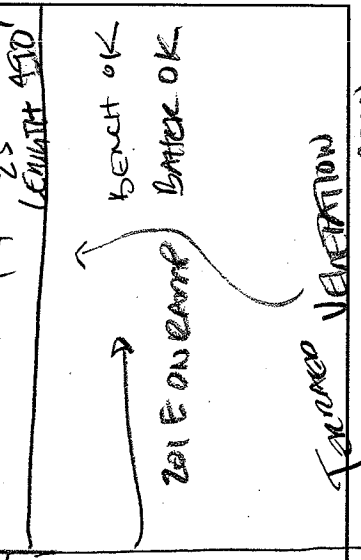
Plan View/Drainage:

MAX HT 27'
LENGTH - 100'
MAX HT 25'
LENGTH 90'
BENCH OK
BENCH OK

MAX HT. 25'
LENGTH - 170'
TERMINATED WITH SLOPE BENCH OR ALL SLOPE BENCH OR ALL SLOPE BENCH
