# STATE OF UTAH MSE WALL INSPECTION FORM

Compiled As Part of Research By The Utah Department of Transportation

Inspection Date	11/10/2007	Names Of Inspectors	Holly Griffin
Region	Z	Identifying Road/Intersection	Redwood + 201

MSE Wall at Bridge	<input checked="" type="radio"/> Y <input type="radio"/> N	Bridge Number if applicable:	UKN	Wall Number	R-444
Surrounding Structures	Commercial			Maximum Height of Wall (ft)	20 FT
Distance to Each Structure	~ 30 FT			One Stage, Two Stage or Block Wall	VICW
State Route Number	201			Estimated Max Length of Wall Abutment:	900'
Approximate Mile Marker	159			Max Slope of Ground in front of wall:	H: 36 V: 18
GPS Datum	<u>WGS/84</u> NAD/83, or NAD/27			Max Height of wall burial line above surrounding level ground:	25 FT
MSE Wall GPS Coordinates (Location of Measurement shown on plan view)	40° 43.495'			Please draw rough layout of panel with approximate dimensions in space provided below:	
	111° 56.319'				
If known, Panel or System Manufacturer	KL - Maxwarrant Construction

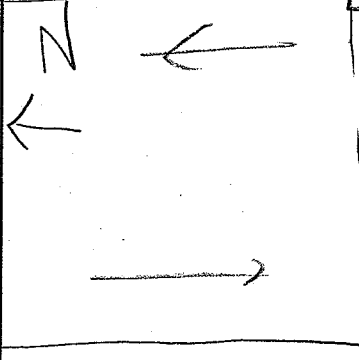
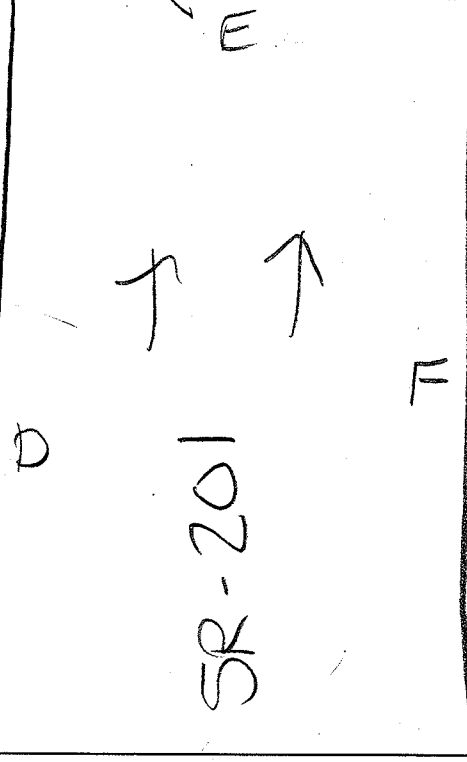
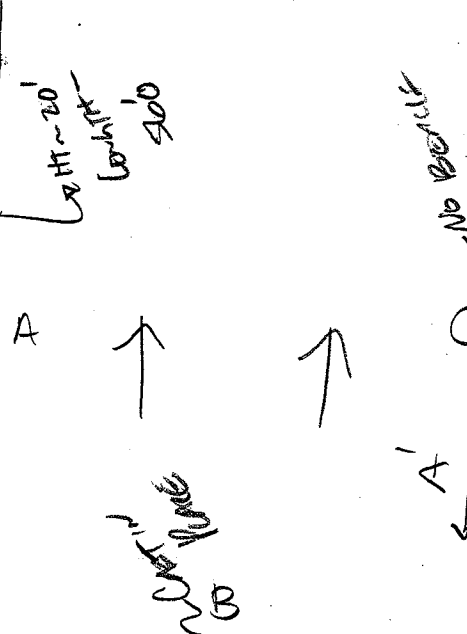
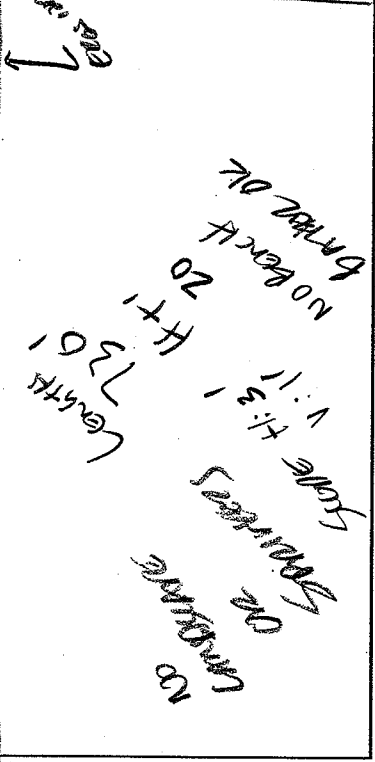
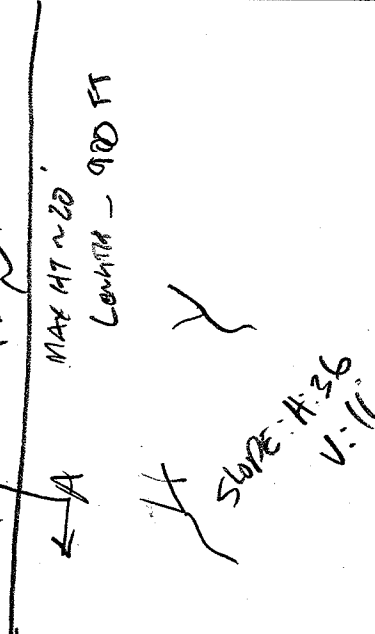
Plan View/Drainage:

Length  
330'  
HT = 20'  
BORIAL ~ 40'

NO SIGNIFICANT SCORE  
ON RAMP TO  
VEGETATION WITH DEEP  
NICER BOSS - FEET TO CORNER  
CANDOCK

HT ~ 20'  
Length 300

MAX HT ~ 20'  
Length 900 FT

SLOPE H:36  
V:16

Length 130'  
HT 20'  
SLOPE H:3 V:1  
NO SIGNIFICANT SCORE
