STATE OF UTAH MSE WALL INSPECTION FORM

Compiled As Part of Research By The Utah Department of Transportation

Region	3	Identifying Road/Intersection	1200 W, 800 N, Orem
---------------	---	--------------------------------------	---------------------

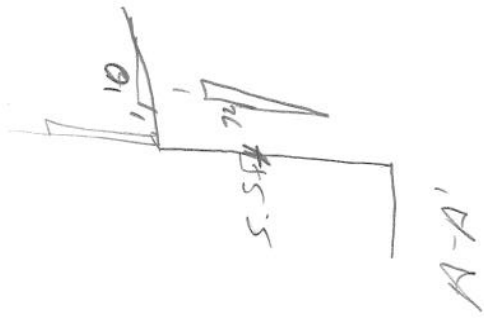
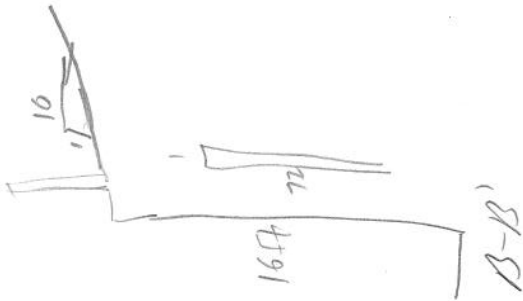
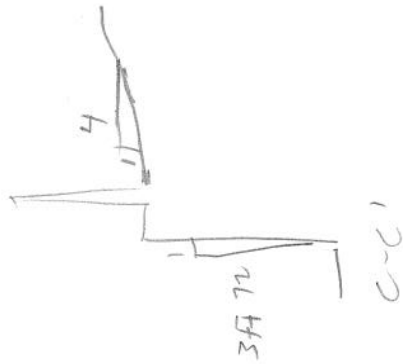
Cross Sections:

- modular block wall
- about 7 blocks with vertical cracks
