# STATE OF UTAH MSE WALL INSPECTION FORM

Compiled As Part of Research By The Utah Department of Transportation

<b>Region</b>	4	<b>Identifying Road/Intersection</b>	Milford, SR-21, WPAR, west side
---------------	---	--------------------------------------	---------------------------------

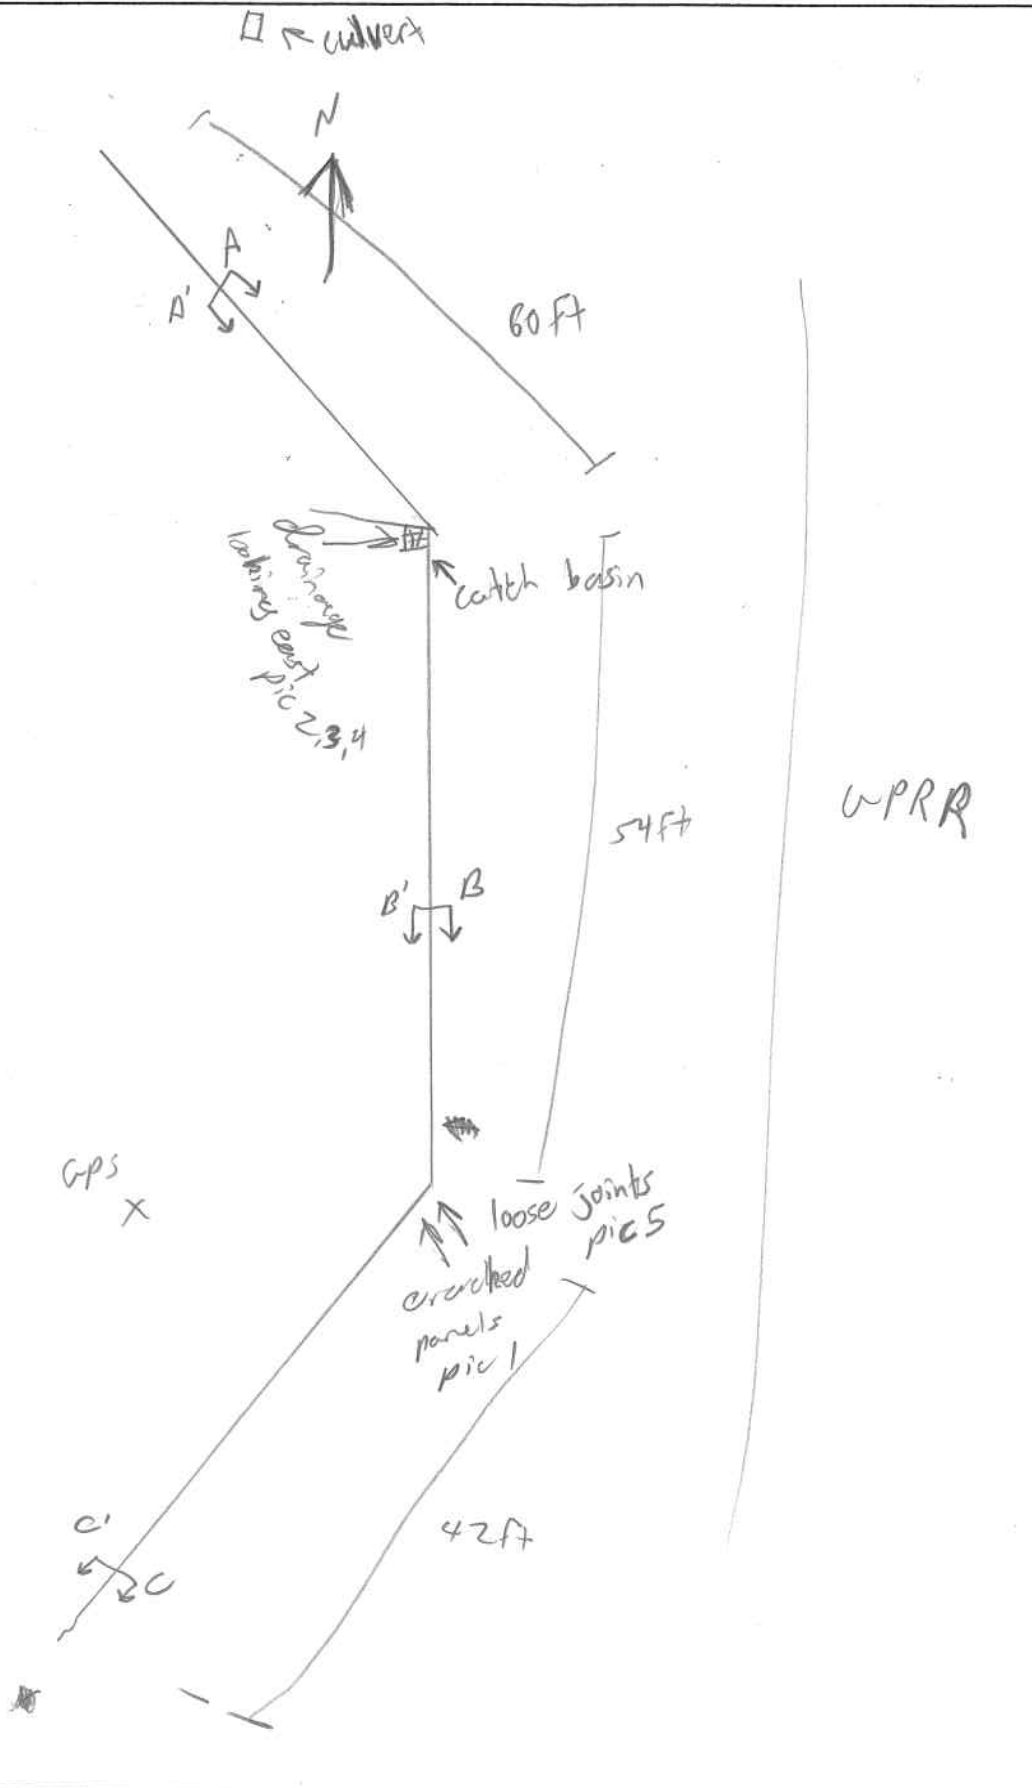
**Plan View/Drainage:**

South, west corner open joints and cracked blocks  
 blocks appear porous (more than others inspected)  
 suggest strength test in compression on blocks  
 water can drain around slope protection
