STATE OF UTAH MSE WALL INSPECTION FORM

Compiled As Part of Research By The Utah Department of Transportation

Region	4	Identifying Road/Intersection	Miltford, SR-21, UPRR, east
---------------	---	--------------------------------------	-----------------------------

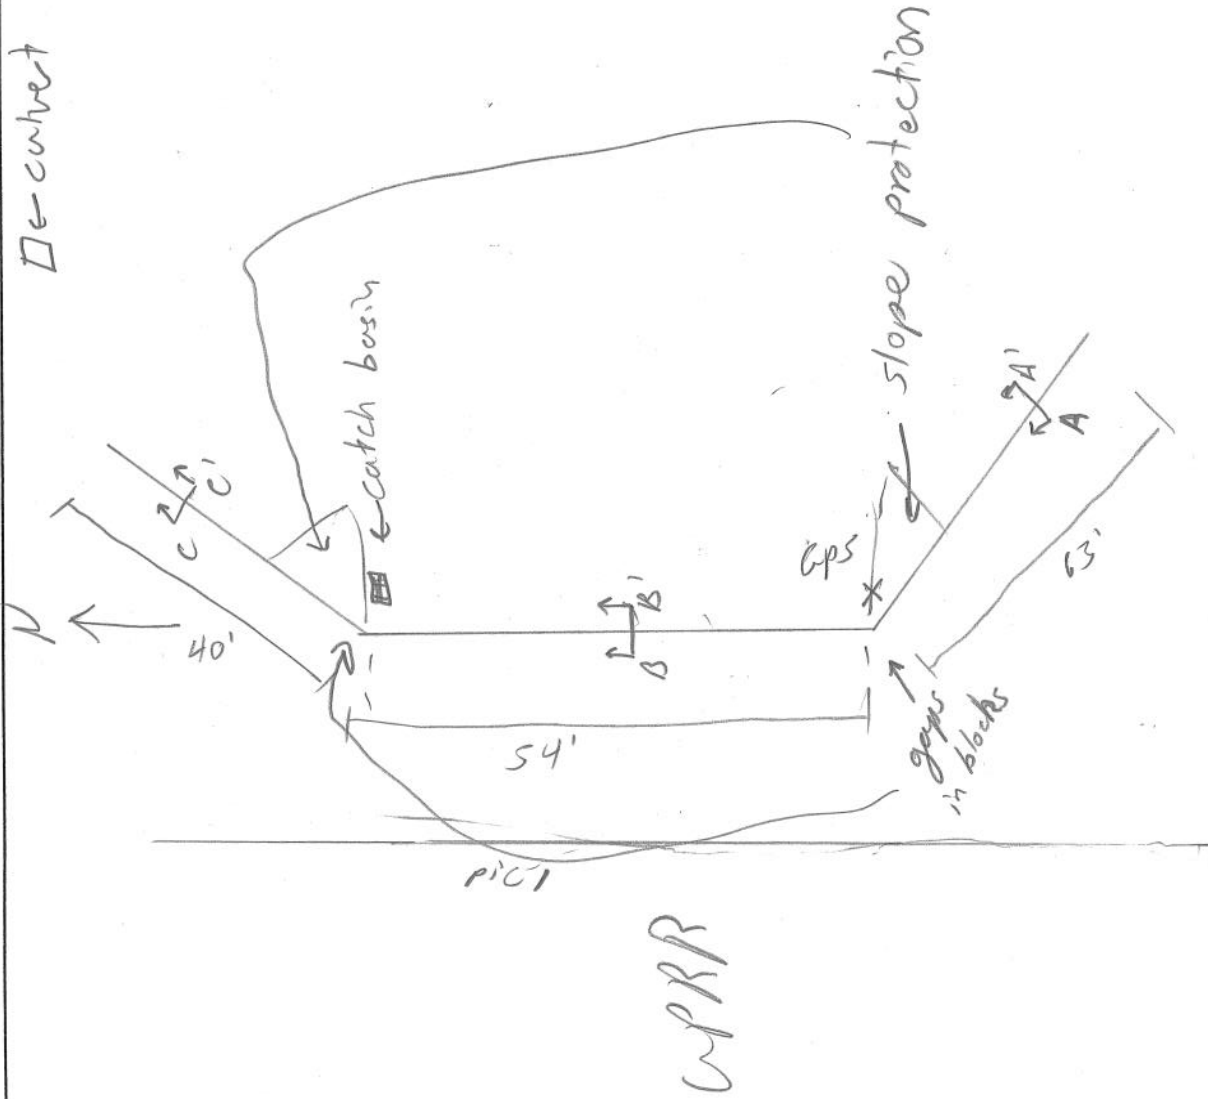
Plan View/Drainage:

loose joints in corners
minimal slope protection
