# STATE OF UTAH MSE WALL INSPECTION FORM

Compiled As Part of Research By The Utah Department of Transportation

Inspection Date	7/20/2009	Names Of Inspectors	Henry/Ryan
Region	Z	Identifying Road/Intersection	SC-71-CARNATION

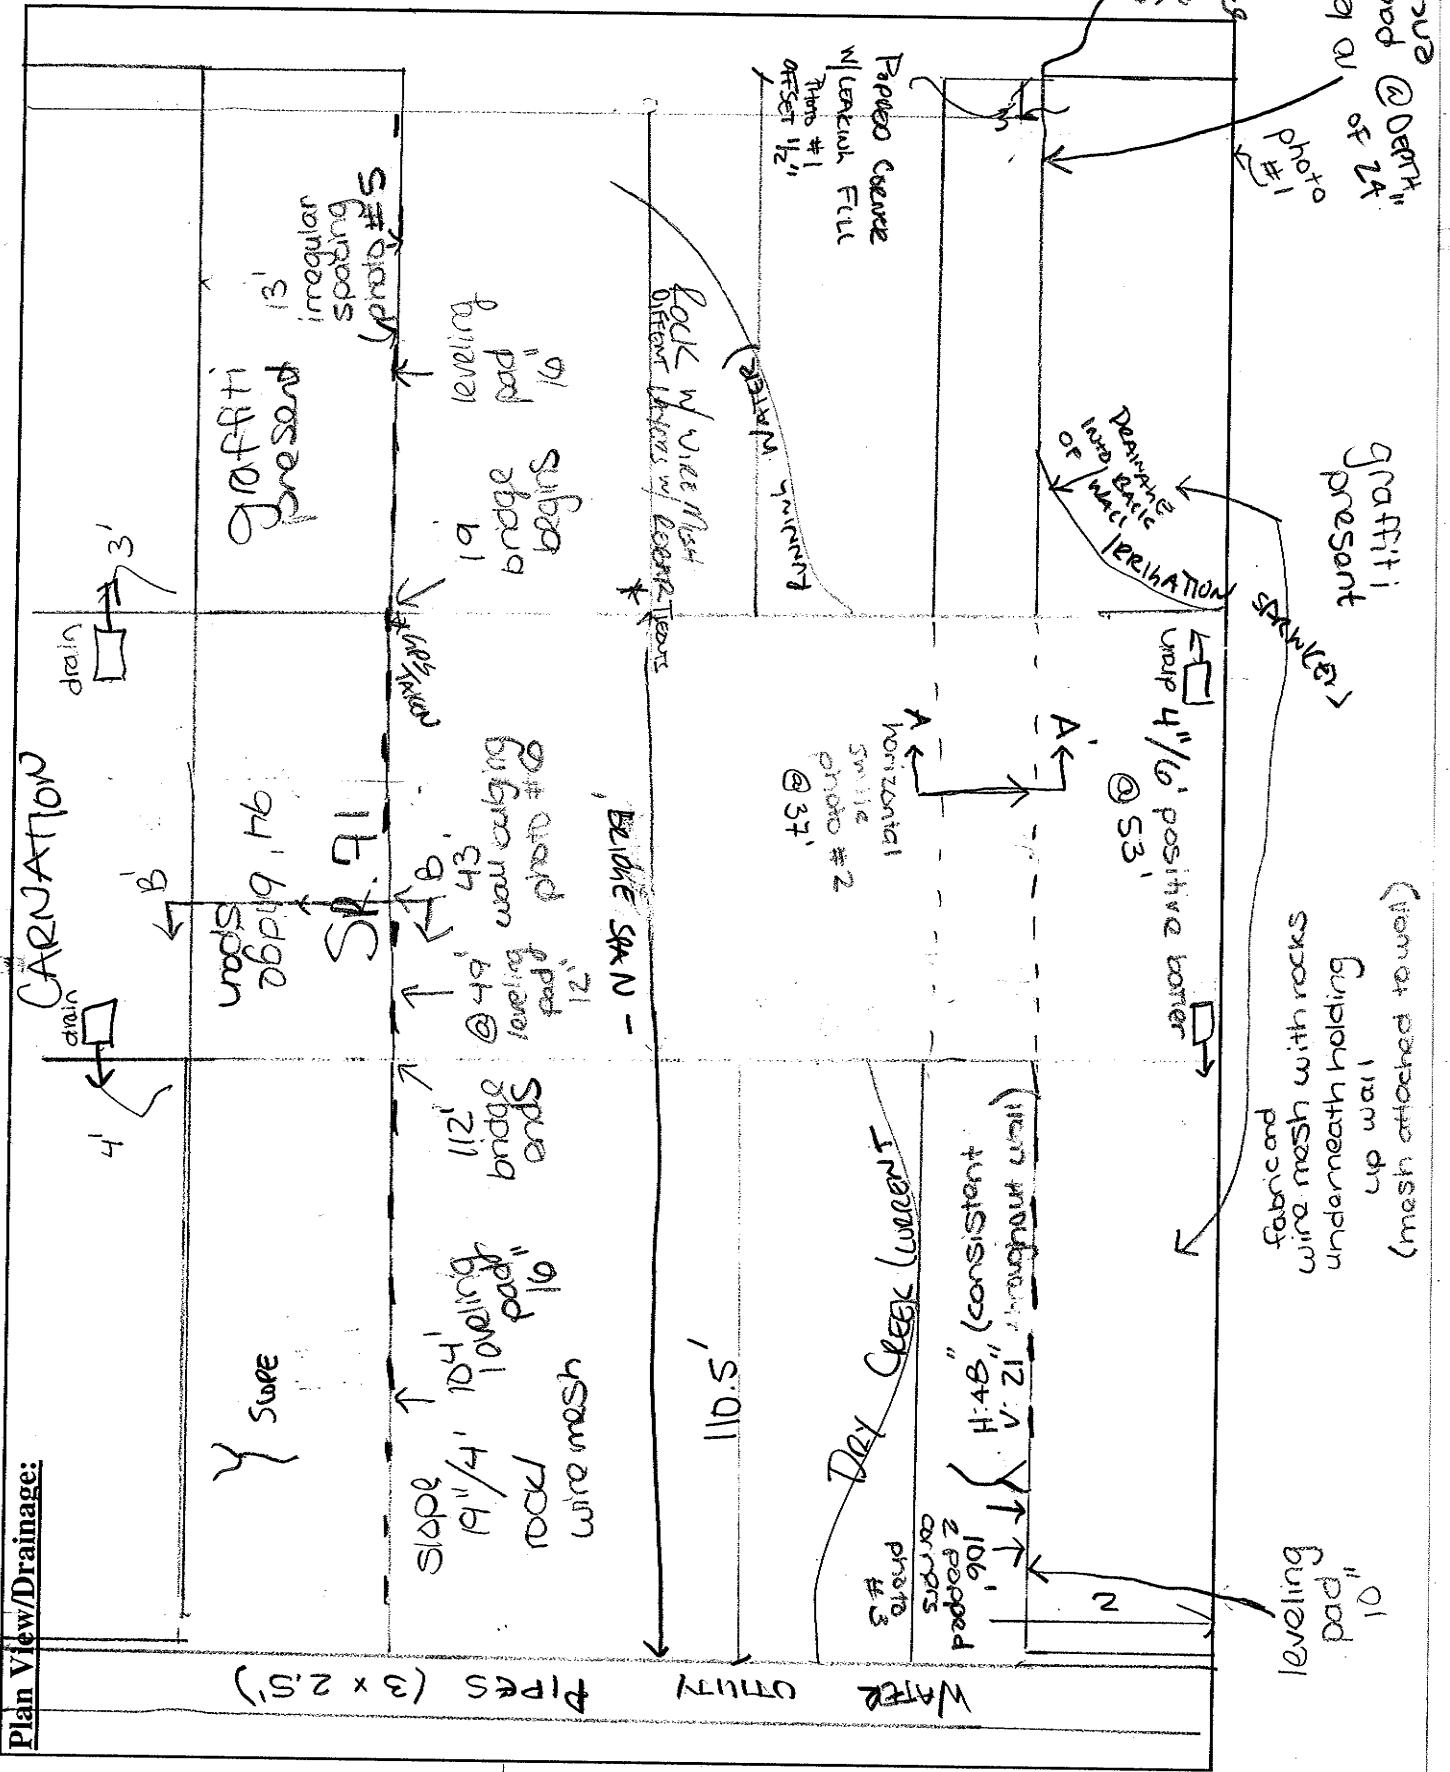
### Plan View/Drainage:

no 4' bench present  
 uneven leveling pad  
 steep slope  
 irrigation sprinklers too close  
 differential settlement

irrigation issues  
continue on  
east side
