STATE OF UTAH MSE WALL INSPECTION FORM

Compiled As Part of Research By The Utah Department of Transportation

Region	4	Identifying Road/Intersection	SR-18 ledges interchange
---------------	---	--------------------------------------	--------------------------

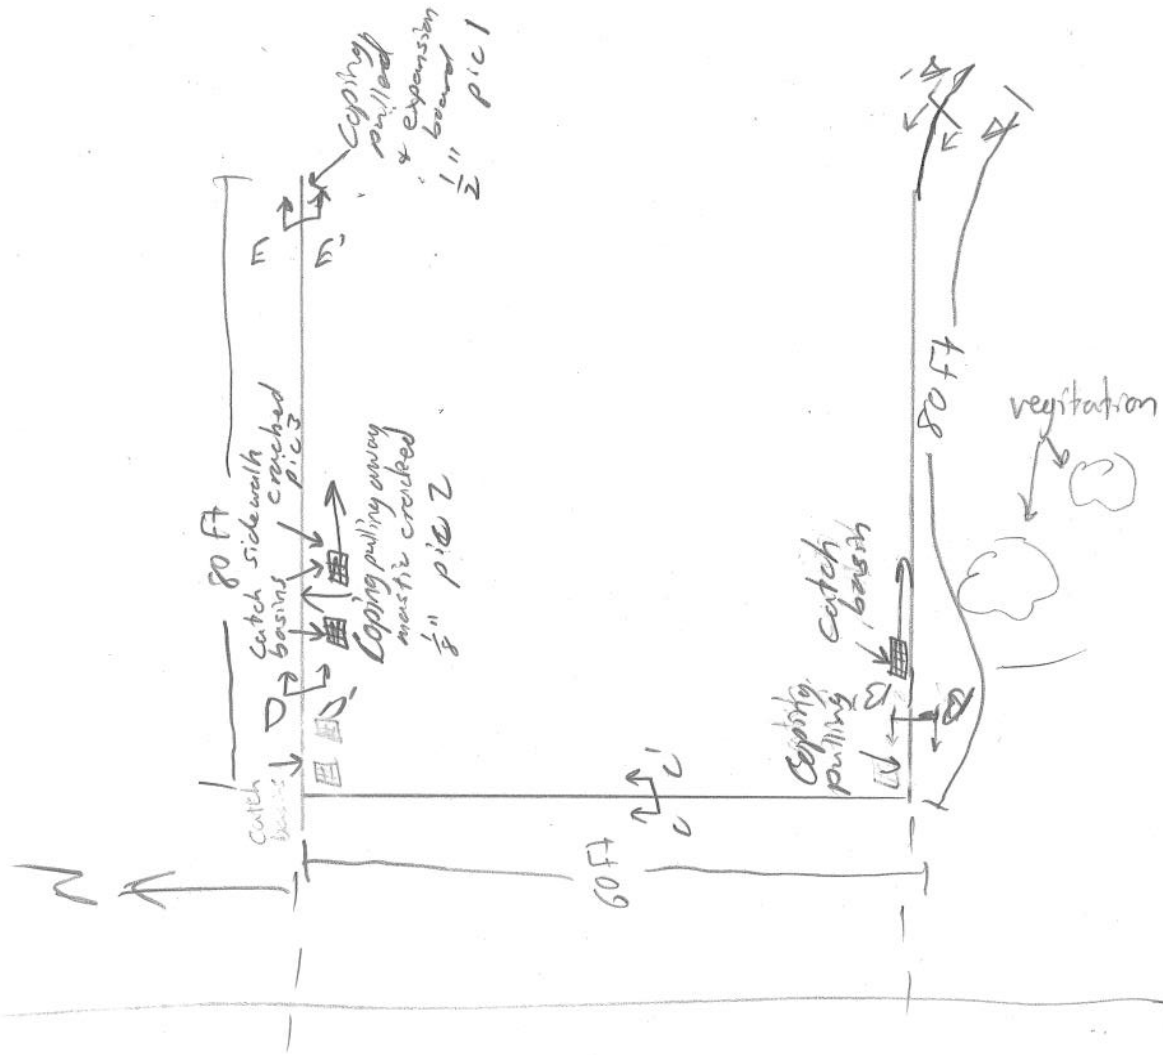
Plan View/Drainage:

coping pulling from slabs on north and south face

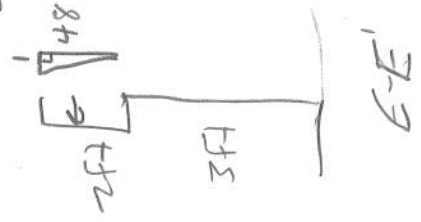
rocking due to
coping pulling
away.
