# STATE OF UTAH MSE WALL INSPECTION FORM

Compiled As Part of Research By The Utah Department of Transportation

<b>Region</b>	4	<b>Identifying Road/Intersection</b>	SR-18, 1200 Ft. N Ledges pkwy Interchange
---------------	---	--------------------------------------	---

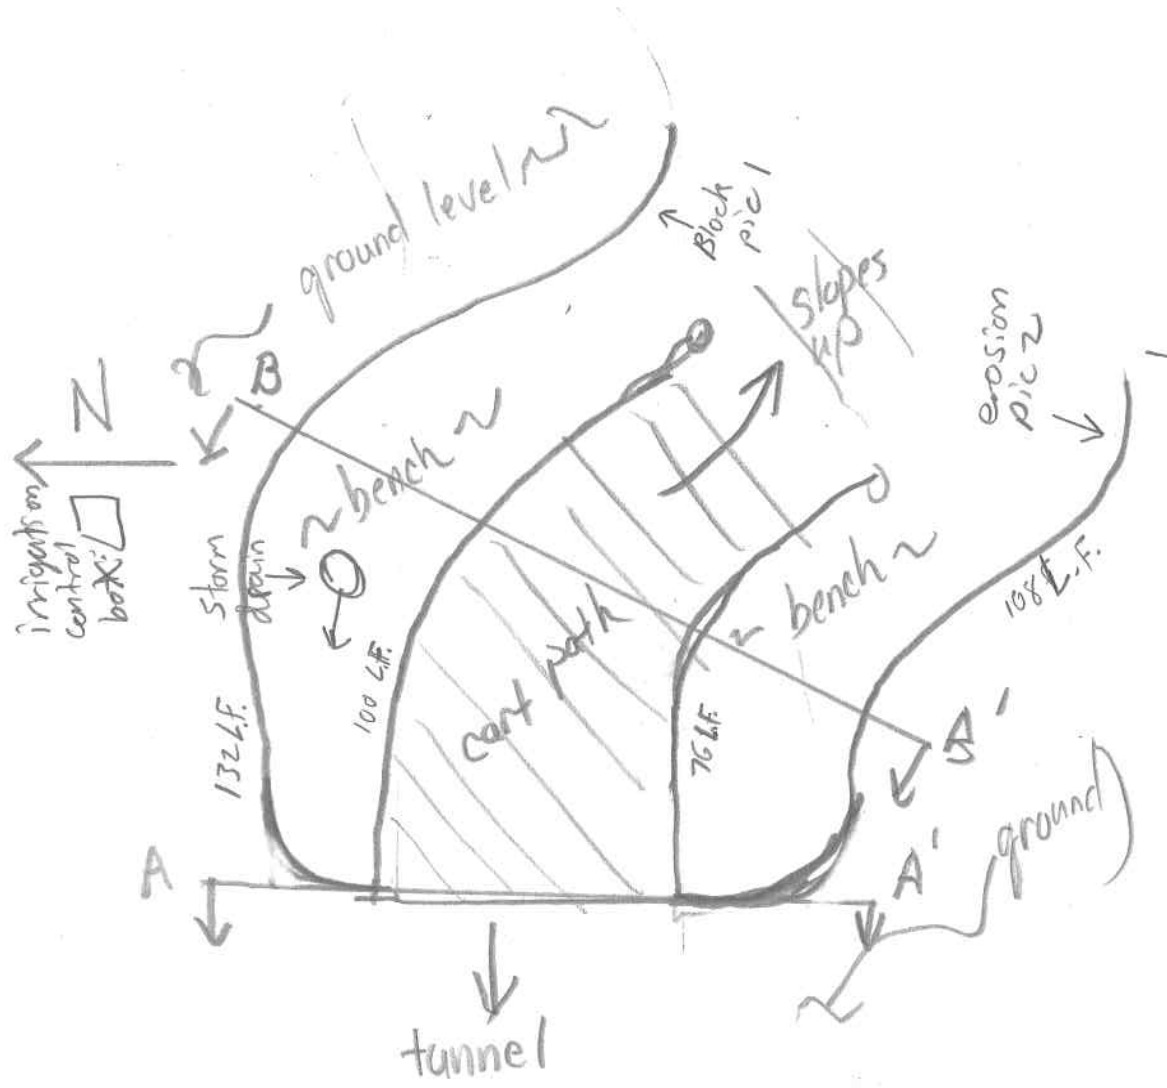
Plan View/Drainage:

leveling shims appear to be asphalt shingles
