STATE OF UTAH MSE WALL INSPECTION FORM

Compiled As Part of Research By The Utah Department of Transportation

Region	3	Identifying Road/Intersection	
		800 N, SR-189 (East side)

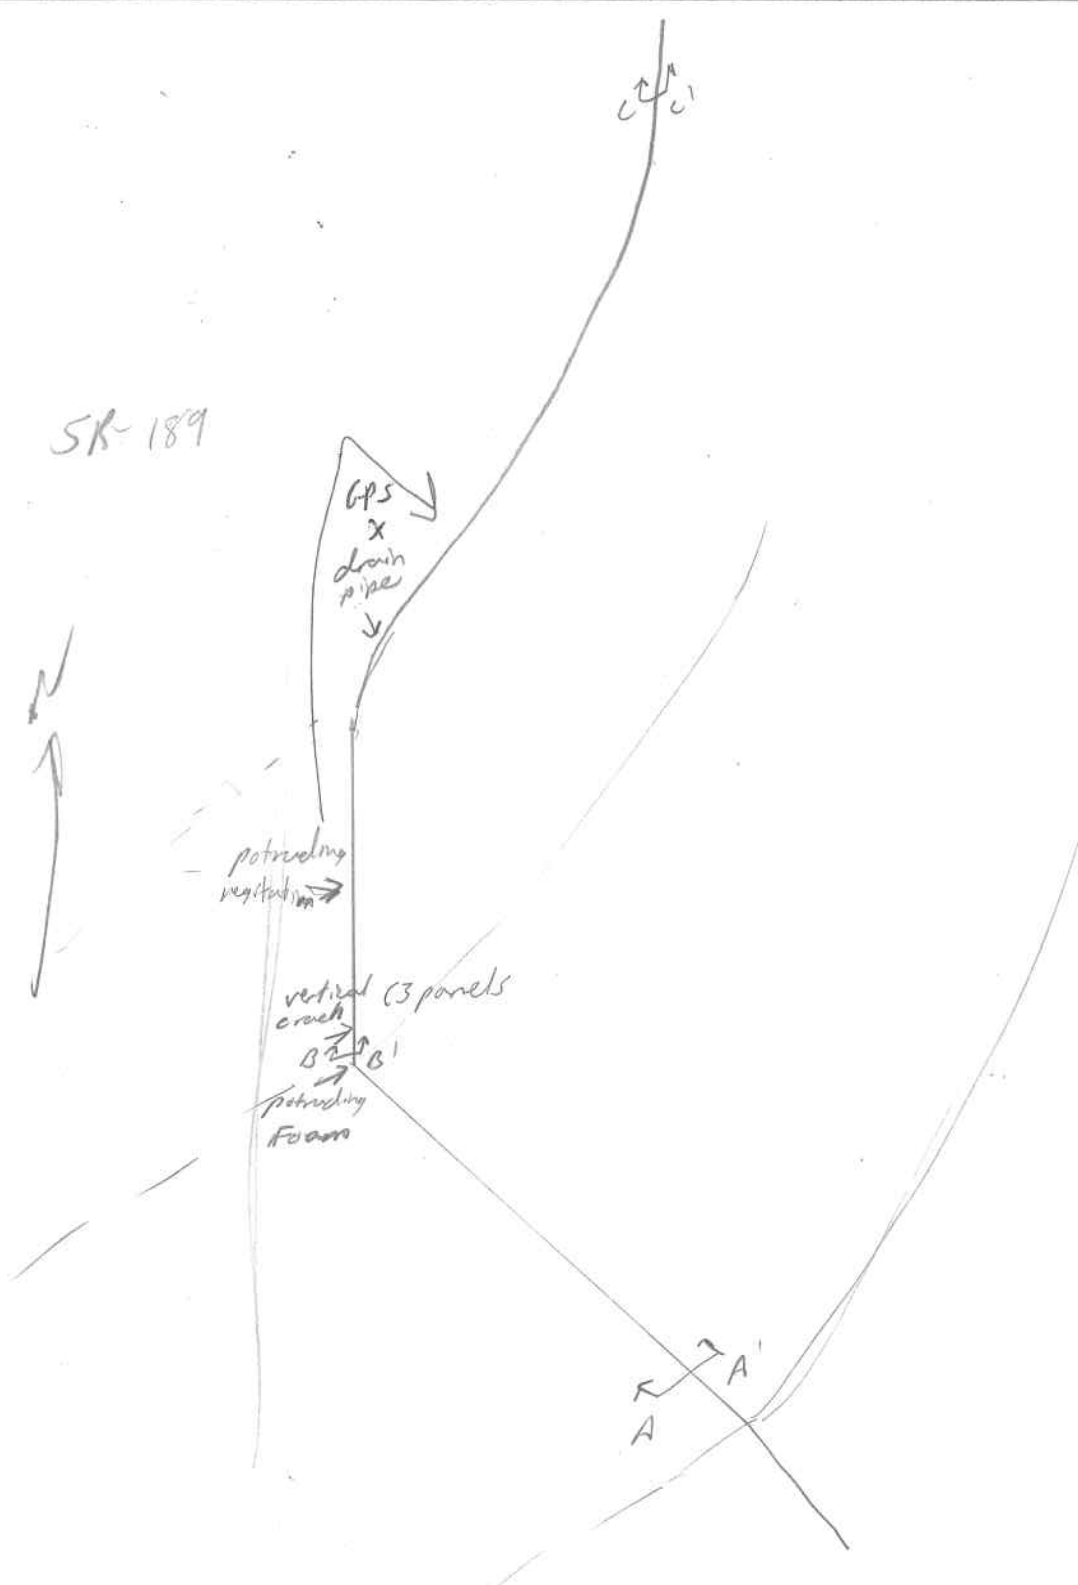
Plan View/Drainage:

plants growing from cracks
panel corrosion
panel cracking
