STATE OF UTAH MSE WALL INSPECTION FORM

Compiled As Part of Research By The Utah Department of Transportation

Inspection Date	11/10/07	Names Of Inspectors	Holly Griffin Rynmar
Region	2	Identifying Road/Intersection	600 N & I-15

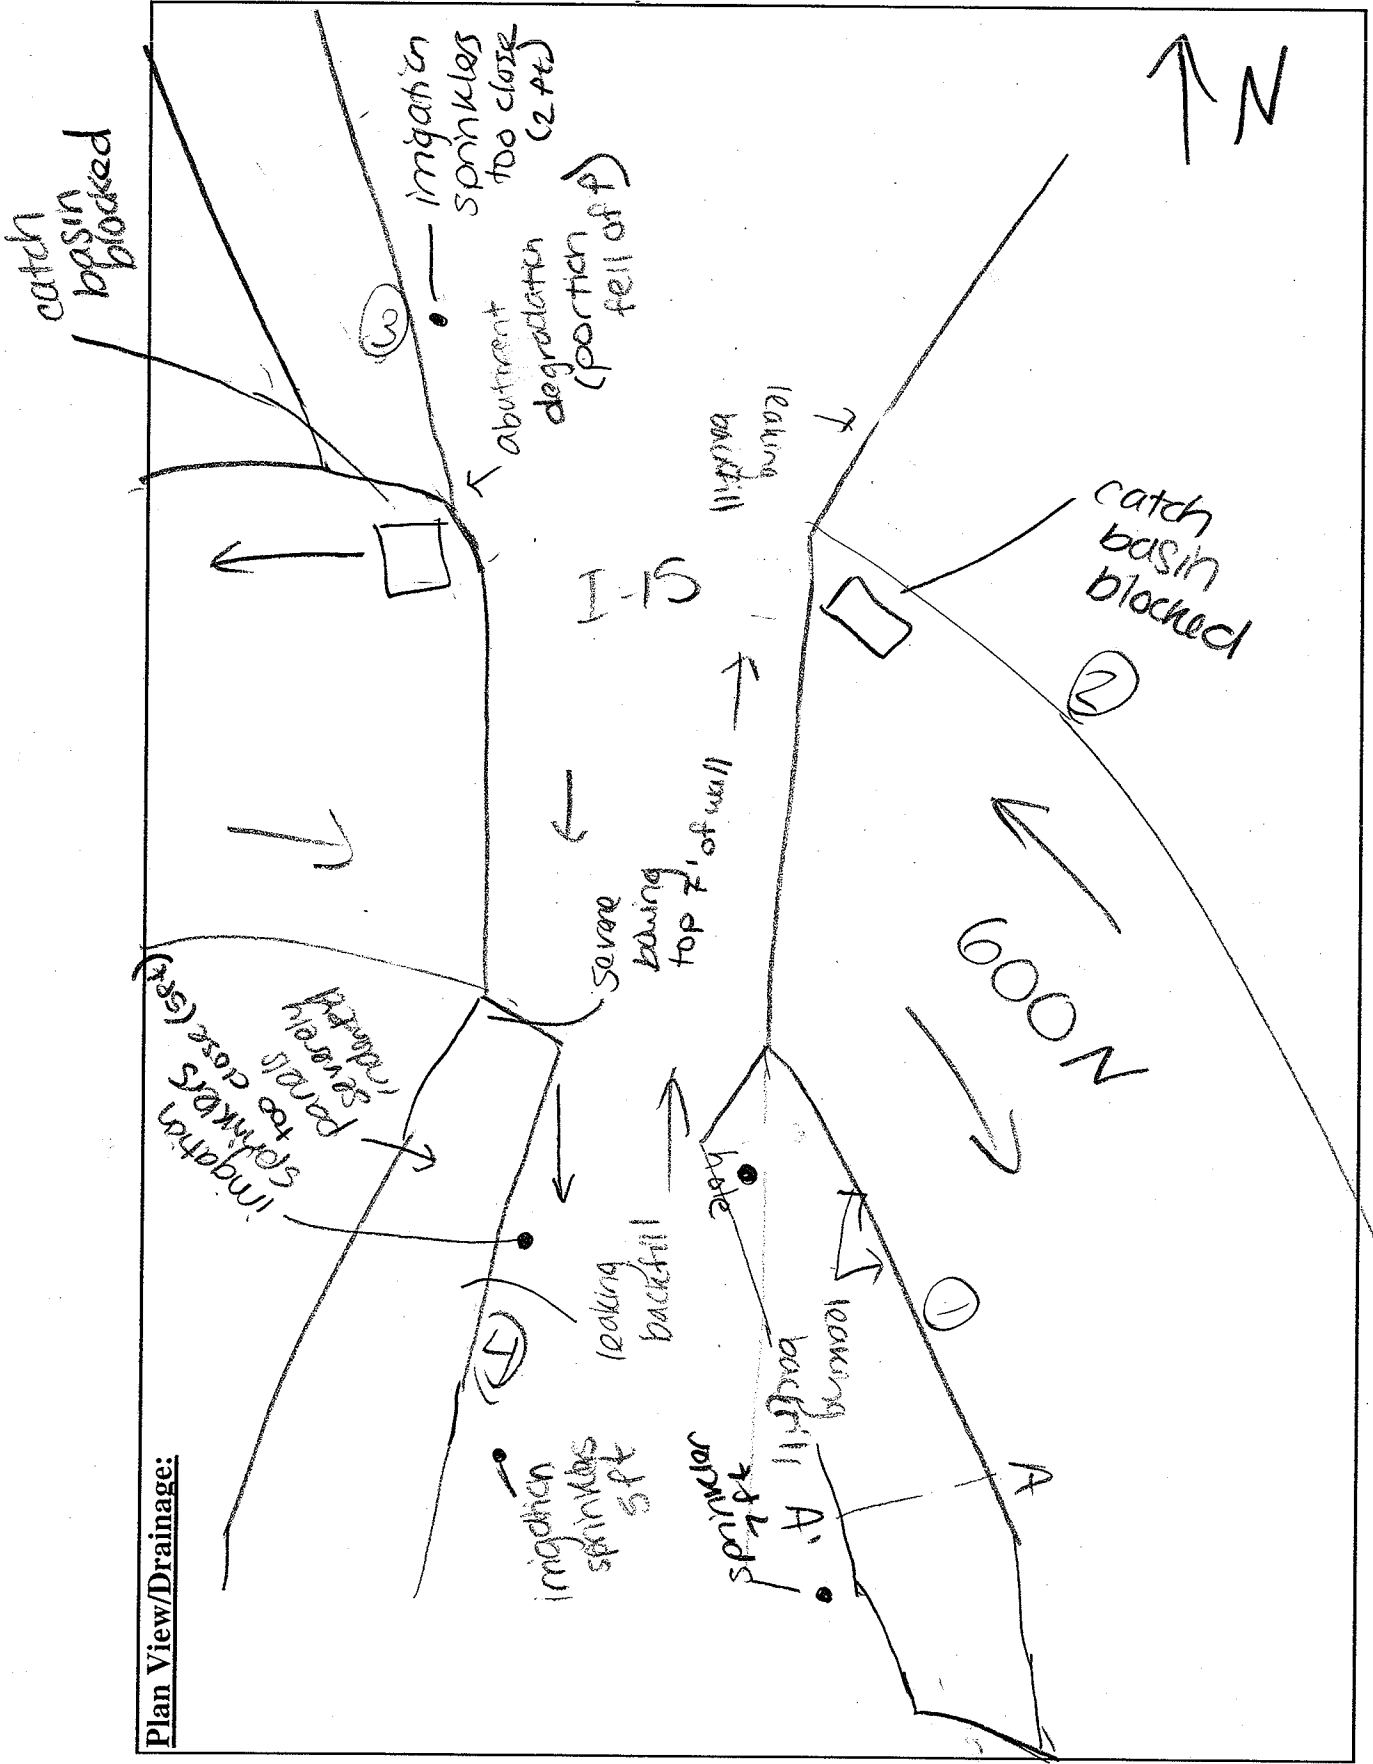
Plan View/Drainage:

Portion # 3 suggests differential settlement - parapet severely degraded and fallen off, rebar exposed, panels appear to have moved just under degraded parapet

Portion # 4 - severe bowing - coping, parapet and wall have displaced about 4"
