STATE OF UTAH MSE WALL INSPECTION FORM

Inspection Date	7/31/07	Names Of Inspectors	Ryan Mow, Holly G. Nash
Region	2	Identifying Road/Intersection	I-215 MP 6.0

MSE Wall at Bridge	Y <input checked="" type="radio"/> N <input type="radio"/>	Bridge Number if applicable:		Wall Number	R-181/448
Surrounding Structures	/		Maximum Height of Wall (ft)	3.5 panels	
Distance to Each Structure	/		<input checked="" type="radio"/> One Stage <input type="radio"/> Two Stage or Block Wall	one stage	
State Route Number	I-215		Estimated Max Length of Wall Abutment:	667 ft	
Approximate Mile Marker	MPS		Max Slope of Ground in front of wall:	level	
GPS Datum	WGS/84, NAD/83, or NAD/27		Max Height of wall burial line above surrounding level ground:	0"	
MSE Wall GPS Coordinates (Location of Measurement shown on plan view)	N 40° 39.539 W 111° 48.364		Please draw rough layout of panel with approximate dimensions in space provided below:		
If known, Panel or System Manufacturer	unknown

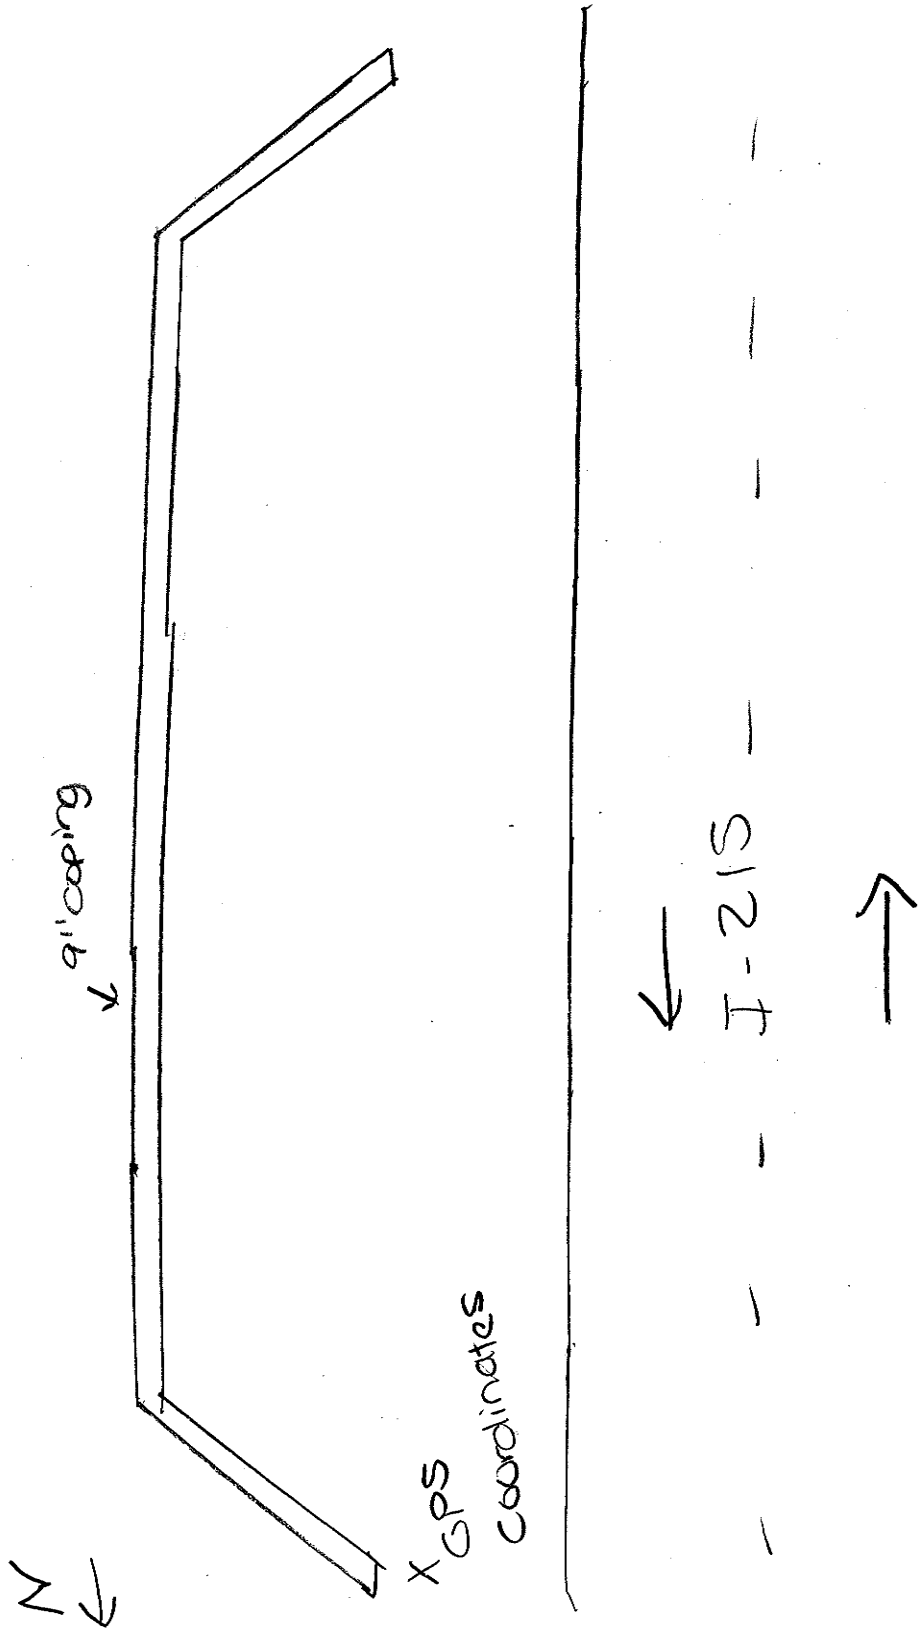
Plan View/Drainage:

9' coping
5 8'x6' panels
