STATE OF UTAH MSE WALL INSPECTION FORM

Compiled As Part of Research By The Utah Department of Transportation

Inspection Date	7/25/07	Names Of Inspectors	Ryan Maw, Holly Griffin
Region	1	Identifying Road/Intersection	SR-91

MSE Wall at Bridge	Y <input checked="" type="radio"/> N	Bridge Number if applicable:	N/A	Wall Number	R-281
Surrounding Structures	N/A		Maximum Height of Wall (ft)	30'	
Distance to Each Structure	N/A		One Stage, Two Stage or Block Wall	one stage	
State Route Number	SR 91/89		Estimated Max Length of Wall Abutment:	110 paces x 2.17 ft	
Approximate Mile Marker	6		Max Slope of Ground in front of wall:	22" x 3'	
GPS Datum	WGS/84, NAD/83, or NAD/27		Max Height of wall burial line above surrounding level ground:	30'	
MSE Wall GPS Coordinates (Location of Measurement shown on plan view)	N 41° 29.827		Please draw rough layout of panel with approximate dimensions in space provided below:		
	W 111° 57.426				
If known, Panel or System Manufacturer	VSL		8x64

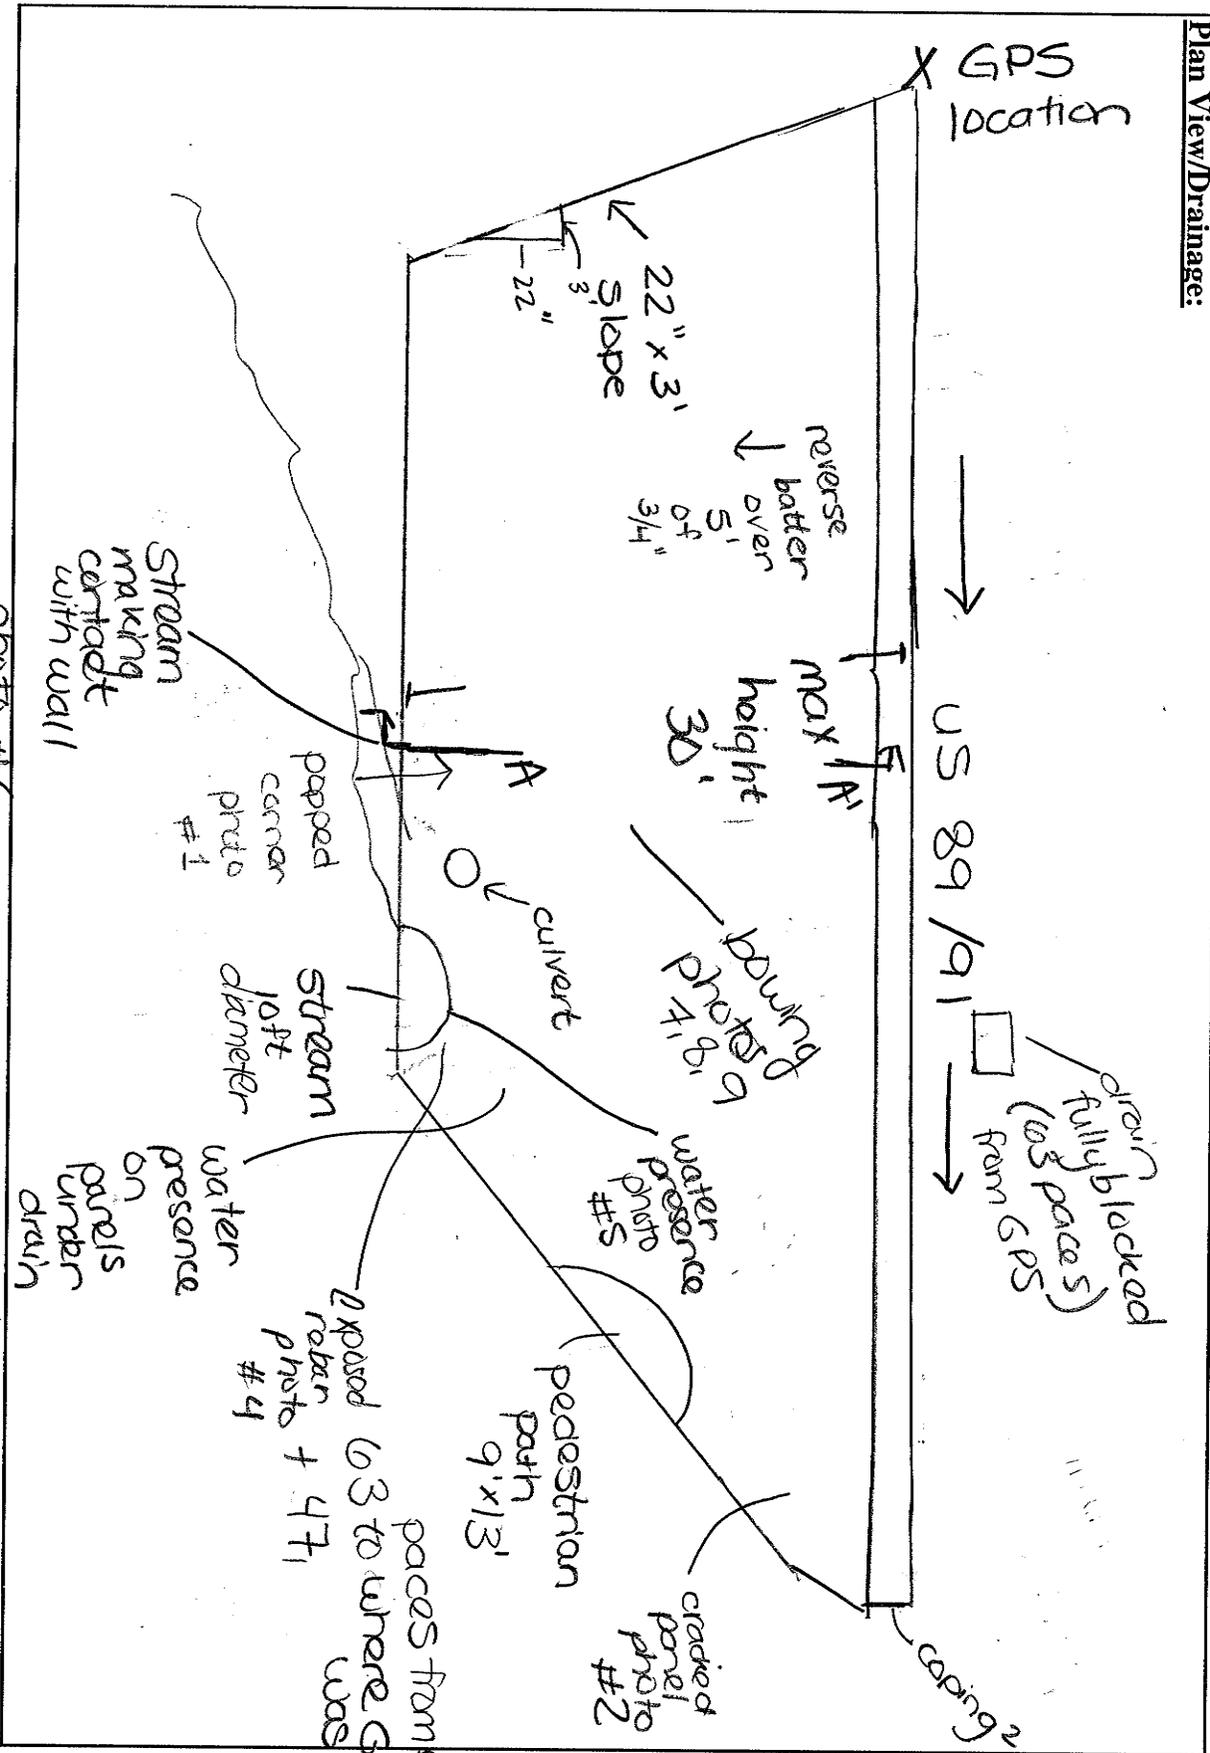
creek eroding wall
 creek in contact w/wall
 bowing present in center of wall
 leaking observed - likely due to blocked drain

photo #6

photo #3

total wall : 63 + 47 paces
 @ 2.17 paces
