# STATE OF UTAH MSE WALL INSPECTION FORM

Compiled As Part of Research By The Utah Department of Transportation

Inspection Date	8/1/2007	Names Of Inspectors	RYAN MAN / HOLLY
Region	2	Identifying Road/Intersection	I-15 / 9000 SOUTH (209)

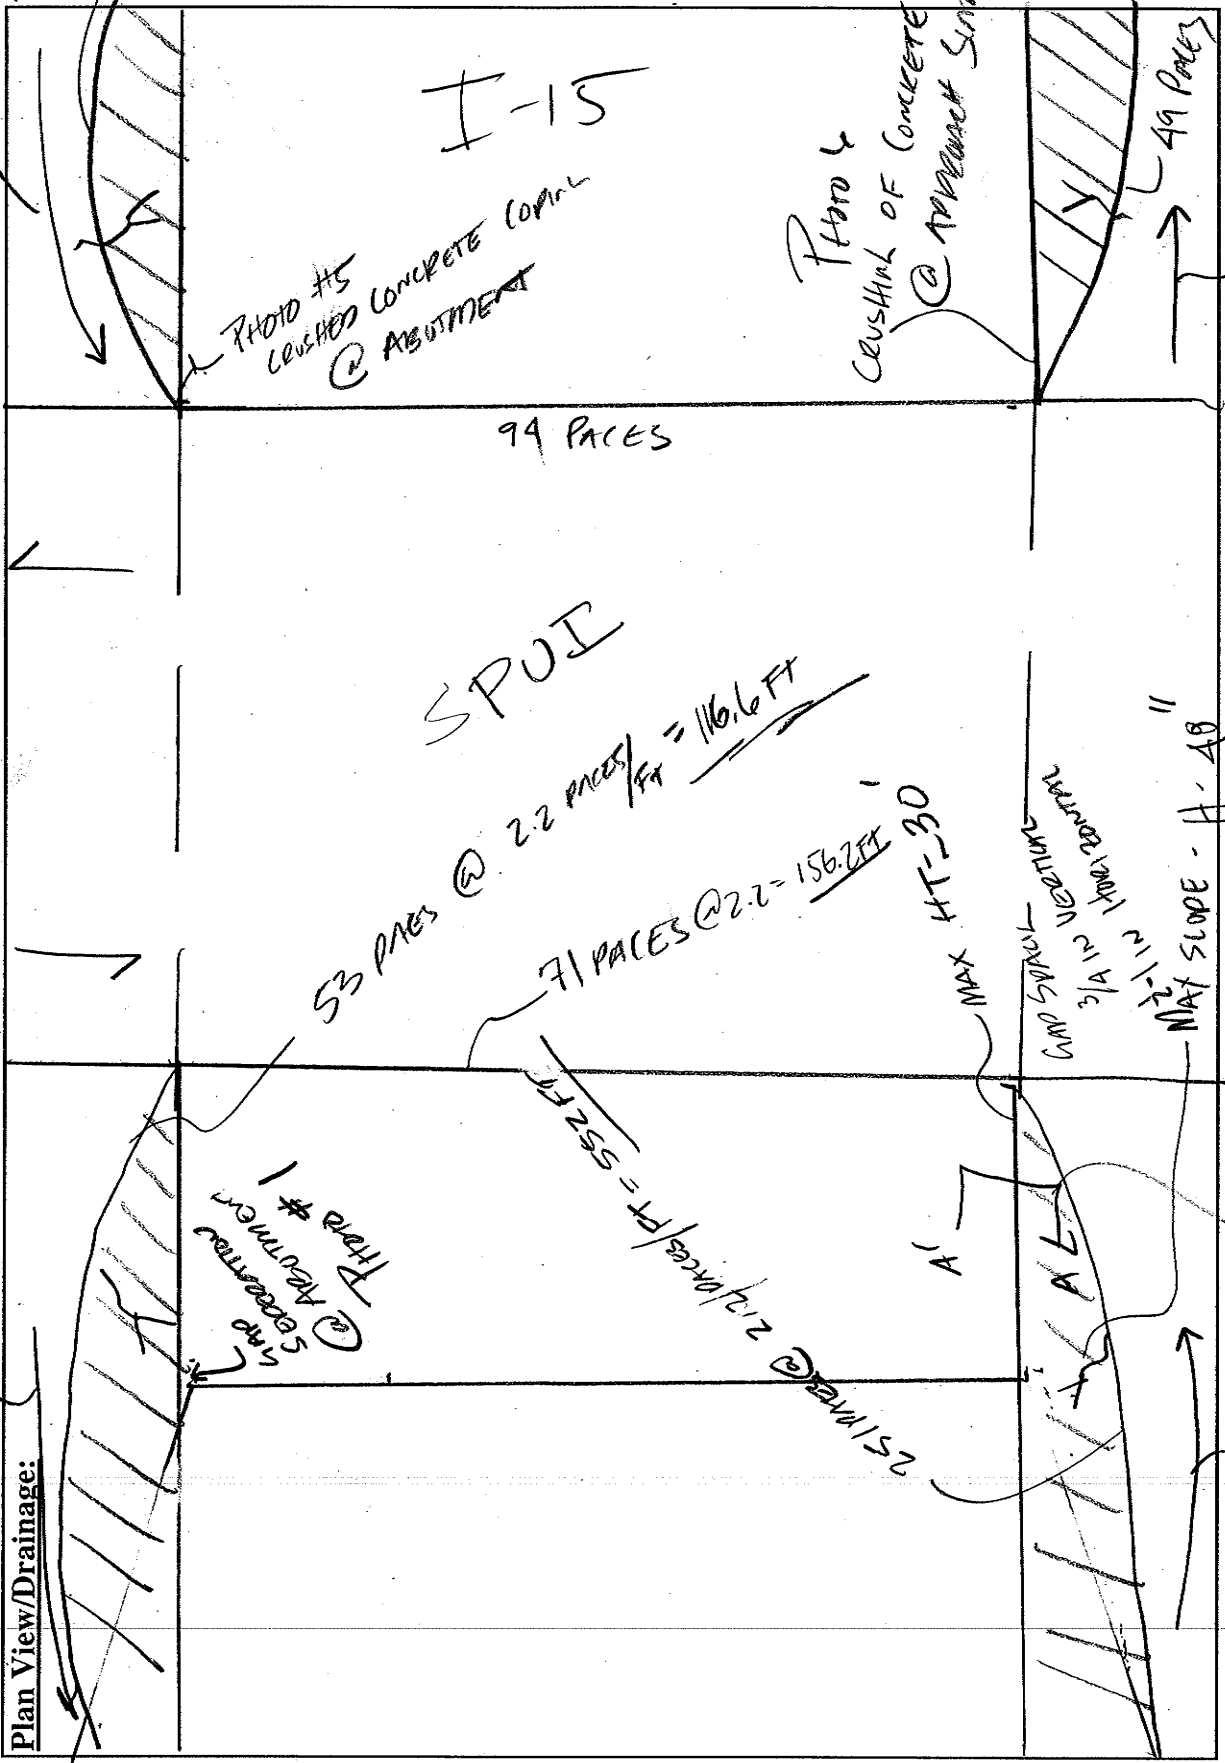
Plan View/Drainage:

□ WALL IN GREAT CONDITION w/ LIMITED PROBLEMS  
LOCATED AT ABUTMENTS

PHOTO #5  
CRUSHED CONCRETE CORNER  
@ ABUTMENT

HARD &  
CRUSHING OF CONCRETE  
@ APPROXIMATE SIGN
