0A, 9, 10B

North Walls

STATE OF UTAH MSE WALL INSPECTION FORM

Compiled As Part of Research By The Utah Department of Transportation

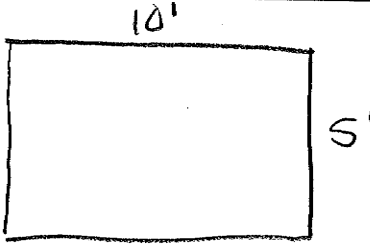
10A
10B
9

- walls inaccessible due to railroad and commercial property
