STATE OF UTAH MSE WALL INSPECTION FORM

Compiled As Part of Research By The Utah Department of Transportation

Inspection Date	8/15/07	Names Of Inspectors	Ryan Mow, Holly Griffin
Region	2

MSE Wall at Bridge	(Y) (N)	Bridge Number if applicable:	F-618 S	Wall Number	R-346
Surrounding Structures	water main		Maximum Height of Wall (ft)	25 ft	
Distance to Each Structure	10 ft		One Stage, Two Stage or Block Wall	A+B one, C+two	
State Route Number	I-15 and 3300 S		Estimated Max Length of Wall Abutment:	1520 Ft (C)	
Approximate Mile Marker			Max Slope of Ground in front of wall:	1' to 2'	
GPS Datum	(WGS/84), NAD/83, or NAD/27		Max Height of wall burial line above surrounding level ground:	level	
MSE Wall GPS Coordinates (Location of Measurement shown on plan view)	N 40° 41.60'		Please draw rough layout of panel with approximate dimensions in space provided below:		
	W 111° 54.216'				
If known, Panel or System Manufacturer	unknown

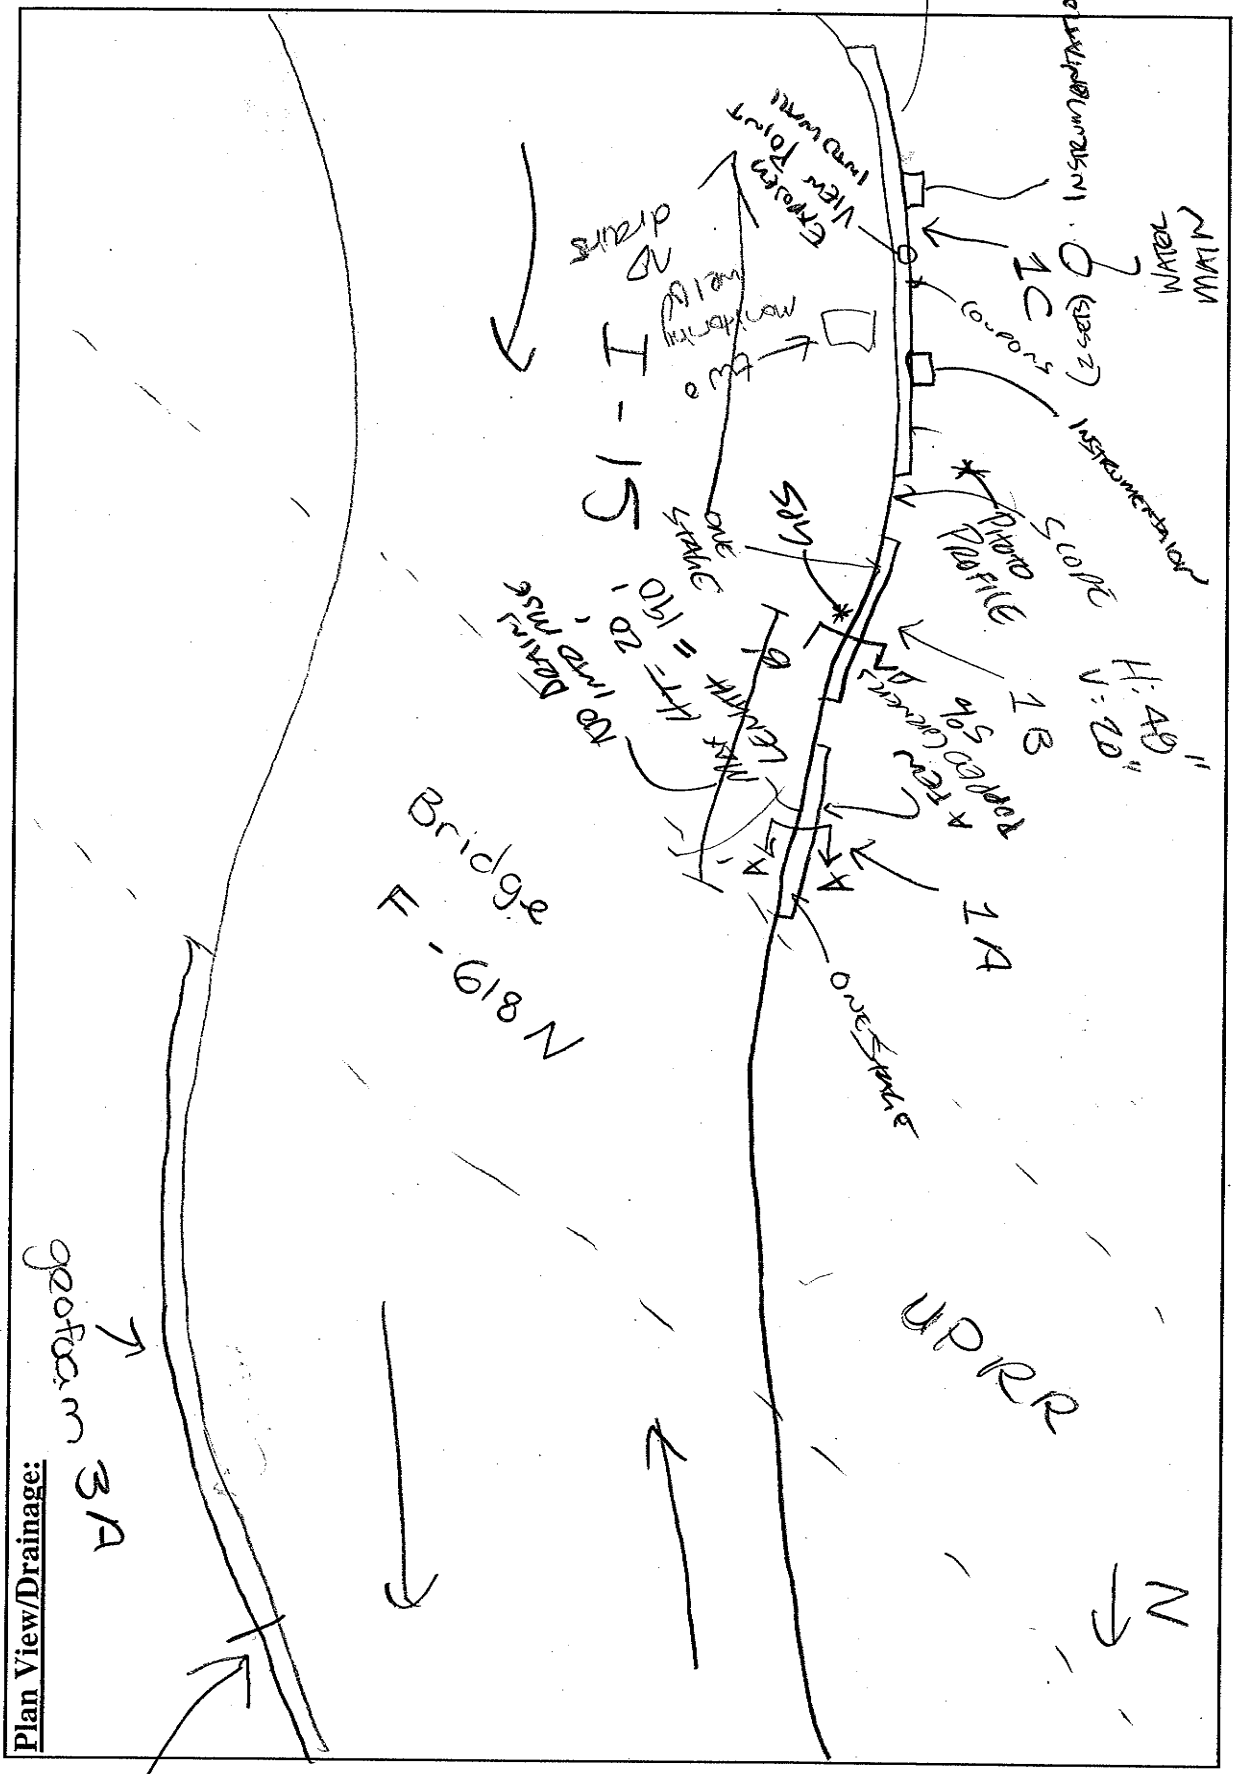
Plan View/Drainage:

geobarn 3A

152 panels long
5 panels max height
panels 10 ft long

two-stage to geobarn
