STATE OF UTAH MSE WALL INSPECTION FORM

Compiled As Part of Research By The Utah Department of Transportation

Inspection Date	7/26/07	Names Of Inspectors Ryan Maw, Holly Griffin
Region	1

MSE Wall at Bridge	(Y) N	Bridge Number if applicable:		Wall Number	R-359
Surrounding Structures	Cast-in-place wall			Maximum Height of Wall (ft)	
Distance to Each Structure	50 ft			One Stage, Two Stage or Block Wall	one
State Route Number	89/91			Estimated Max Length of Wall Abutment:	
Approximate Mile Marker				Max Slope of Ground in front of wall:	0
GPS Datum	(WGS/84) NAD/83, or NAD/27			Max Height of wall burial line above surrounding level ground:	
MSE Wall GPS Coordinates (Location of Measurement shown on plan view)					
If known, Panel or System Manufacturer					
			Please draw rough layout of panel with approximate dimensions in space provided below:		
			<div style="border: 1px solid black; width: 100px; height: 80px; margin: 0 auto;"></div> <p style="text-align: right; margin-right: 20px;">5 ft</p>

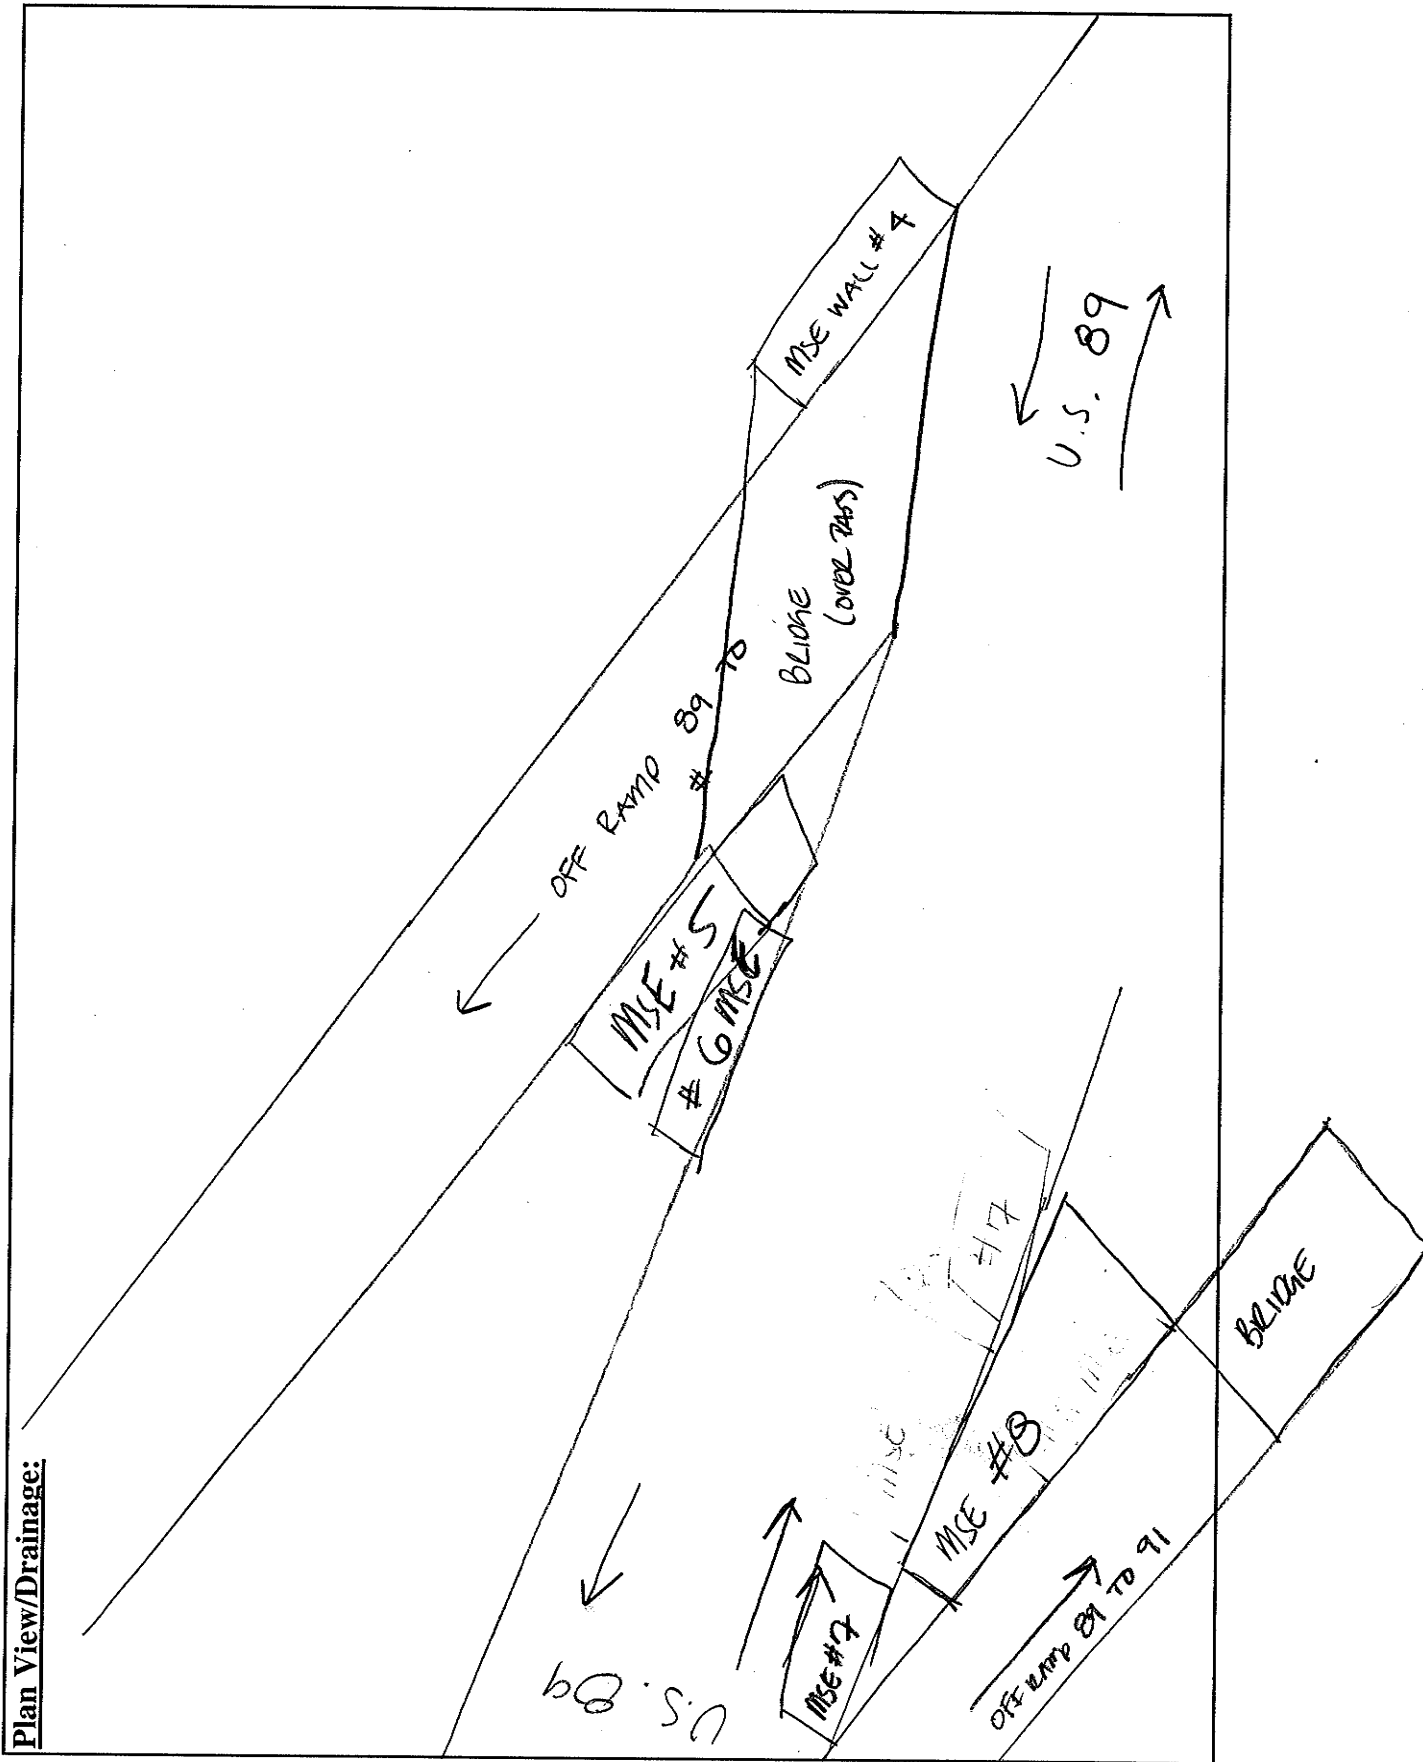
South Walls

drains into pipe which drains back into gutter along west

erosion along top of walls
