STATE OF UTAH MSE WALL INSPECTION FORM

Inspection Date	8/1/07	Names Of Inspectors	Ruan Maw, Holly Goffin
Region	2	Identifying Road/Intersection	400S. + UTA TRAX

MSE Wall at Bridge	(Y) N	Bridge Number if applicable:	035146F	Wall Number	R-385
Surrounding Structures	railroad tracks - 275 ft		Maximum Height of Wall (ft)		14.5 ft
Distance to Each Structure	275 ft		One Stage, Two Stage or Block Wall		continuous panels
State Route Number	400S + UTA TRAX		Estimated Max Length of Wall Abutment:		
Approximate Mile Marker			Max Slope of Ground in front of wall:		level
GPS Datum	(WGS/84) NAD/83, or NAD/27		Max Height of wall burial line above surrounding level ground:		0
MSE Wall GPS Coordinates (Location of Measurement shown on plan view)	N 40° 43.617		Please draw rough layout of panel with approximate dimensions in space provided below:		
	W 111° 54.448				
If known, Panel or System Manufacturer			<div style="display: flex; align-items: center;"> <div style="margin-right: 20px;">east side:</div> </div>

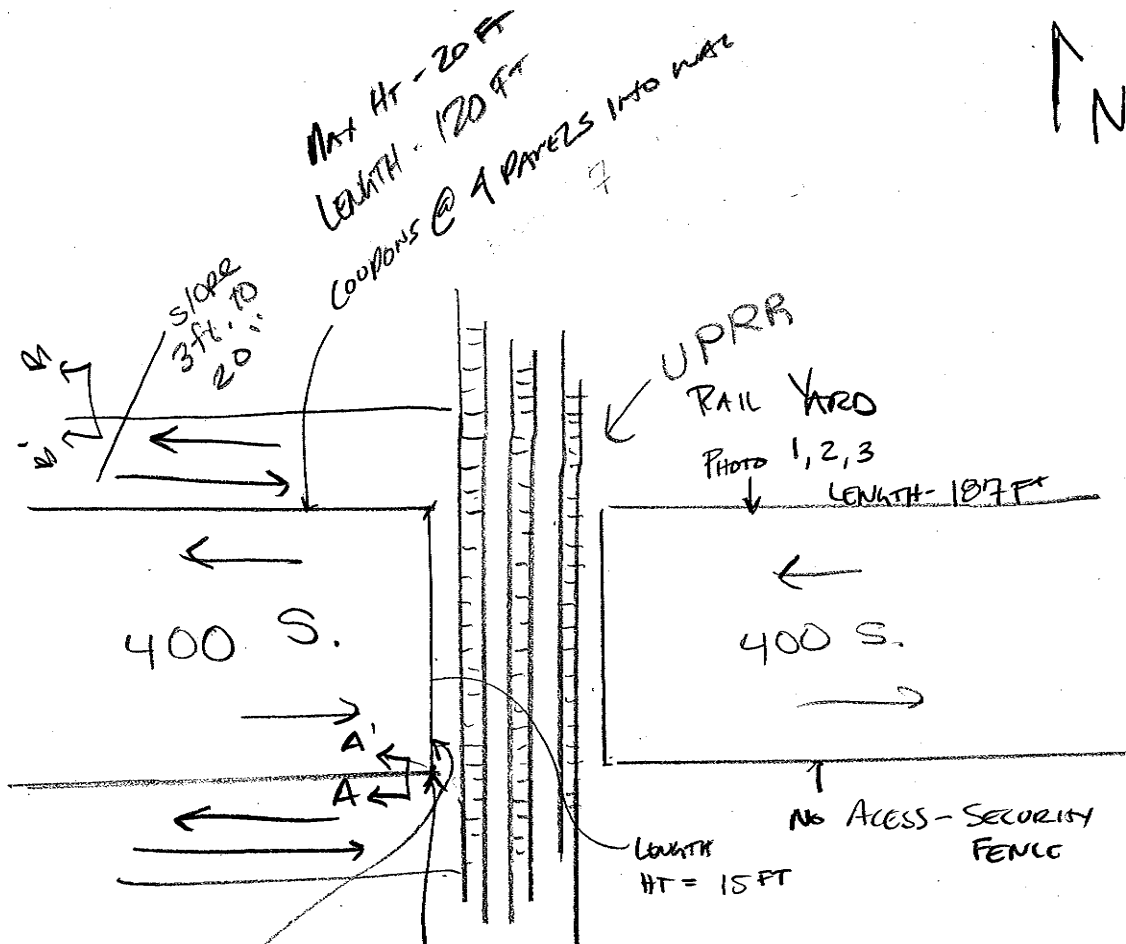
Plan View/Drainage:

STEEL
DRAIN
PIPE
PHOTO #6

PHOTO #4 - CRACK IN COPING
MAX HT - 20'
LENGTH OF SW
ABUTMENT - 360 FT
SLOPE = 0 / ROAD BASE
UNIFORM JOINT SPACING

@ PANEL 13 COOPONS - PHOTO #5
