STATE OF UTAH MSE WALL INSPECTION FORM

Compiled As Part of Research By The Utah Department of Transportation

Inspection Date	8/1/2007	Names Of Inspectors	B/AN MAN / HOLLY HELFEN
Region	2	Identifying Road/Intersection	1-15 / SR-71 (2300 SOUTH)

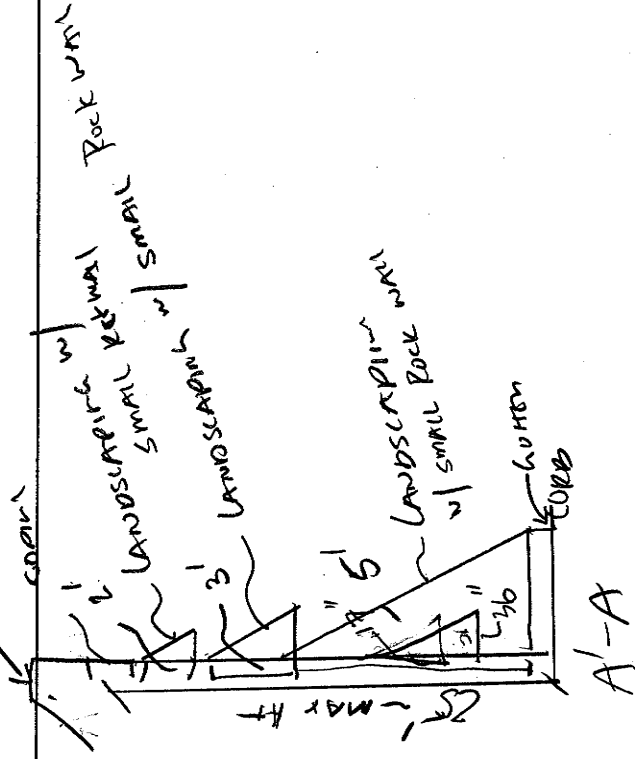
Cross Sections:

NEW WALL IN GREAT CONDITION
