STATE OF UTAH MSE WALL INSPECTION FORM

Compiled As Part of Research By The Utah Department of Transportation

Inspection Date	11/10/07	Names Of Inspectors	Ruan Maw, Holly Griffith
Region	2	Identifying Road/Intersection	Back St. off I-15

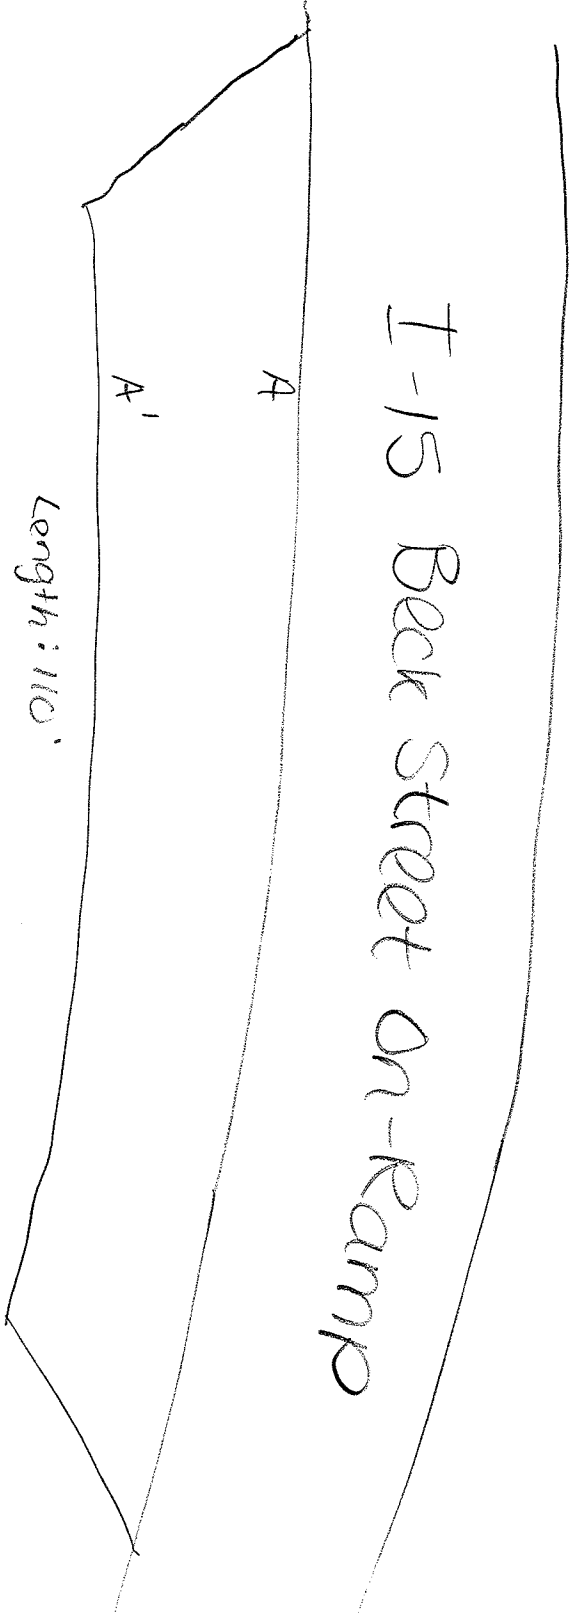
Plan View/Drainage:

I-15 Back Street on-Ramp
