# STATE OF UTAH MSE WALL INSPECTION FORM

Compiled As Part of Research By The Utah Department of Transportation

Inspection Date	11/10/07	Names Of Inspectors	Holly Griffin, Ryan Maw
Region	2	Identifying Road/Intersection	Parish Lane (North Wall)

MSE Wall at Bridge	(Y) N	Bridge Number if applicable:		Wall Number	R-491
Surrounding Structures	telephone pole		Maximum Height of Wall (ft)	96"	
Distance to Each Structure	8'		One Stage, Two Stage or Block Wall		
State Route Number	Parish Lane		Estimated Max Length of Wall Abutment:	1620"	
Approximate Mile Marker			Max Slope of Ground in front of wall:	0	
GPS Datum	WGS/84, NAD/83, or NAD/27		Max Height of wall burial line above surrounding level ground:	0	
MSE Wall GPS Coordinates (Location of Measurement shown on plan view)	40° 55.299 111° 53.353		Please draw rough layout of panel with approximate dimensions in space provided below:		
If known, Panel or System Manufacturer	keystone-tensor

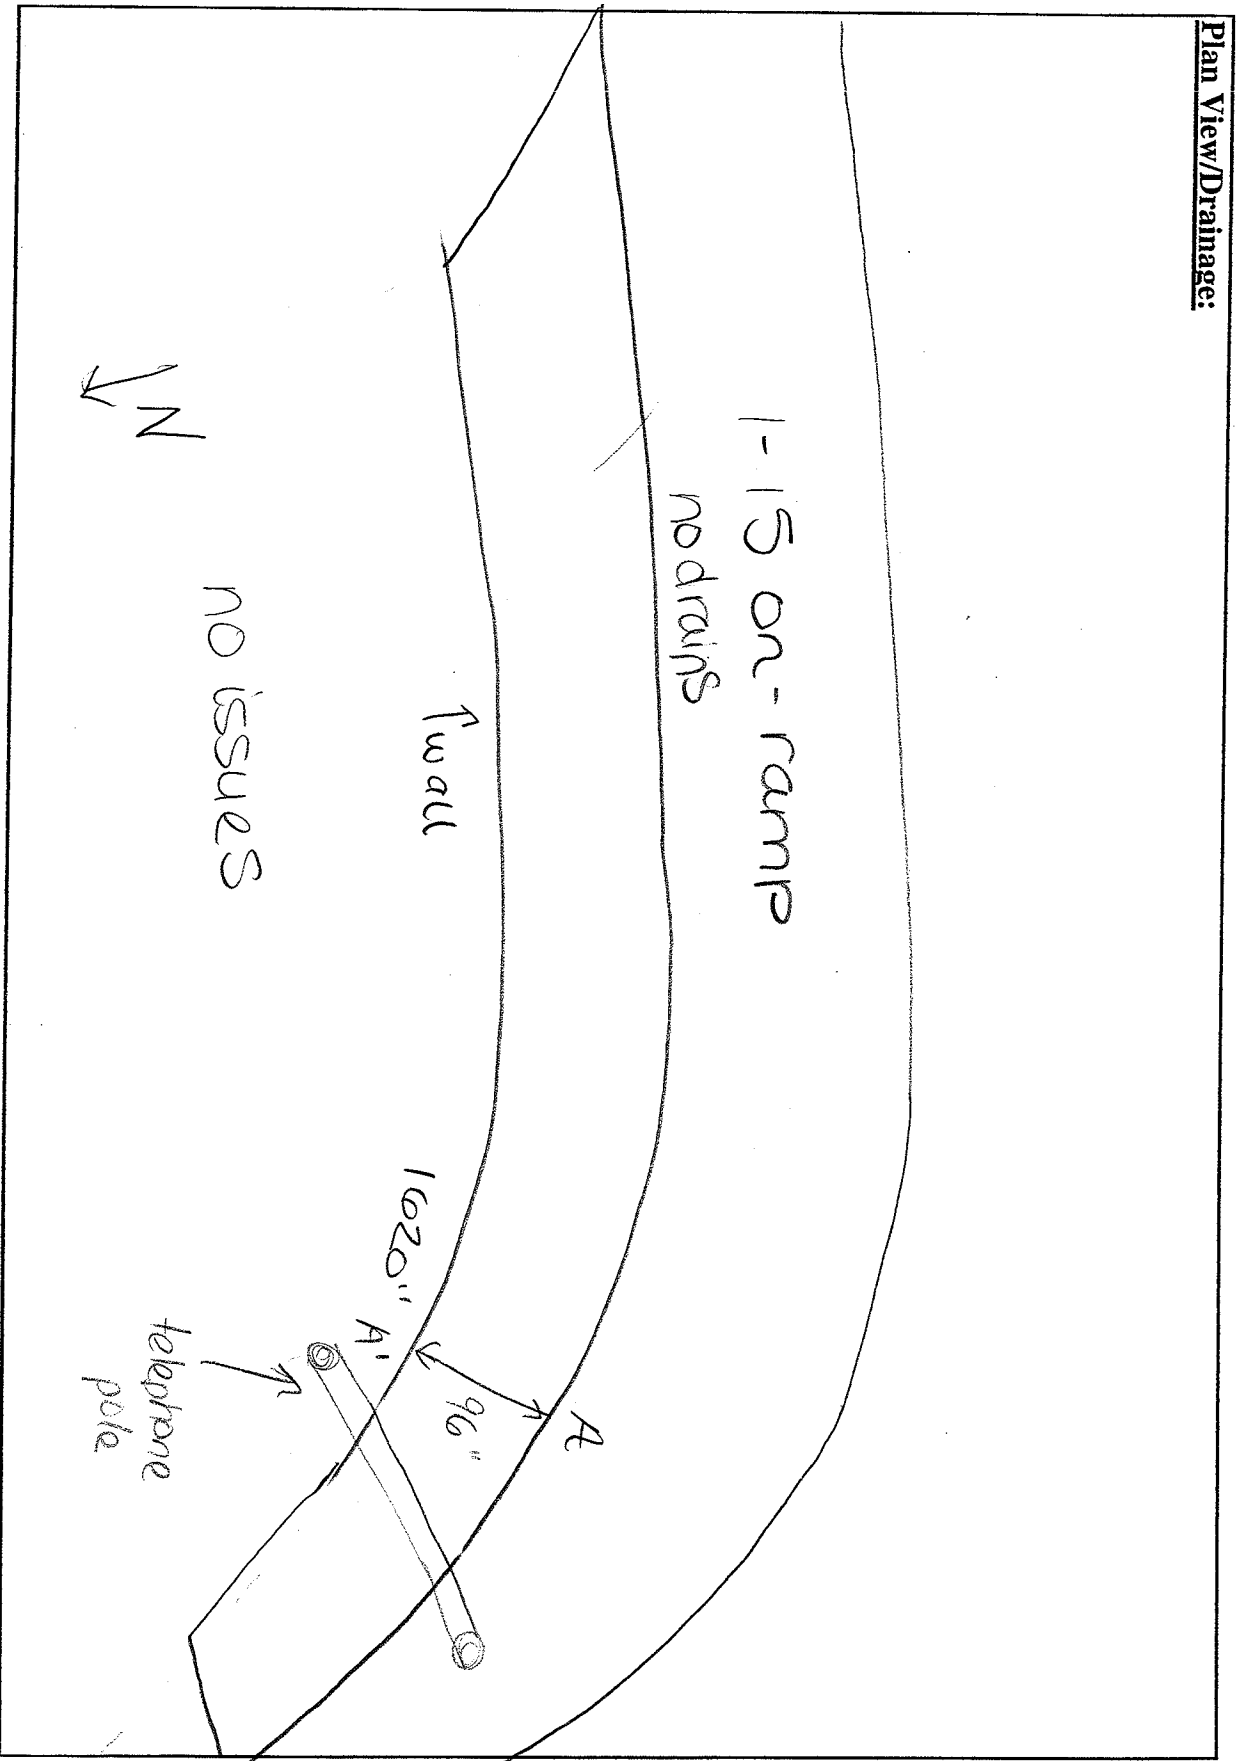
Plan View/Drainage:

new wall in excellent condition
