# STATE OF UTAH MSE WALL INSPECTION FORM

Compiled As Part of Research By The Utah Department of Transportation

Inspection Date	7/27/07	Names Of Inspectors	Holly Griffin Ryan maw
Region	1

R-495 & 496  
 31st street & I-15  
 24th street & I-15

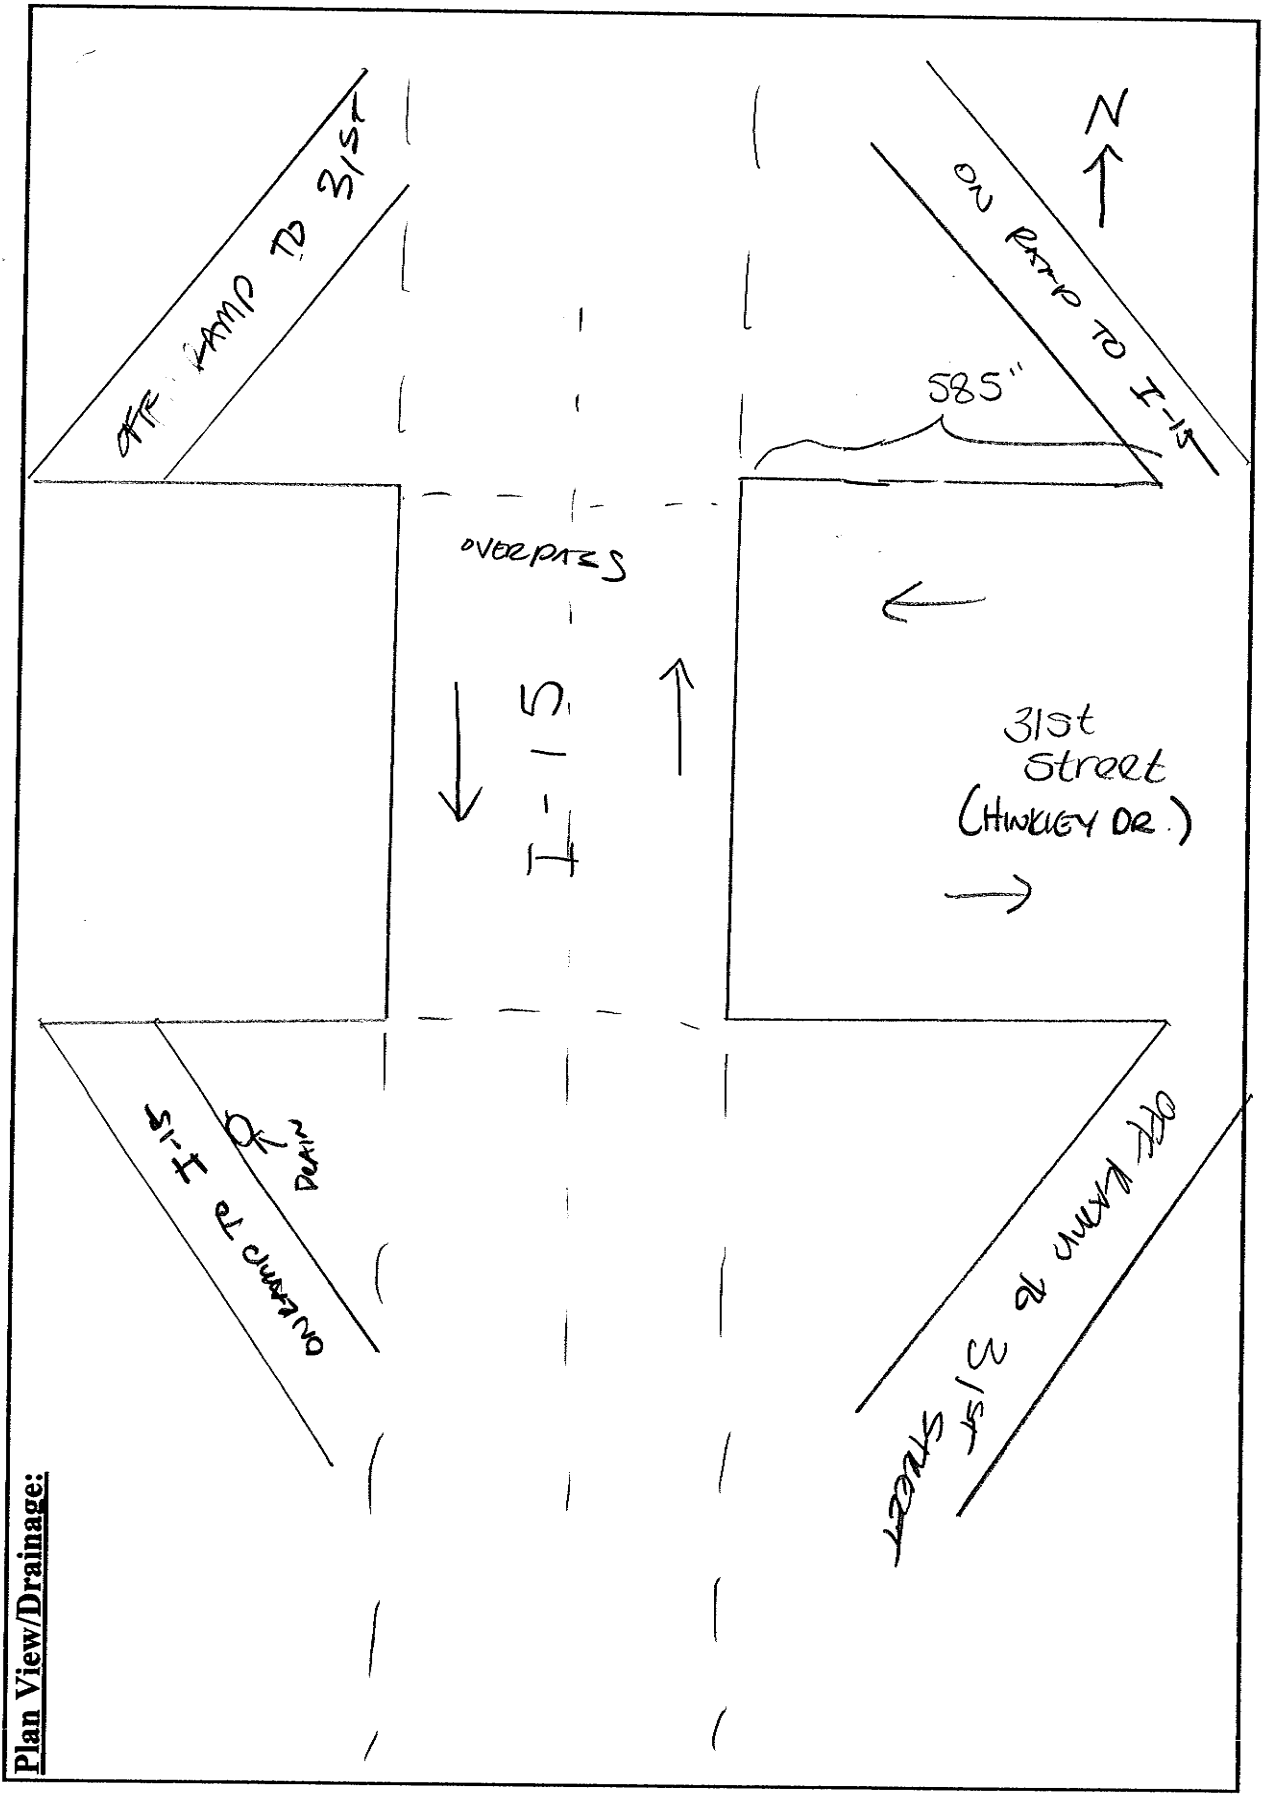
# 31st Street

UNDER CONSTRUCTION - WALL ACCESS WAS LIMITED  
 DIDN'T ALLOW FULL INSPECTION

UNDER CONSTRUCTION COULD NOT  
ACCESS WALL
