STATE OF UTAH MSE WALL INSPECTION FORM

Inspection Date	7/18/07	Names Of Inspectors	Holly Griffin, Ryan Maw
Region	1	Identifying Road/Intersection	I-215 and California

MSE Wall at Bridge	(Y) N	Bridge Number if applicable:		Wall Number	R-146
Surrounding Structures	none			Maximum Height of Wall (ft)	25
Distance to Each Structure				One Stage, Two Stage or Block Wall	one
State Route Number	I-215			Estimated Max Length of Wall Abutment:	650 ft
Approximate Mile Marker				Max Slope of Ground in front of wall:	2:1
GPS Datum	WGS/84, NAD/83, or NAD/27			Max Height of wall burial line above surrounding level ground:	0
MSE Wall GPS Coordinates (Location of Measurement shown on plan view)	N 40° 44.484'	Please draw rough layout of panel with approximate dimensions in space provided below.

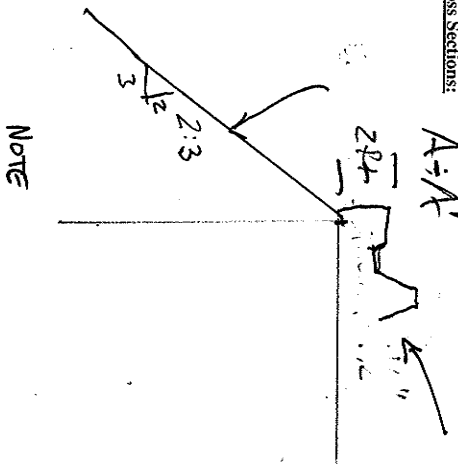
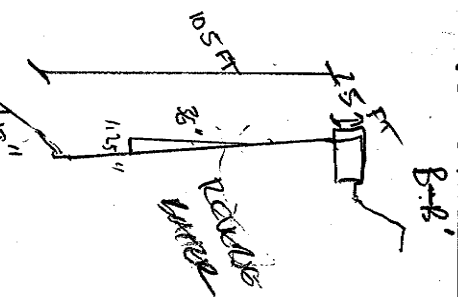
SPACING OF PANELS 1 TO 1.5" HORIZONTAL DISPLACEMENT 0-0.75"

NOTE 1: AS WALL APPROACHES BRIDGE ACCESS, WENTER HORIZONTAL DISPLACEMENT EXISTS BETWEEN PANELS (BOUNDARY OF PANELS).
