STATE OF UTAH MSE WALL INSPECTION FORM

Compiled As Part of Research By The Utah Department of Transportation

Inspection Date	7/25/07	Names Of Inspectors	Ryan Maw / Holly Griffin
Region	1	Identifying Road/Intersection	SR 91-890

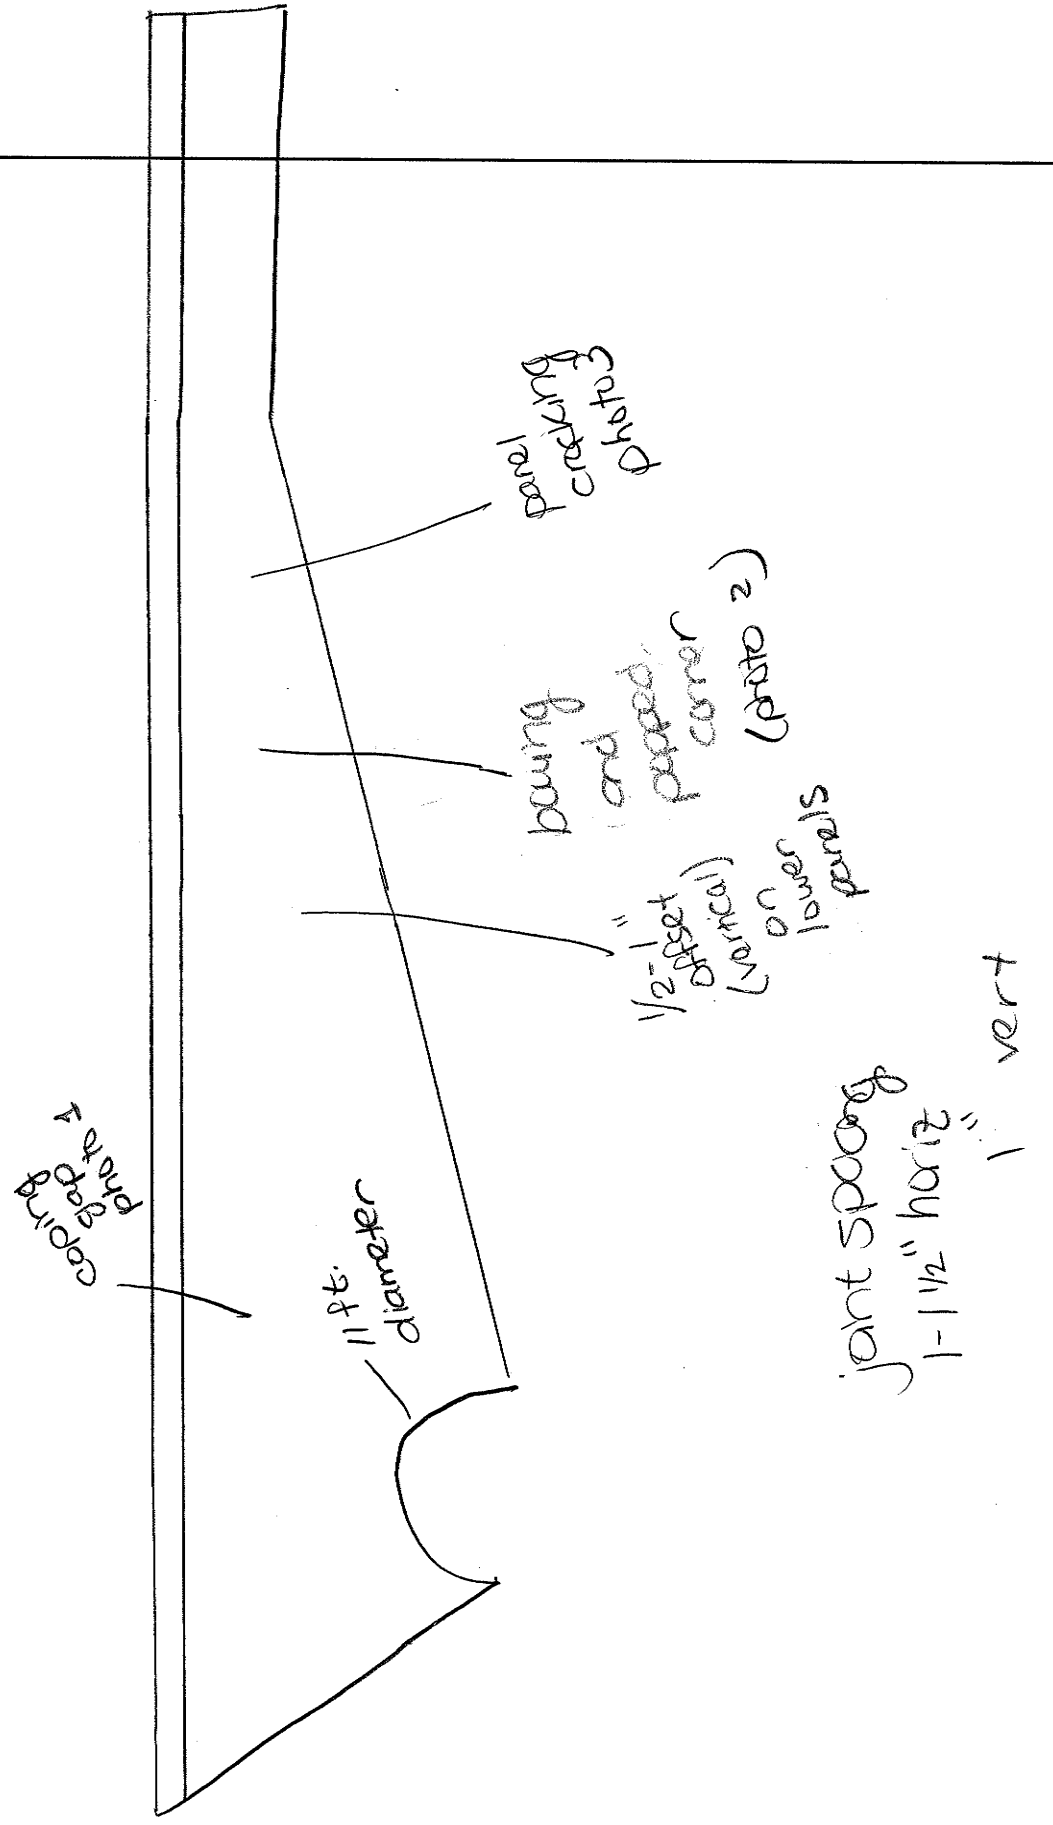
Plan View/Drainage:

copying photo 1

panel buckling cracks photo 3

boring and packed corner (photo 2)

1/2" offset (vertical) on lower panels

joint spacing
1-1 1/2" horiz
1" vert
