STATE OF UTAH MSE WALL INSPECTION FORM

Compiled As Part of Research By The Utah Department of Transportation

Inspection Date	8/11/2009	Names Of Inspectors	RYAN MAW & HOWY
Region	2	Identifying Road/Intersection	10600 S (SR-151) - I-15

MSE Wall at Bridge	Ⓟ N	Bridge Number if applicable:	F-663	Wall Number	R-40K-3
Surrounding Structures	NONE			Maximum Height of Wall (ft)	~20'
Distance to Each Structure	-			One Stage, Two Stage or Block Wall	TWO STAGE
State Route Number	I-15			Estimated Max Length of Wall Abutment:	160'
Approximate Mile Marker	293			Max Slope of Ground in front of wall:	0'
GPS Datum	WGS84	NAD/83, or NAD/27		Max Height of wall burial line above surrounding level ground:	0'
MSE Wall GPS Coordinates (Location of Measurement shown on plan view)	N 40° 33.497'			Please draw rough layout of panel with approximate dimensions in space provided below:	
	W 111° 53.855'

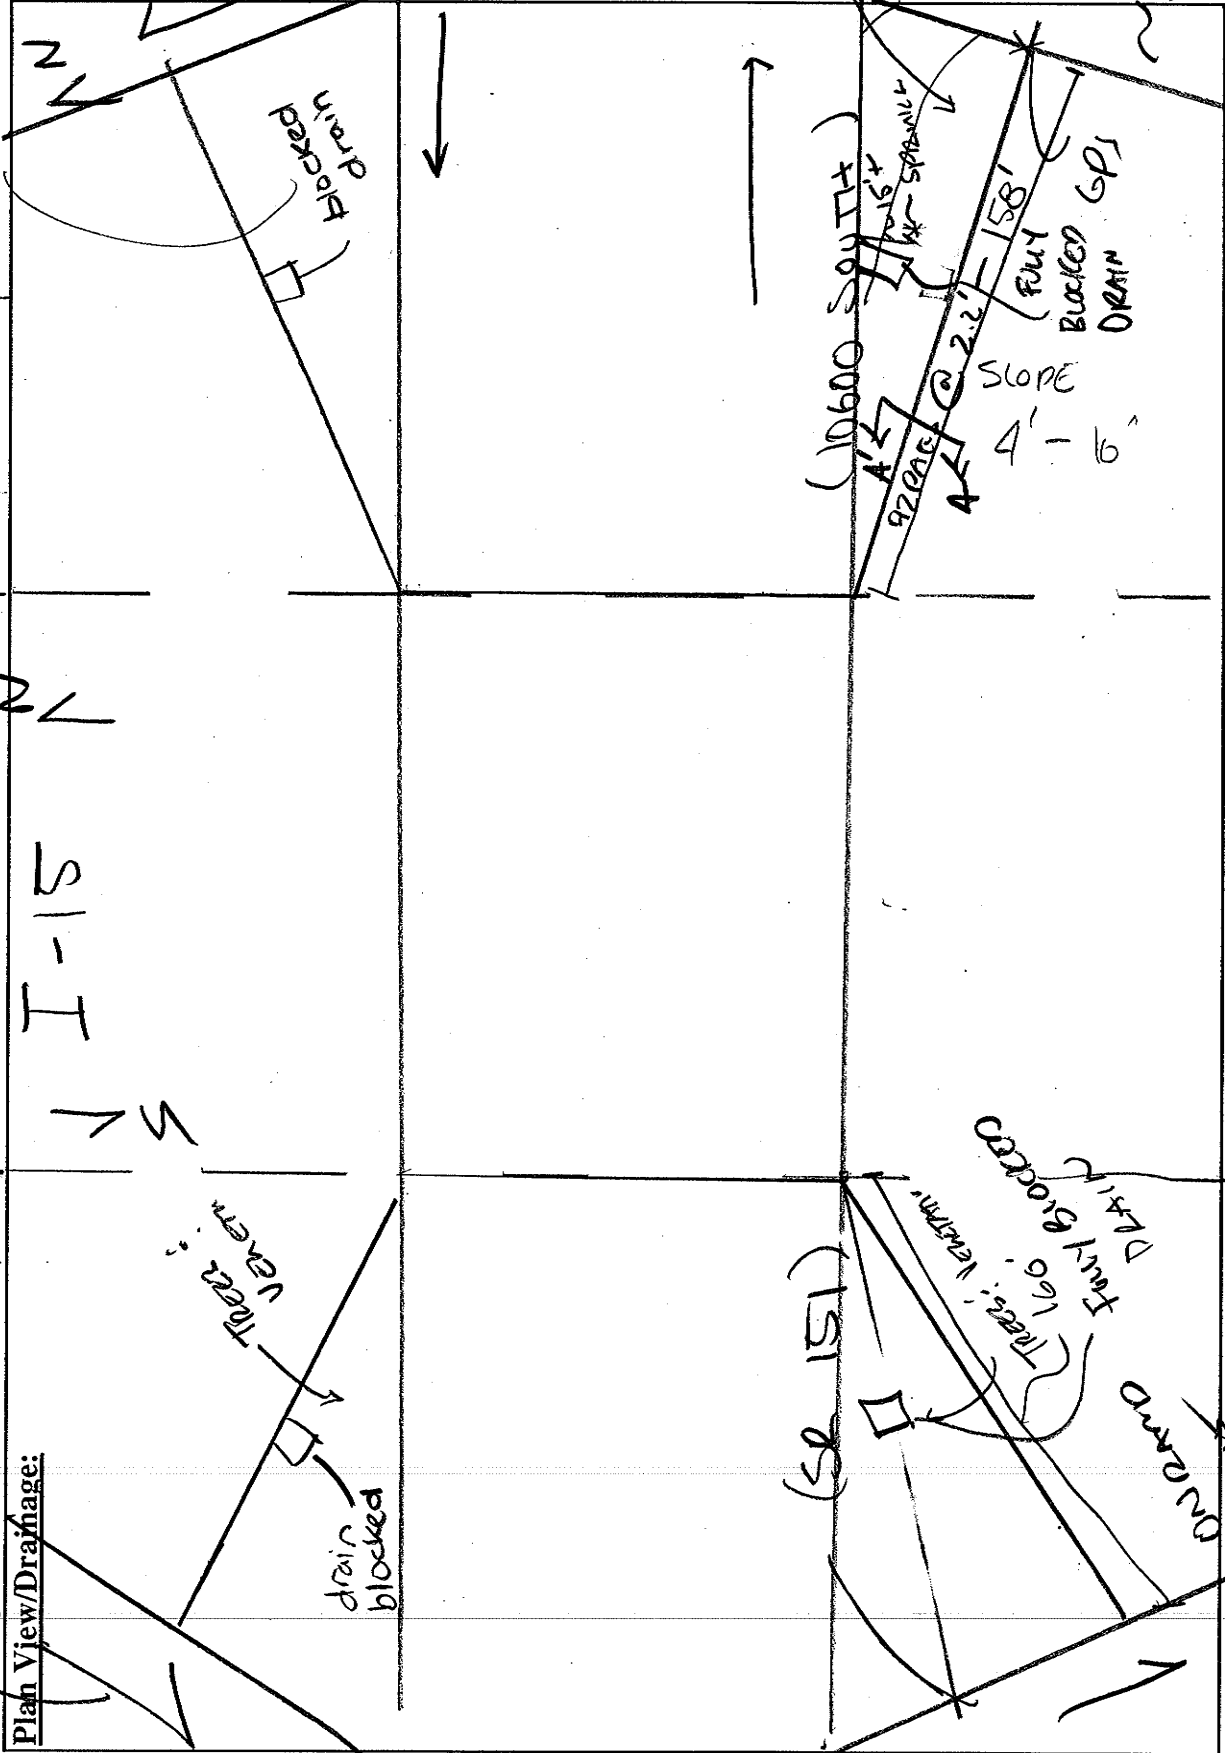
Plan View/Drainage:

* ALL FOUR DRAINS WERE BLOCKED - DRAINAGE A MAJOR CONCERN
