# STATE OF UTAH MSE WALL INSPECTION FORM

Compiled As Part of Research By The Utah Department of Transportation

Inspection Date	8/17/2007	Names Of Inspectors	RYAN MAW + HOLLY GRIFFIN
Region	2	Identifying Road/Intersection	5900 SOUTH + I-15

MSE Wall at Bridge	(Y) N	Bridge Number if applicable:	I-830	Wall Number	R-344
Surrounding Structures	Noise Wall / Commercial Developments		Maximum Height of Wall (ft)	25'	
Distance to Each Structure			One Stage, Two Stage or Block Wall	Two Stage	
State Route Number	I-15		Estimated Max Length of Wall Abutment:	160'	
Approximate Mile Marker			Max Slope of Ground in front of wall:	0	
GPS Datum	(WGS/84) NAD/83, or NAD/27		Max Height of wall burial line above surrounding level ground:	0	
MSE Wall GPS Coordinates (Location of Measurement shown on plan view)	N 40° 38.626'		Please draw rough layout of panel with approximate dimensions in space provided below:

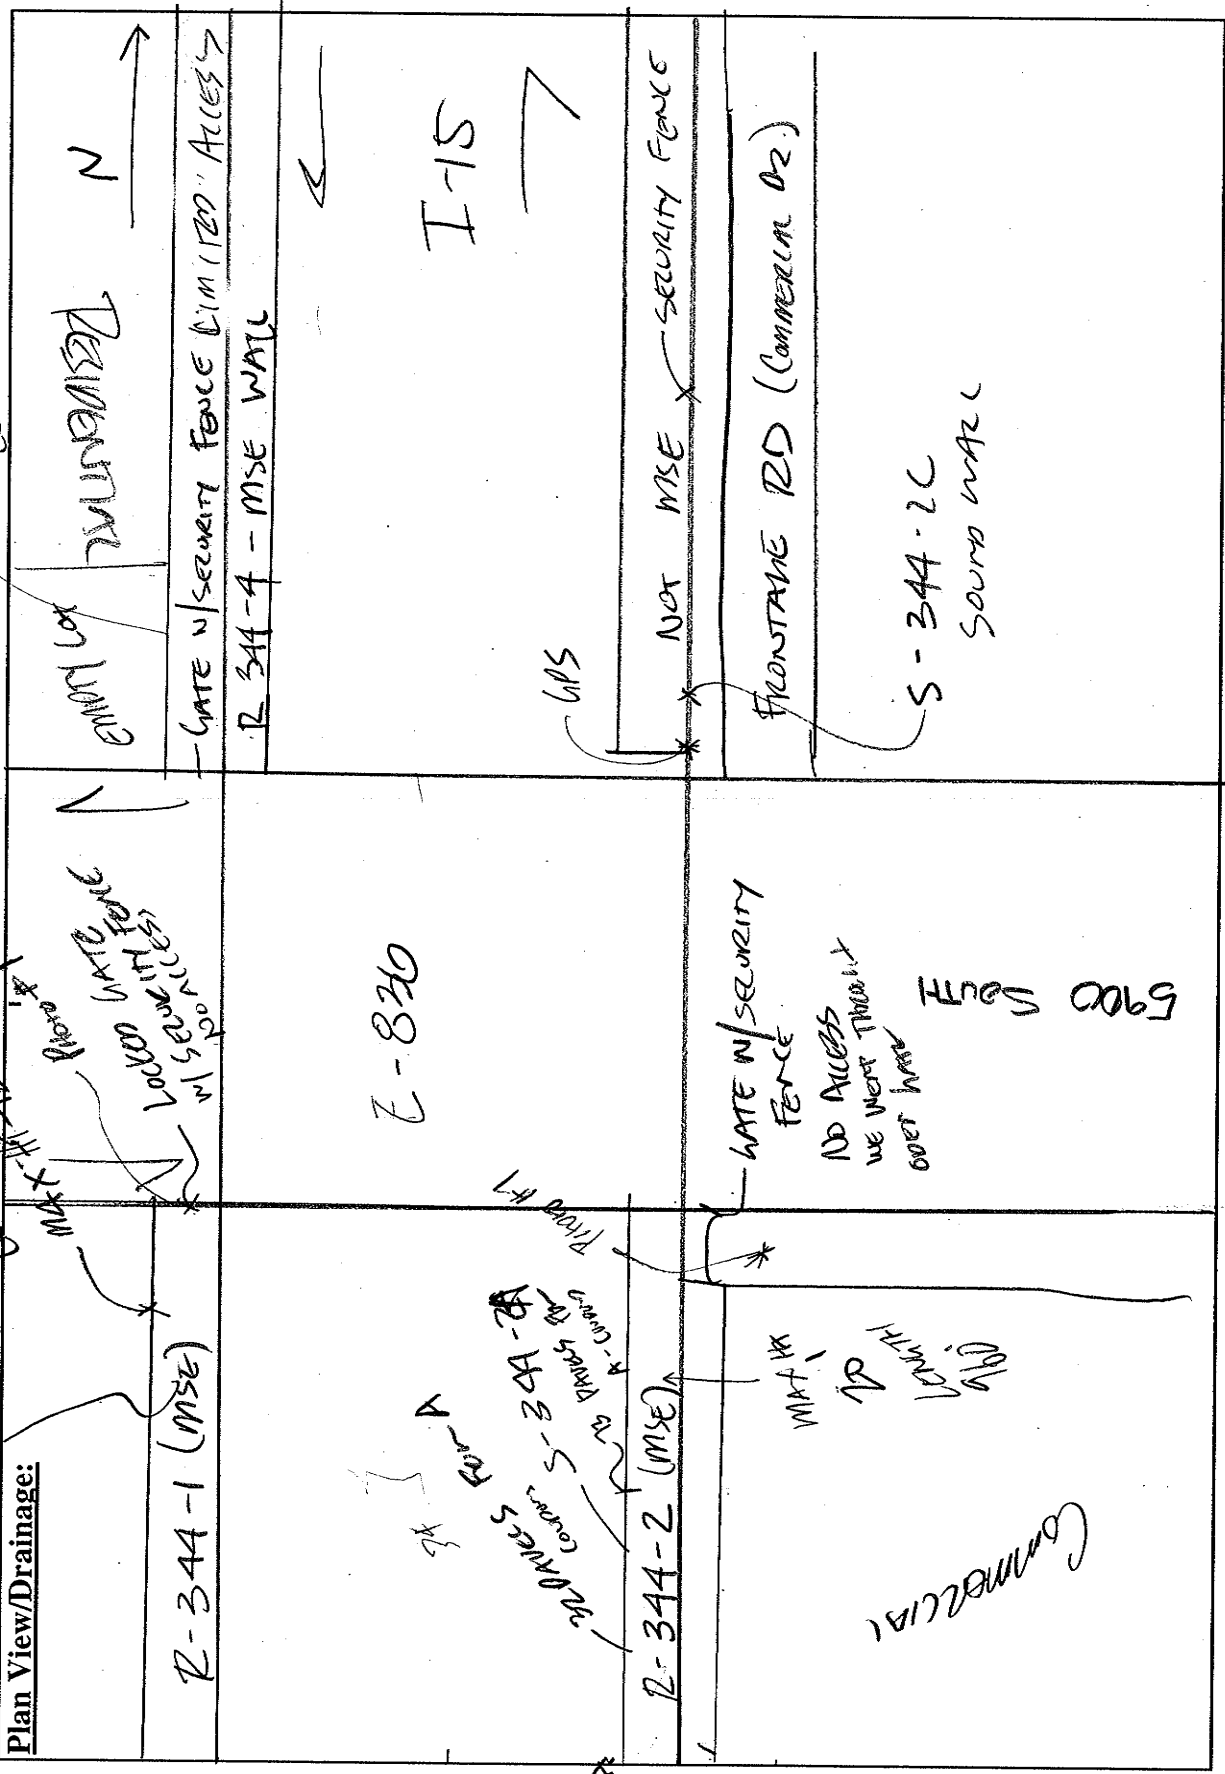
Plan View/Drainage:

\* clogged drains
