STATE OF UTAH MSE WALL INSPECTION FORM

Compiled As Part of Research By The Utah Department of Transportation

Inspection Date	8/17/2007	Names Of Inspectors	RYAN MAN/ HOLLY GRIFFIN
Region	2	Identifying Road/Intersection	4500 SOUTH I-15

MSE Wall at Bridge	(Y) N	Bridge Number if applicable:	F-6175-N	Wall Number	345-4, 10, 9, 3
Surrounding Structures	COMMERCIAL DEVELOPMENT		Maximum Height of Wall (ft)	~25'	
Distance to Each Structure	20 FT		One Stage, Two Stage or Block Wall	TWO STAGE	
State Route Number	I-15		Estimated Max Length of Wall Abutment:	595'	
Approximate Mile Marker	294		Max Slope of Ground in front of wall:	2:1	
GPS Datum	(WGS/84) NAD/83, or, NAD/27		Max Height of wall burial line above surrounding level ground:	15'	
MSE Wall GPS Coordinates (Location of Measurement shown on plan view)	N 40° 40.466'		Please draw rough layout of panel with approximate dimensions in space provided below:		
	W 111° 54.118'

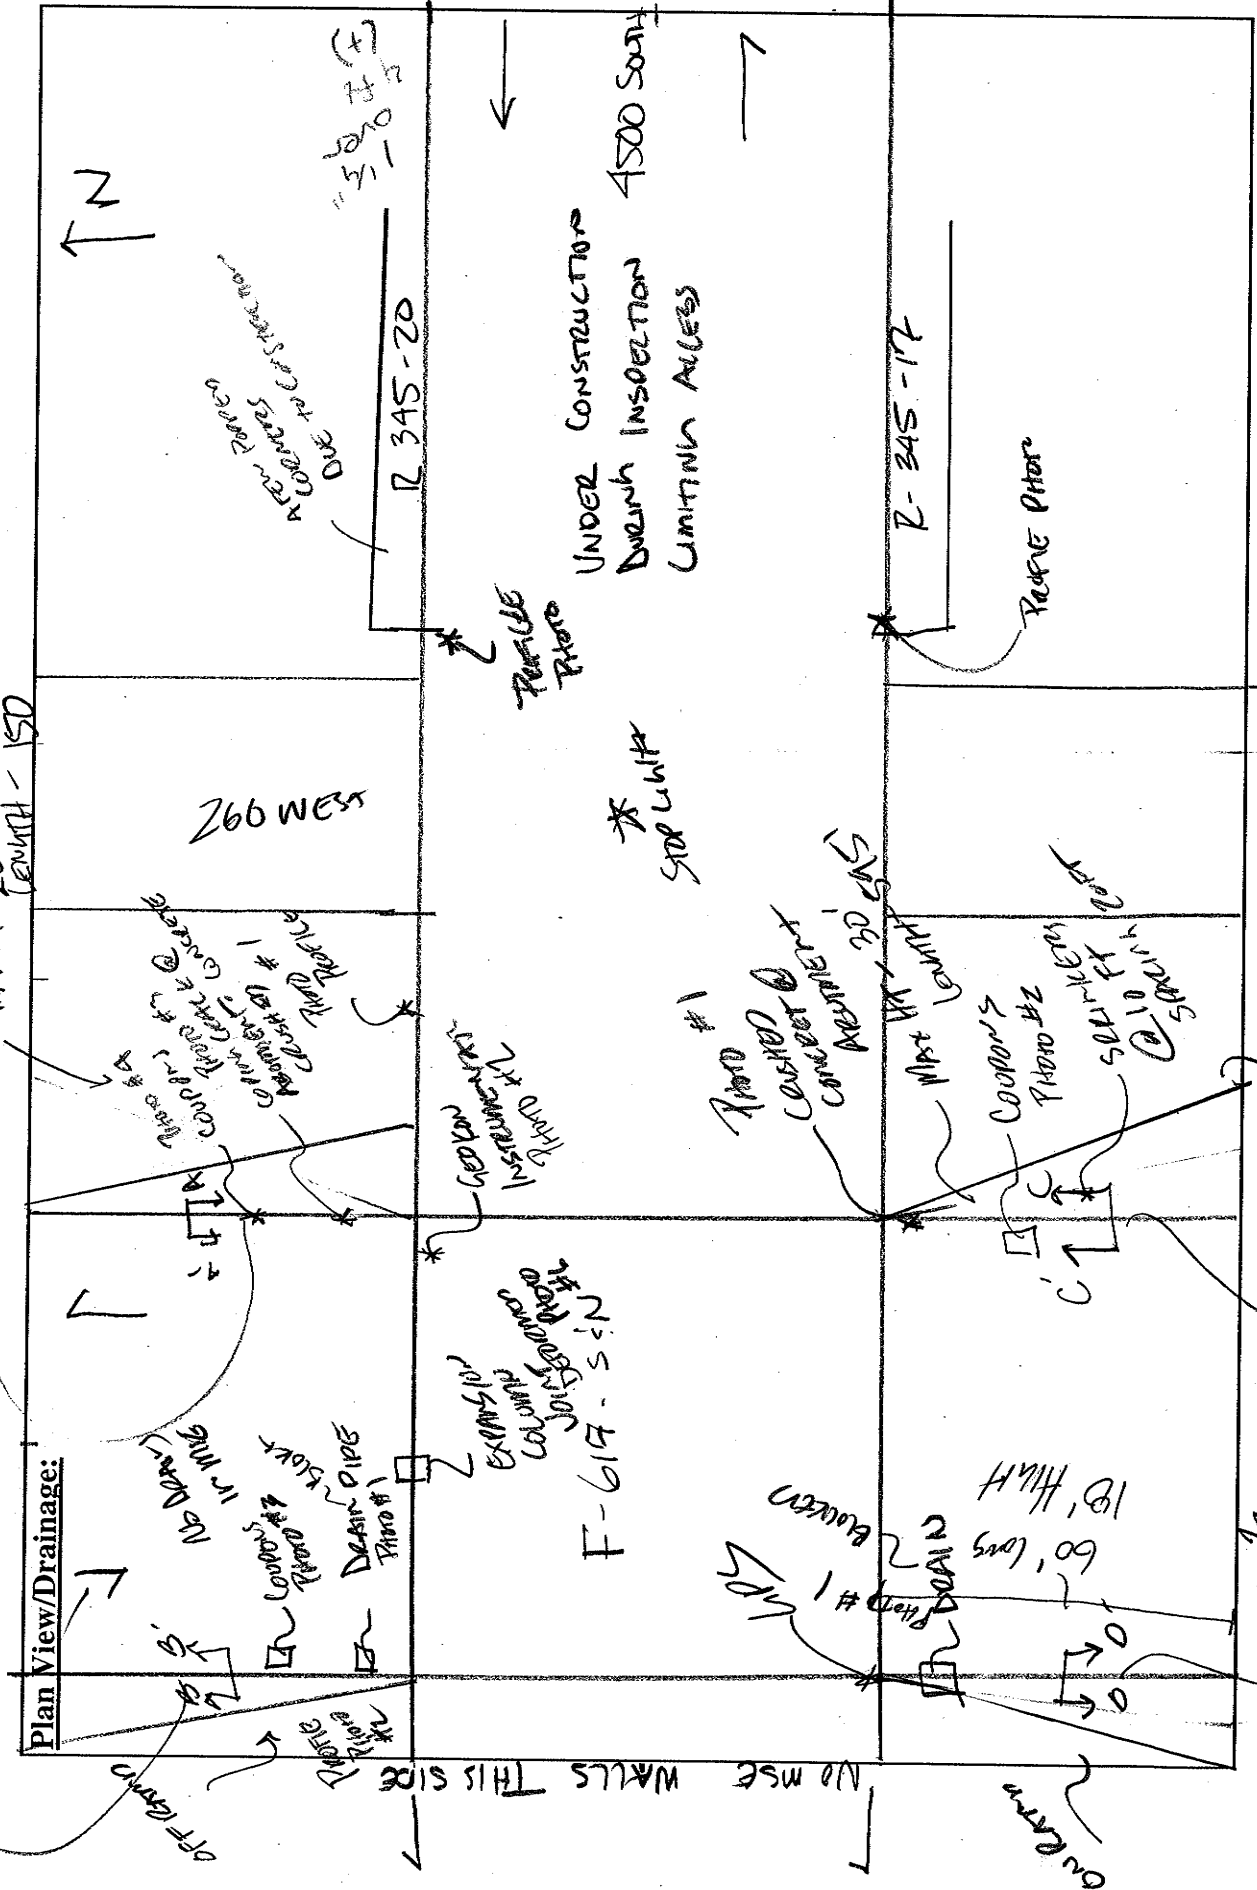
Plan View/Drainage:

NAIUS INCLUDED IN THIS FORM
 345 HAS MULTIPLE
 345-4
 345-10
 345-9
 345-3

MAX HT: 20 FT
LENGTH: 150'

UNDER CONSTRUCTION
DRAIN INSPECTION
LIMITING ACCESS

NO MSE WALLS THIS SIDE

18' HEIGHT
60' LONG
