STATE OF UTAH MSE WALL INSPECTION FORM

Compiled As Part of Research By The Utah Department of Transportation

Inspection Date	8/15/07	Names Of Inspectors	Ryan Maw, Holly Griffin
Region	2

MSE Wall at Bridge	Y	N	Bridge Number if applicable:	F-019N	Wall Number	1-346 OVERPASS
Surrounding Structures	noise wall (246-3)			Maximum Height of Wall (ft)	30 FT	
Distance to Each Structure	5 FT			One Stage, Two Stage or Block Wall	TWO STAGE	
State Route Number	I-15			Estimated Max Length of Wall Abutment:	560 FT	
Approximate Mile Marker	296			Max Slope of Ground in front of wall:	4:1 V:1	
GPS Datum	WGS/84, NAD/83, or NAD/27			Max Height of wall burial line above surrounding level ground:	2-10 FT	
MSE Wall GPS Coordinates (Location of Measurement shown on plan view)	N 42° 02' 21"			Please draw rough layout of panel with approximate dimensions in space provided below:		
	W 111° 52' 120"					
If known, Panel or System Manufacturer	UKN

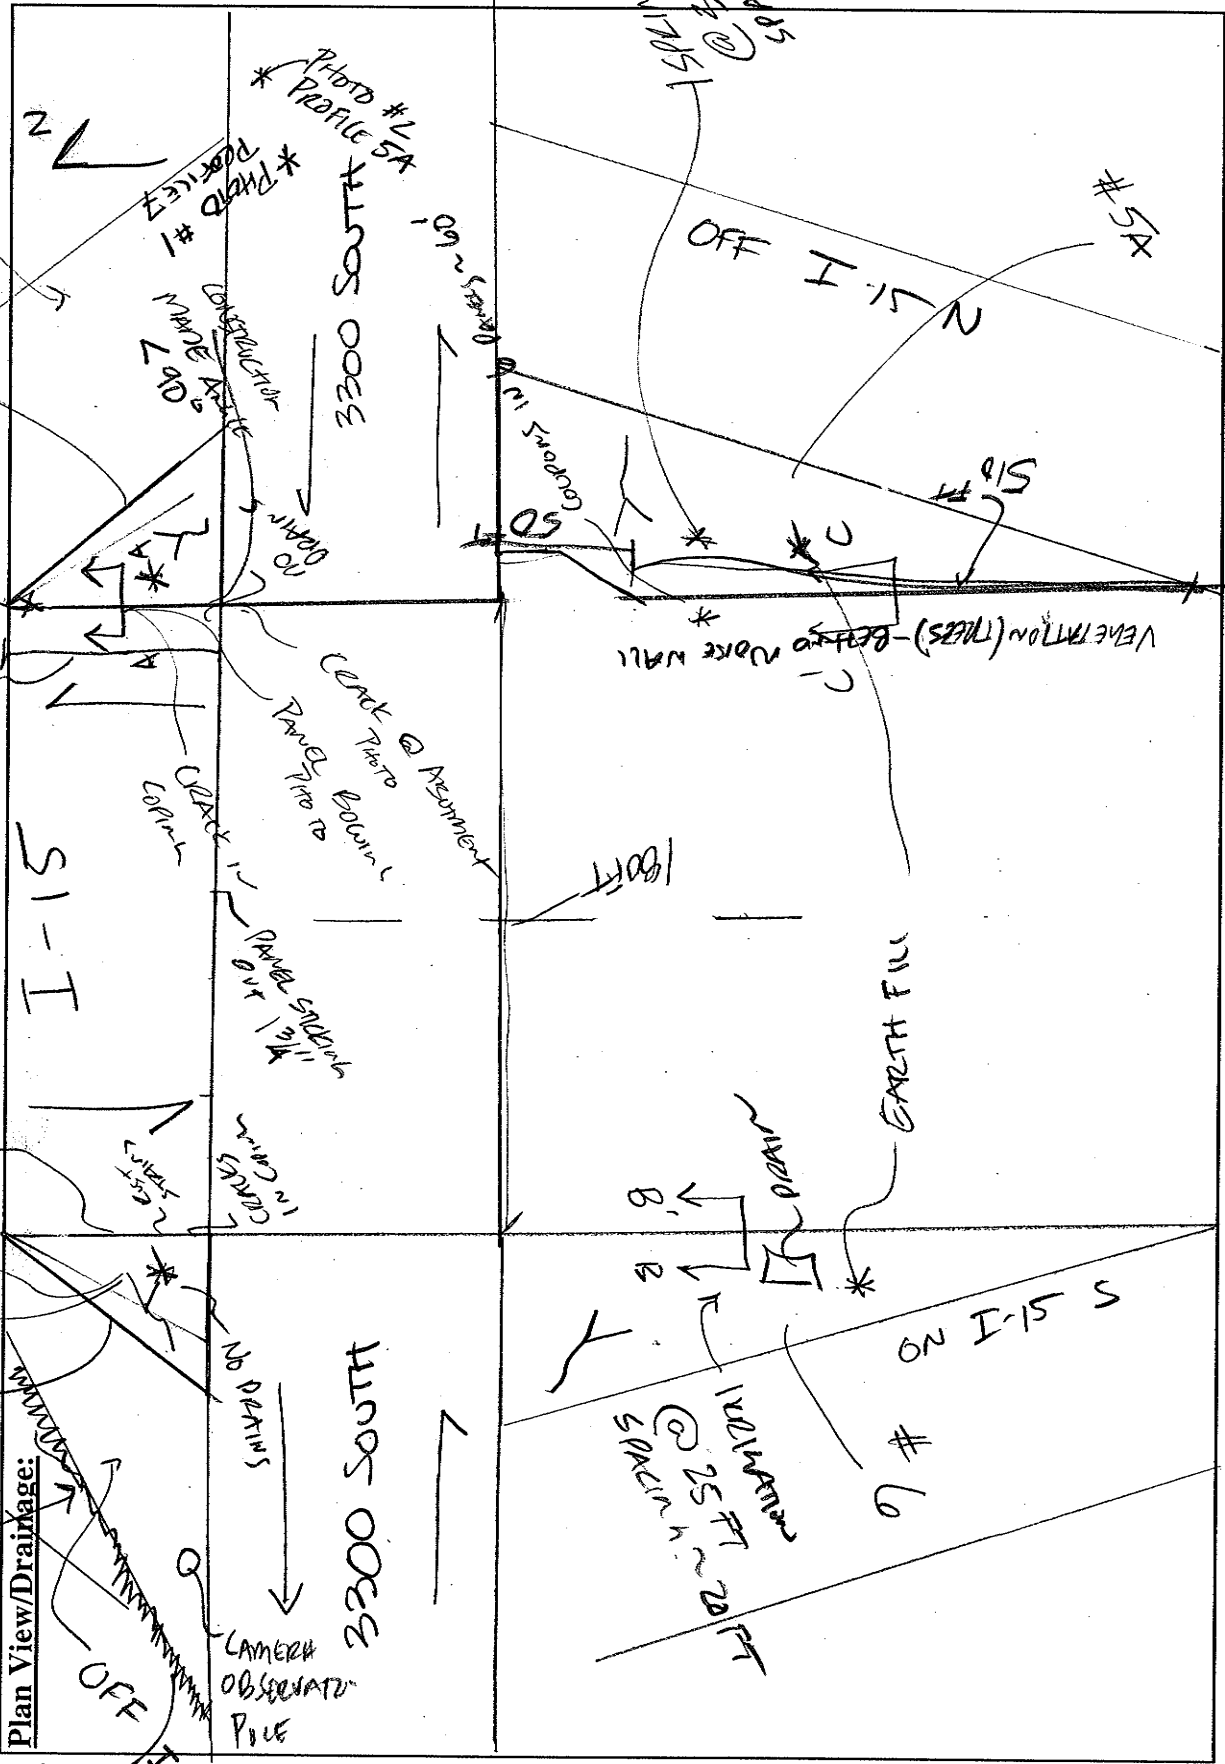
Plan View/Drainage:

CONCRETE
EARTH FILL
VEGETATION
CAMERA OBSERVATION POLE
CRACK IN CONCRETE
CANT PHOTO @ ASSESSMENT
SLOPE
NO DRINKING WATER
PHOTO #12
PHOTO #8
PHOTO #1
PHOTO #12 PROFILE 5A
PHOTO #1 PROFILE 5A

MAX HT-15 FT
LEAKAGE

CRACK IN CONCRETE

CANT PHOTO @ ASSESSMENT
