STATE OF UTAH MSE WALL INSPECTION FORM

Compiled As Part of Research By The Utah Department of Transportation

Inspection Date	7/20/07	Names Of Inspectors	Ryan maw, Holly Griffin
Region	2	Identifying Road/Intersection	480N / I-15

MSE Wall at Bridge	<input checked="" type="radio"/> Y <input type="radio"/> N	Bridge Number if applicable:		Wall Number	351-30
Surrounding Structures	residential		Maximum Height of Wall (ft)	8ft min to 21.5'	
Distance to Each Structure	150ft		One or Two Stage Wall	+10	
State Route Number			Estimated Max Length of Wall Abutment:	1000 ft	
Approximate Mile Marker			Max Slope of Ground in front of wall:	level - 0	
GPS Datum	WGS/84, NAD/83, or NAD/27		Max Height of wall burial line above surrounding level ground:	0	
MSE Wall GPS Coordinates (Location of Measurement shown on plan view)	N 40° 46.676 (400N)		Please draw rough layout of panel with approximate dimensions in space provided below:

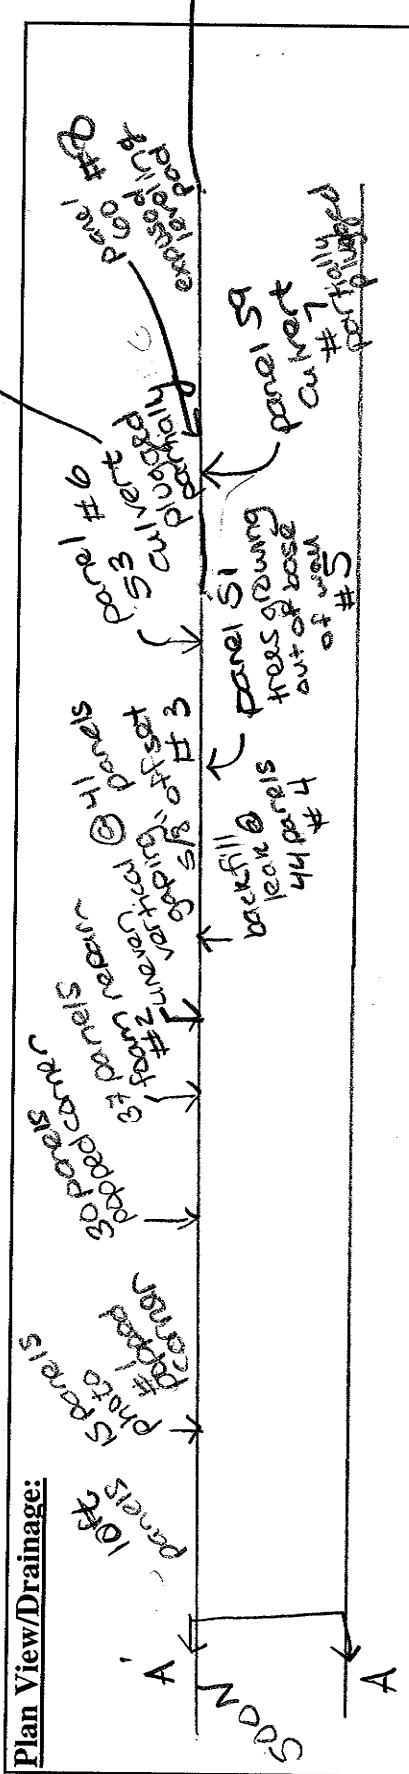
Plan View/Drainage:

20" between two stages

laeving pad # 9

331 N - #10 - ivy

#11 - coupons @ 30s N apple court

#12 - panel buldge " " " " " "

#13 " " " " " "

#14 approach slab covered

#15 differential gap between abutment and approach slab @ 300N

← 3" offset
