Hampton-Seabrook Estuary Habitat Restoration Compendium

Alyson L. Eberhardt and David M. Burdick
University of New Hampshire

Cite as: Eberhardt, A.L. and D.M. Burdick. 2009. Hampton-Seabrook Estuary Habitat Restoration Compendium. Report to the Piscataqua Region Estuaries Partnership and the New Hampshire Coastal Program, Durham and Portsmouth, NH.

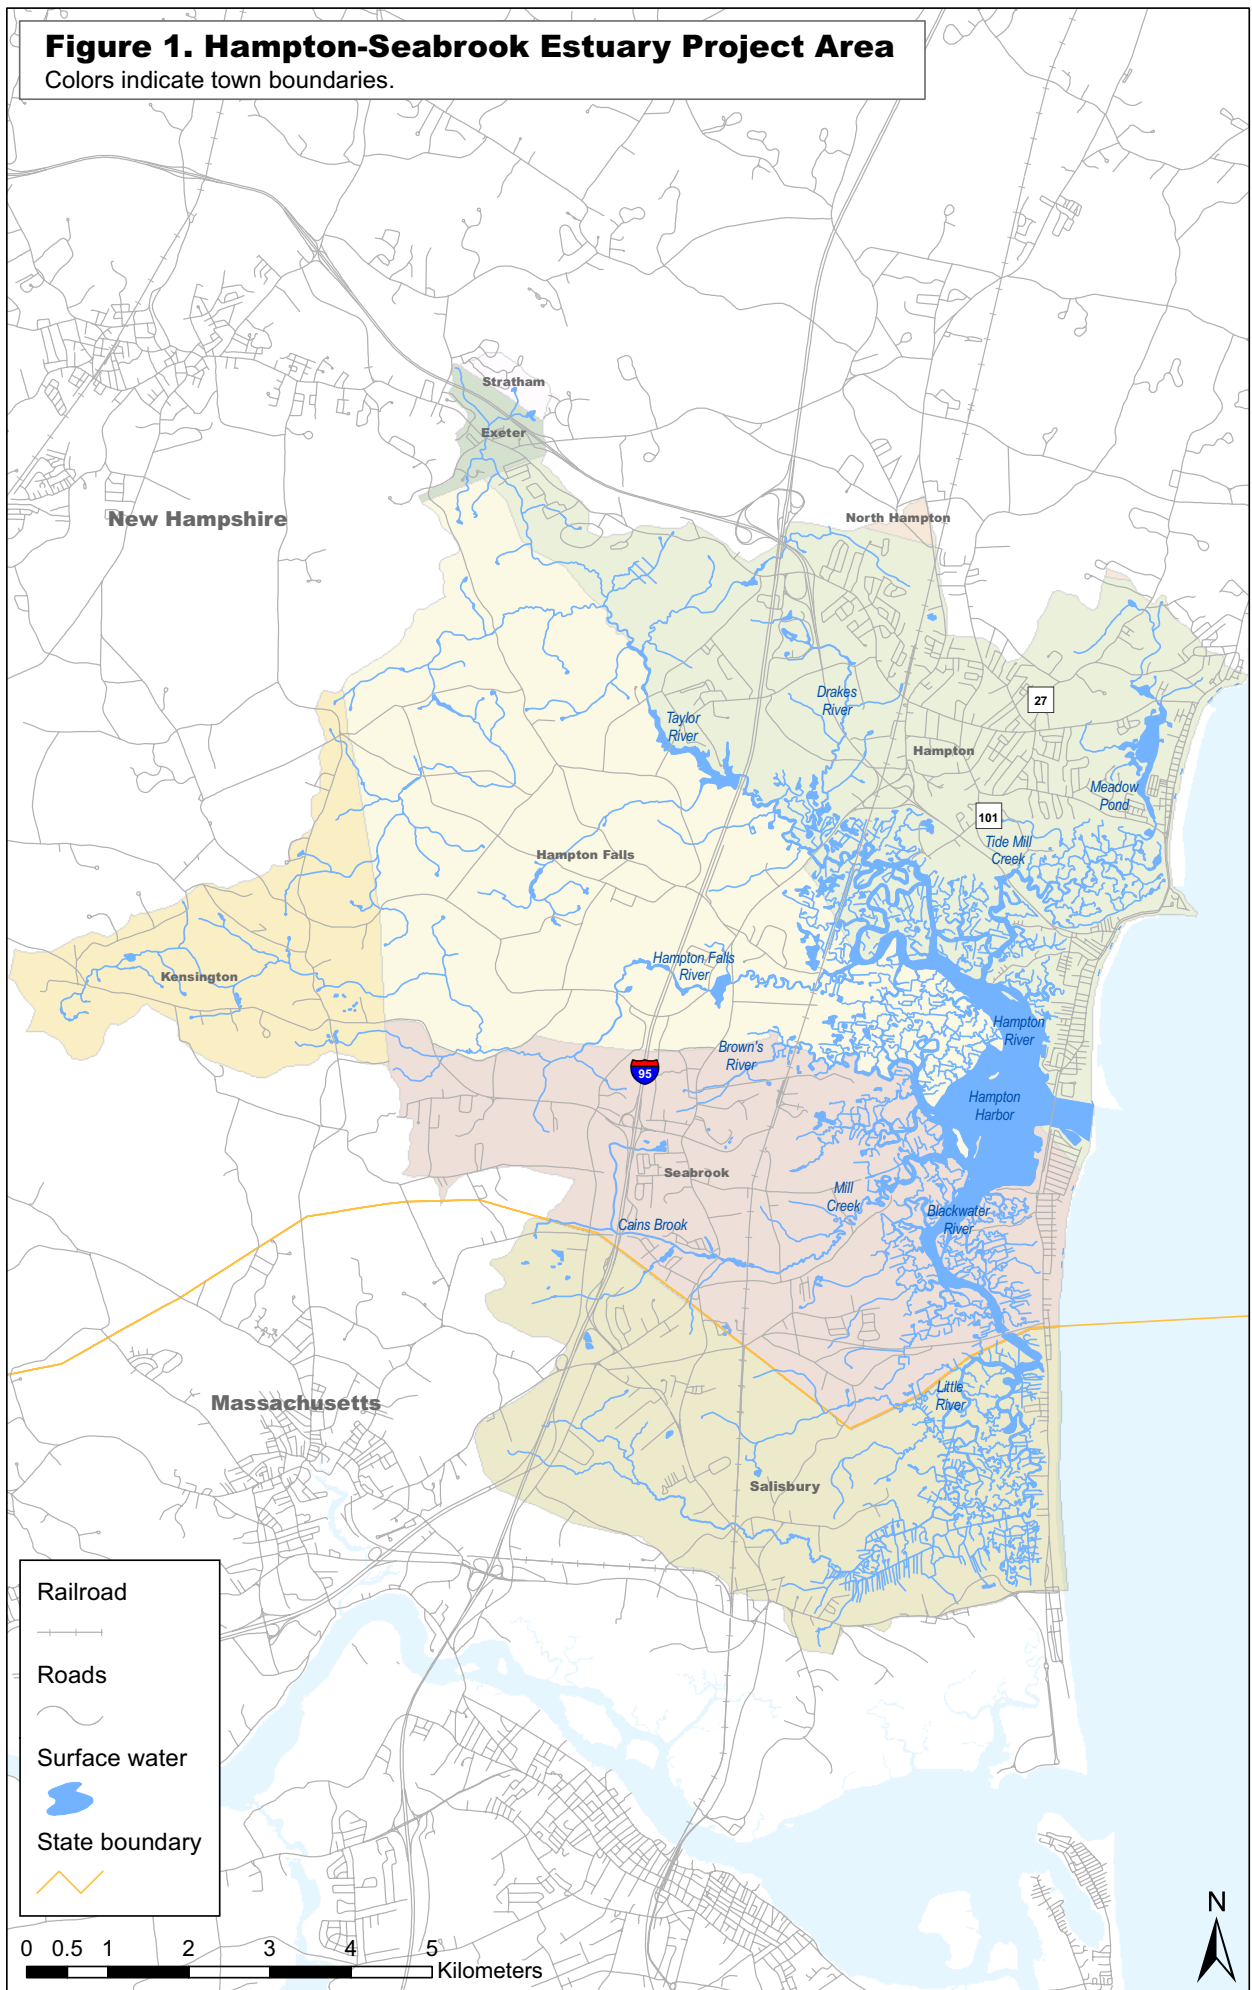
Figure 1. Hampton-Seabrook Estuary Project Area

Colors indicate town boundaries.

The Hampton-Seabrook Estuary (Figure 1) is a shallow, tidally dominated, barrier beach system. The watershed encompasses 47 square miles and includes the towns of Hampton, Hampton Falls, North Hampton, Stratham, Seabrook, Exeter, and Kensington, NH and Salisbury, MA. The Estuary receives freshwater inputs from Tide Mill Creek to the north, the Taylor and Hampton Falls Rivers from the northwest, Brown's River and Cain's Brook from the west, and the Blackwater and Little Rivers from the south. Unlike the Great Bay Estuary, the Hampton Seabrook Estuary is dominated by salt marsh habitat. In fact, the Estuary contains over 1800 hectares (4000 acres) of tidal marsh. In addition, the Estuary supports many other important coastal habitats including the most productive softshell clam beds in the state, important roosting, feeding and nesting grounds for shorebirds and saltmarsh sparrows, as well as remnant sand dunes. As a result of the important ecological services provided by the Hampton-Seabrook Estuary, it was listed as a conservation focus area in The Nature Conservancy's Land Conservation Plan for New Hampshire's Coastal Watersheds (Zankel et al. 2006).

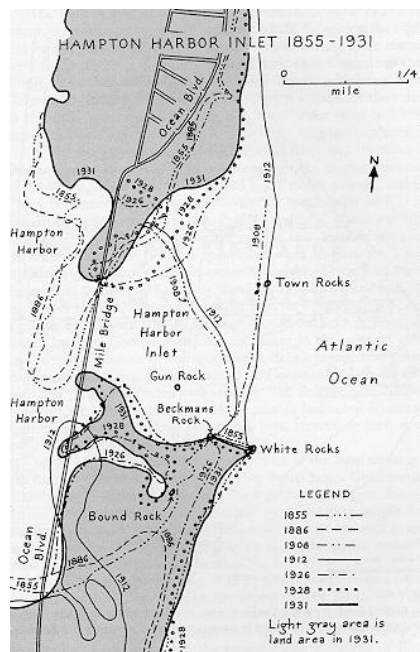
Figure 2. Hampton River inlet change, 1855-1931.
Map by Alex Wallach, in Randall 1989.

Historically, the shoreline of the Hampton-Seabrook Estuary was quite dynamic (Figure 2). The rapid development of the dunes and marshes, as well as the construction of the mile-long bridge at the turn of the 19th century, served to harden and decrease the dynamic nature of the shoreline. The jetties along either side of the inlet, installed in 1930, further decreased shoreline movement. As the narrow channel connecting the Estuary to the ocean filled with sediment, it required dredging, first conducted in 1965, to maintain a navigable inlet. The inlet is currently maintained by the U.S. Army Corps of Engineers and due to the high rates of sediment transport and deposition within and around the channel, maintenance dredging is required approximately every 5 years.

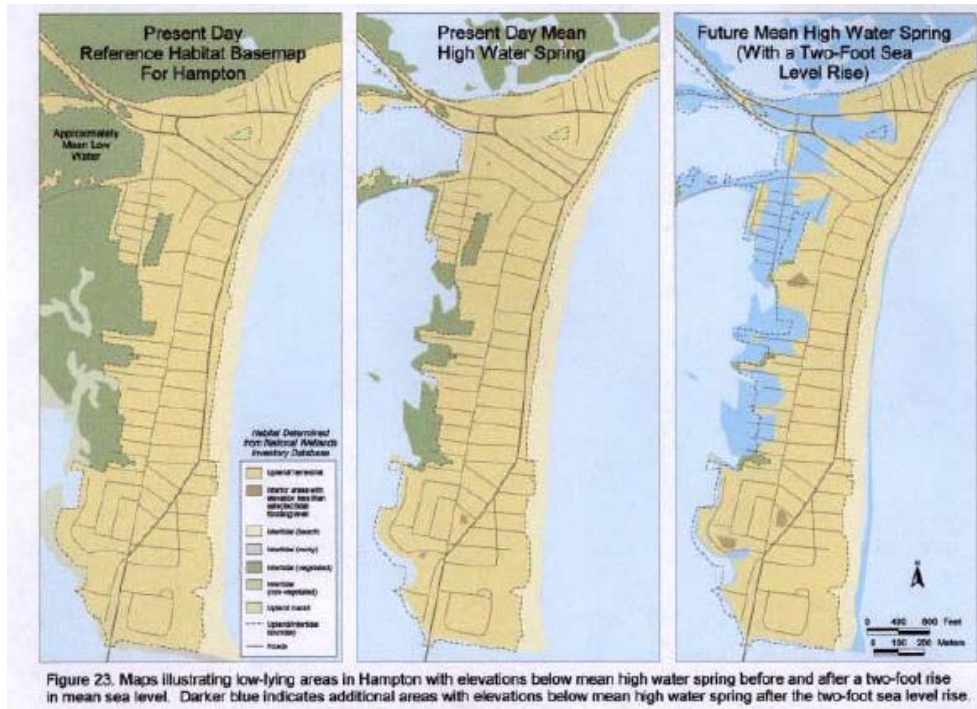
Figure 23. Maps illustrating low-lying areas in Hampton with elevations below mean high water spring before and after a two-foot rise in mean sea level. Darker blue indicates additional areas with elevations below mean high water spring after the two-foot sea level rise.

Figure 3. Increases in the areas flooded in Hampton, NH with a two foot increase in tidal height due to sea level rise. From Ward and Adams (2001).

The high level of development in low-lying areas within the Hampton-Seabrook Estuary renders many areas vulnerable to increased coastal flooding as sea level rises. In fact, a 2001 study of coastal flooding in New Hampshire found that an additional 550 acres of non-marsh land could be subject to flooding in Hampton and Seabrook with a two foot sea level rise (Figures 3 and 4; Ward and Adams 2001). As areas of undeveloped upland allow for natural marsh expansion, they play an important role in the protection of coastal communities with sea level rise. As a result, conservation of both existing salt marsh as well as undeveloped uplands is an important tool in combating sea level rise.

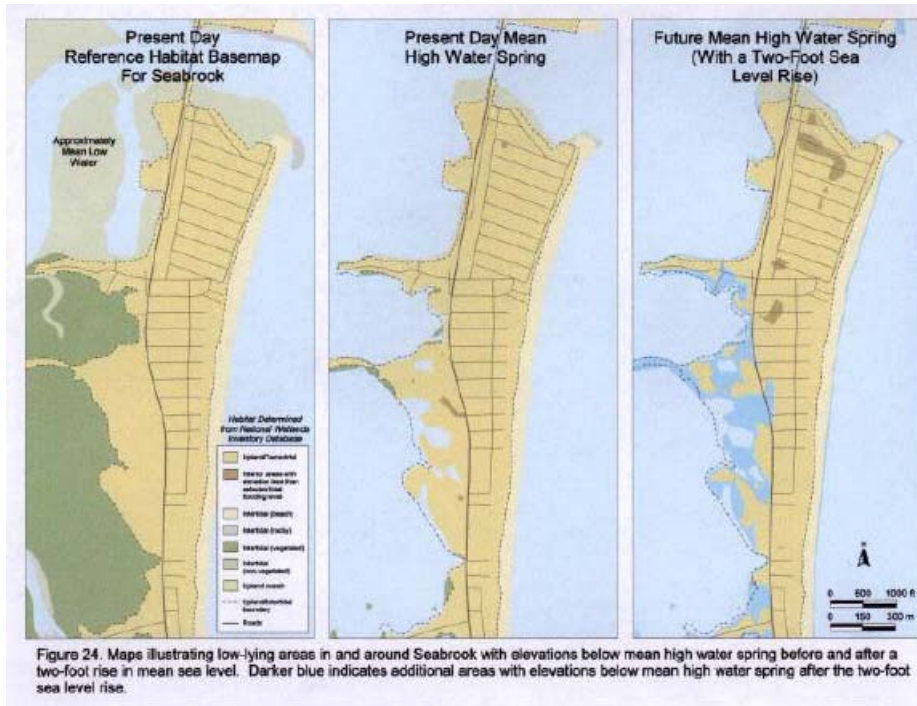
Figure 4. Increases in the areas flooded in Seabrook, NH with a two foot increase in tidal height due to sea level rise. From Ward and Adams (2001).

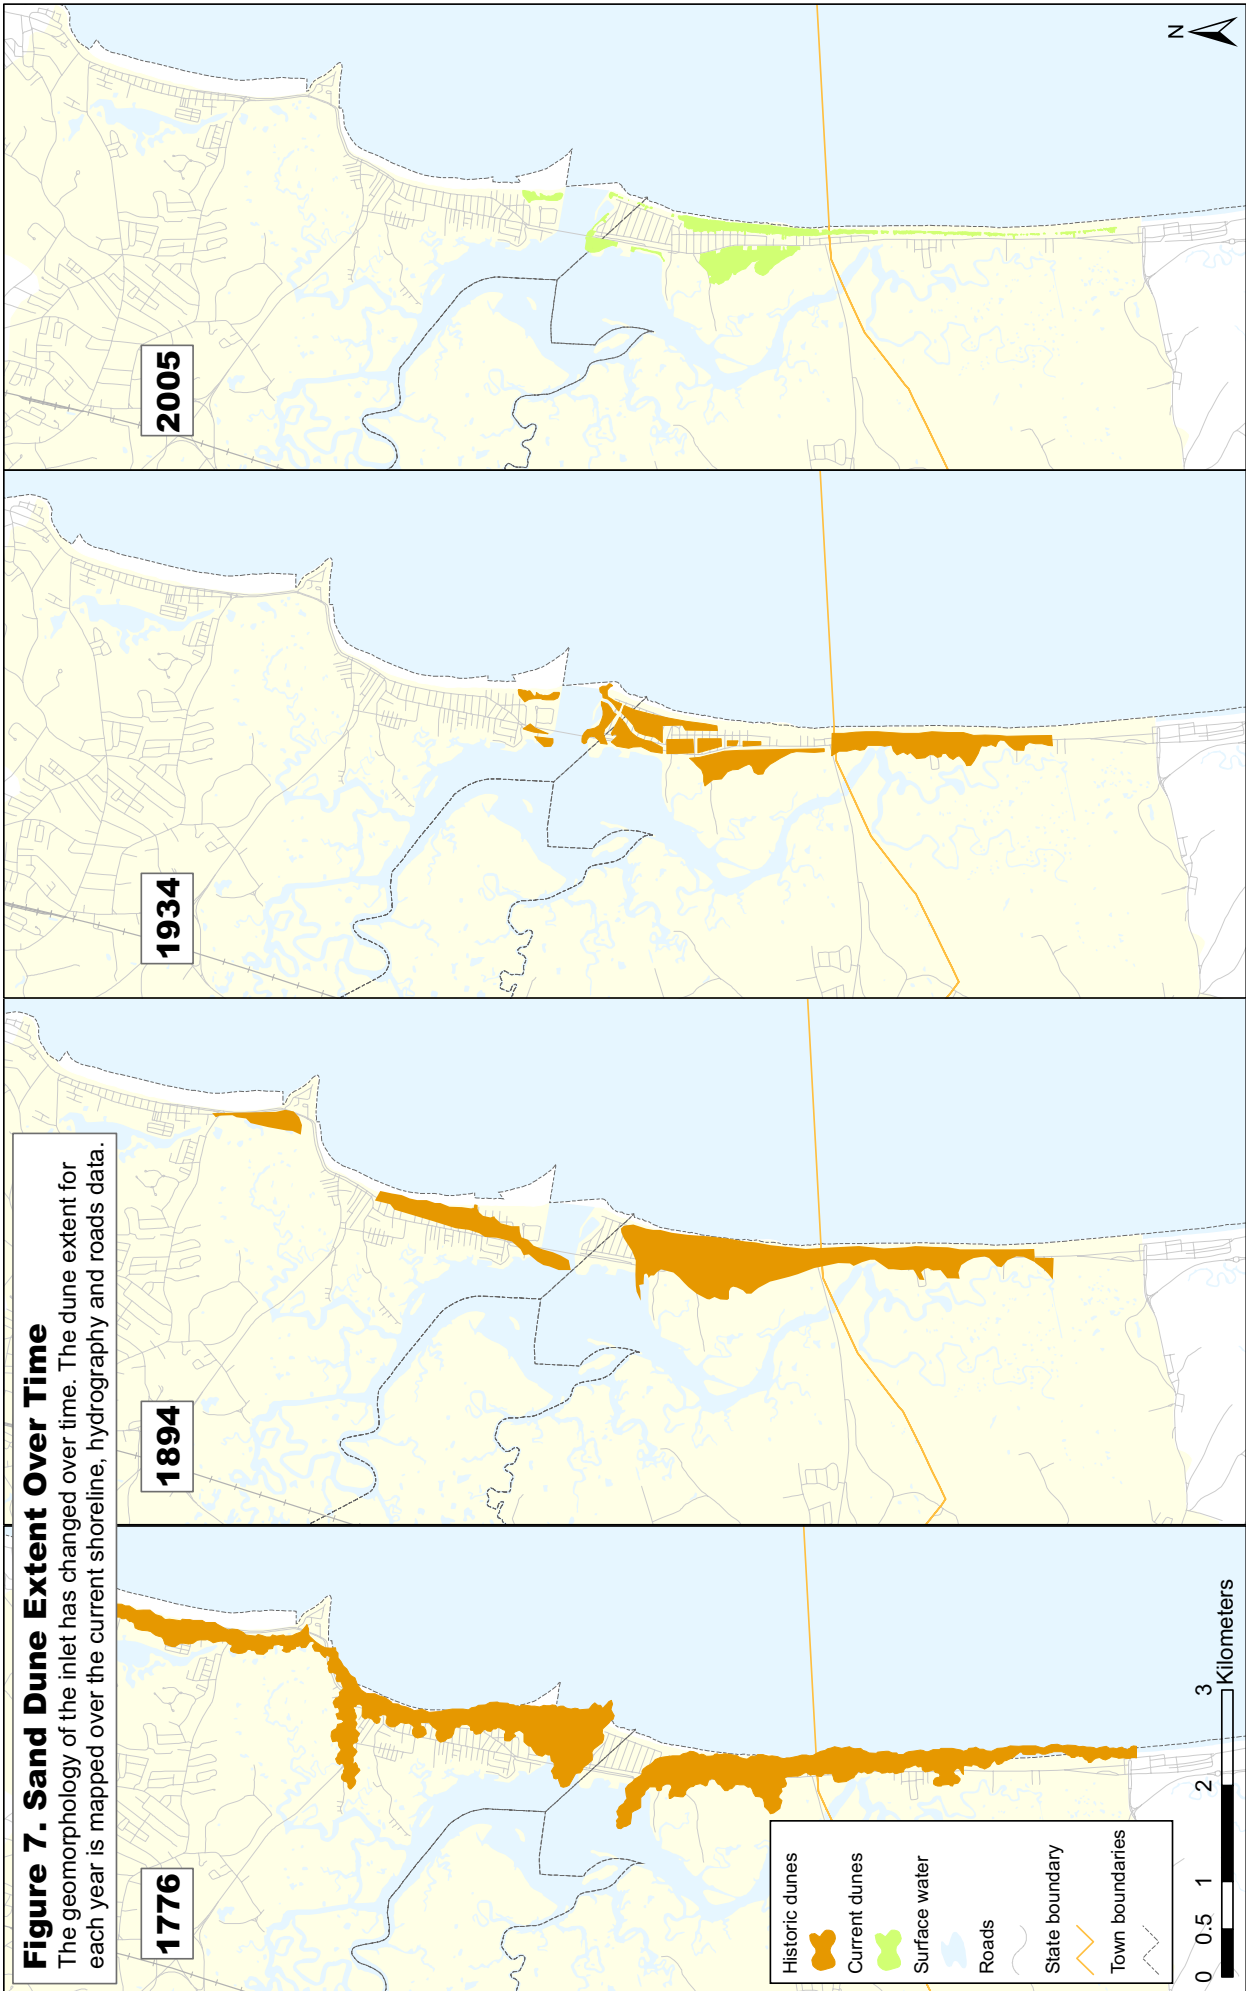
Figure 7. Sand Dune Extent Over Time

The geomorphology of the inlet has changed over time. The dune extent for each year is mapped over the current shoreline, hydrography and roads data.

The extent of sand dune habitat in the watershed was evaluated from 1776 to the present (Figures 7 and 8). Over the past 230 years, 83.6% of the total area of sand dune habitat in the watershed has been lost. Table 3 includes the area of sand dune calculated for each survey year as well as losses.

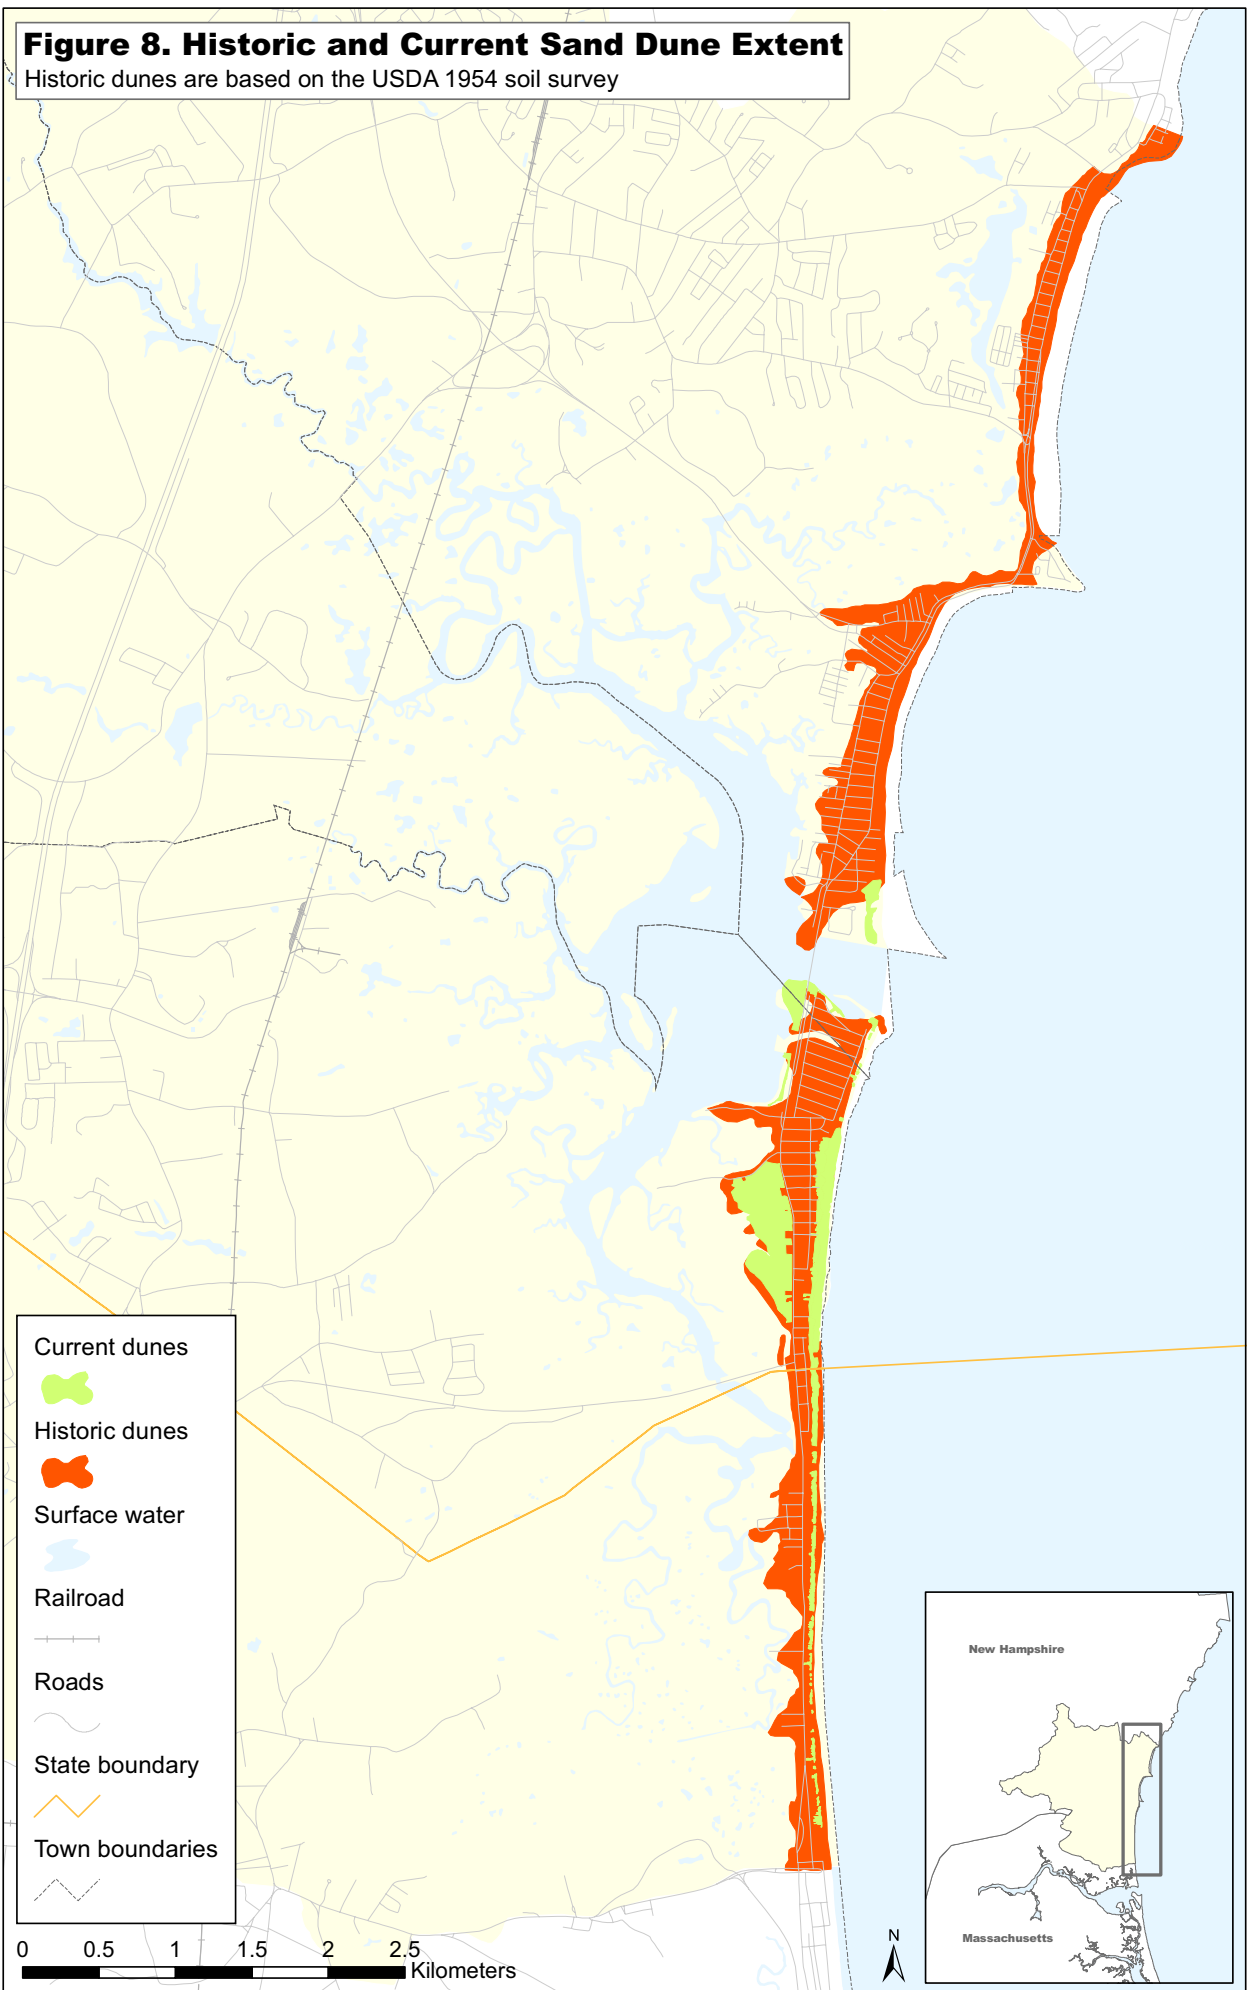
Figure 8. Historic and Current Sand Dune Extent

Historic dunes are based on the USDA 1954 soil survey

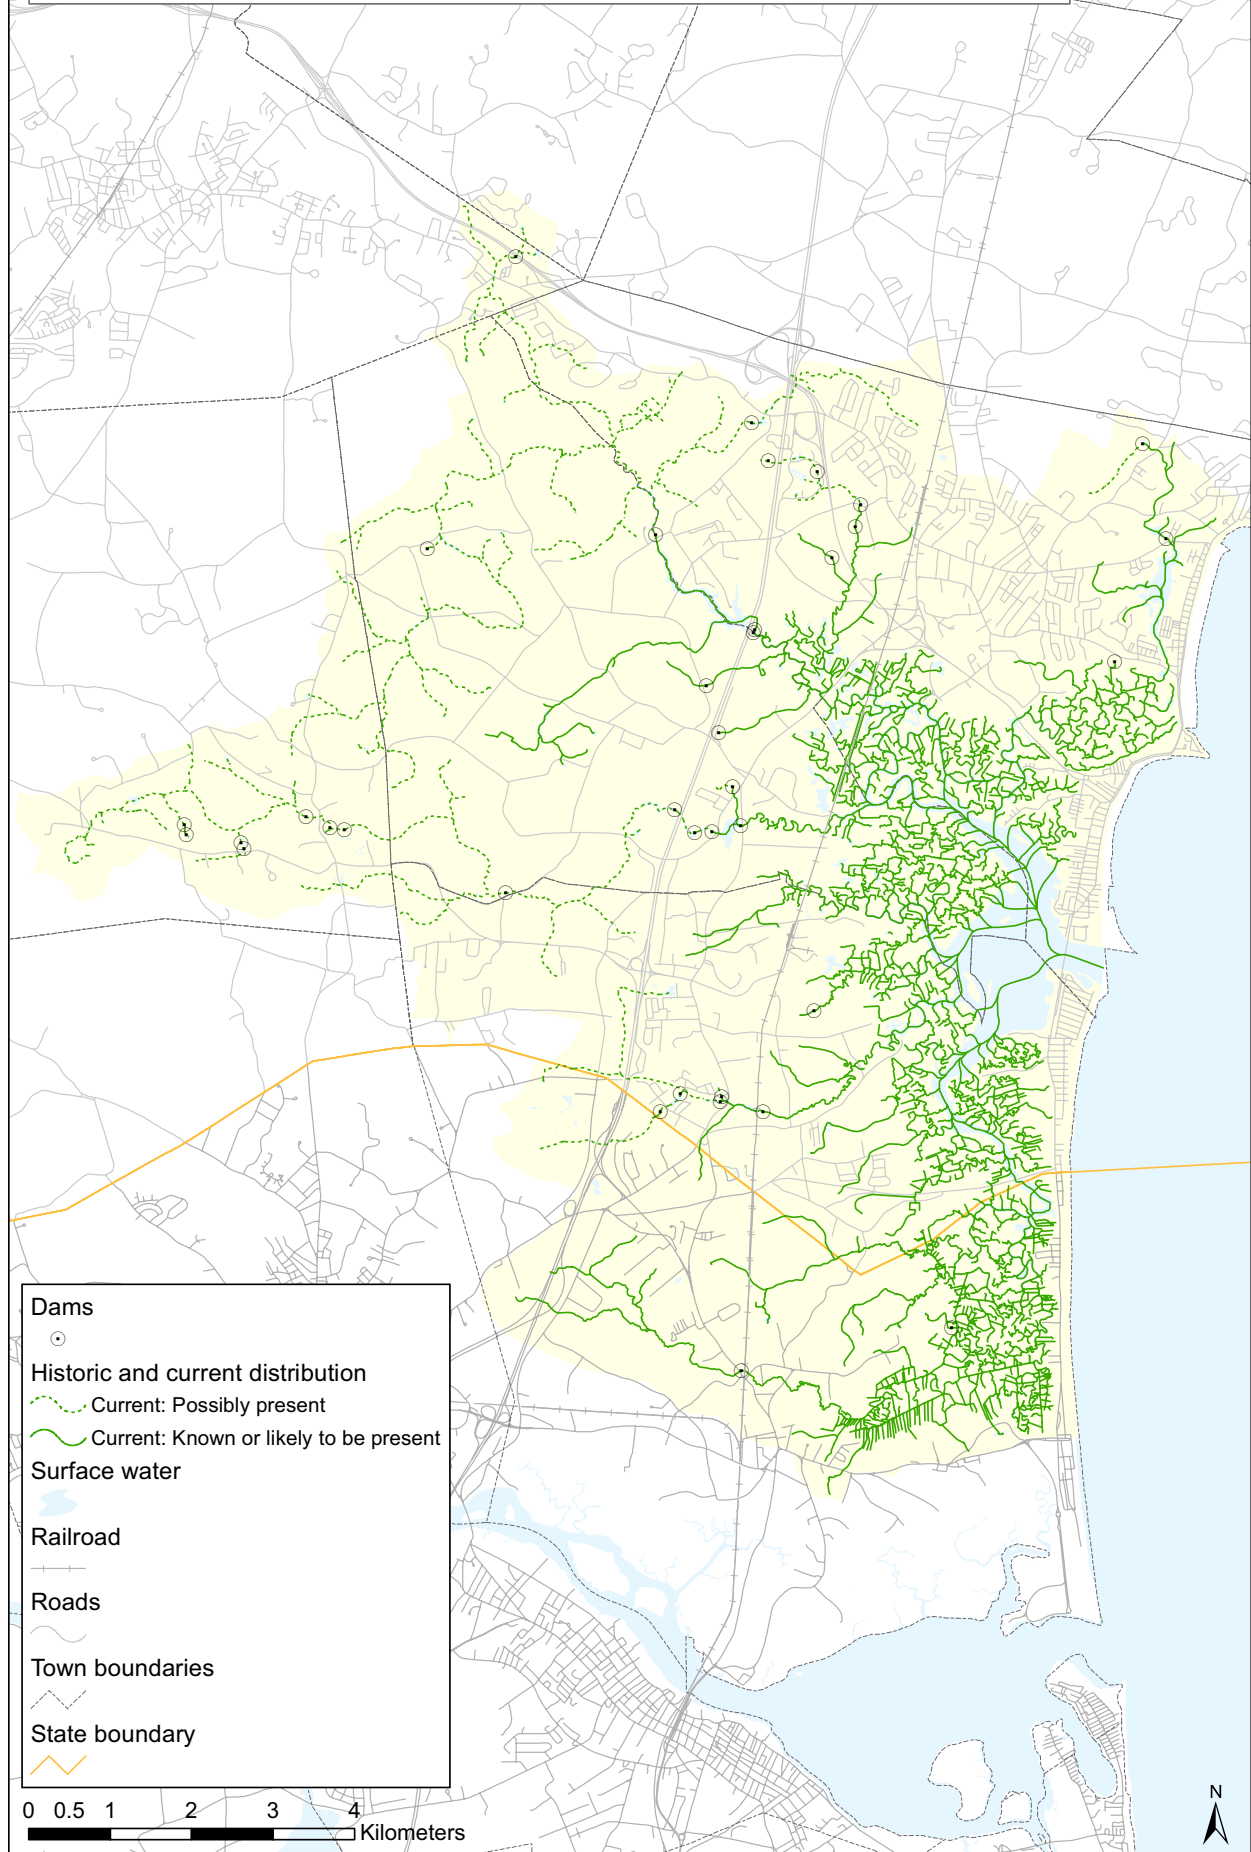
Figure 14. Historic and Current Distribution of American Eel

Although eels are currently found throughout the Hampton-Seabrook Estuary, populations are likely greatly reduced relative to historic numbers.

The following tables contain data for the amount of river miles in each river system available to diadromous fish. Each table follows the same format. The first column (Mainstem dams) identifies by ordinal number each dam along the main corridor of each river. The second column (Mainstem river miles upstream from the estuary) lists the length, in river miles, from the open estuary (defined as the inlet to the harbor) to each successive dam (i.e., lengths are cumulative). The final row in the second column (upstream terminus) is the total length of the mainstem river. The third column (Currently unobstructed miles, including tributaries) lists the number of mainstem and tributary river miles upstream of each dam until the next obstruction. The fourth column (Cumulative connectivity potential) lists the length of the river system, in river miles, that would be gained by installing fish passage at or removing each successive dam. The first row of the fourth column lists the number of river miles that are currently unobstructed in that system. The last column (System percent) lists the amount of the river system, as a percent of the total river system, that would be gained by installing fish passage or removing each successive dam. It should be noted that the downstream-most dams are the most important to target for removal in order to restore connectivity and increase available fish habitat. The last two rows indicate the length of tributary streams currently obstructed by dams and the length of the river system historically connected (i.e., the total length of the river system), respectively. With each table is a brief narrative describing current and historic use of each system by the seven target diadromous fish species for this project: alewife, blueback herring (these two species are collectively known as river herring), American shad, rainbow smelt, Atlantic sturgeon, Atlantic salmon and the American eel. Data for each species' current and historic distribution in the watershed are presented in figures 11-16.

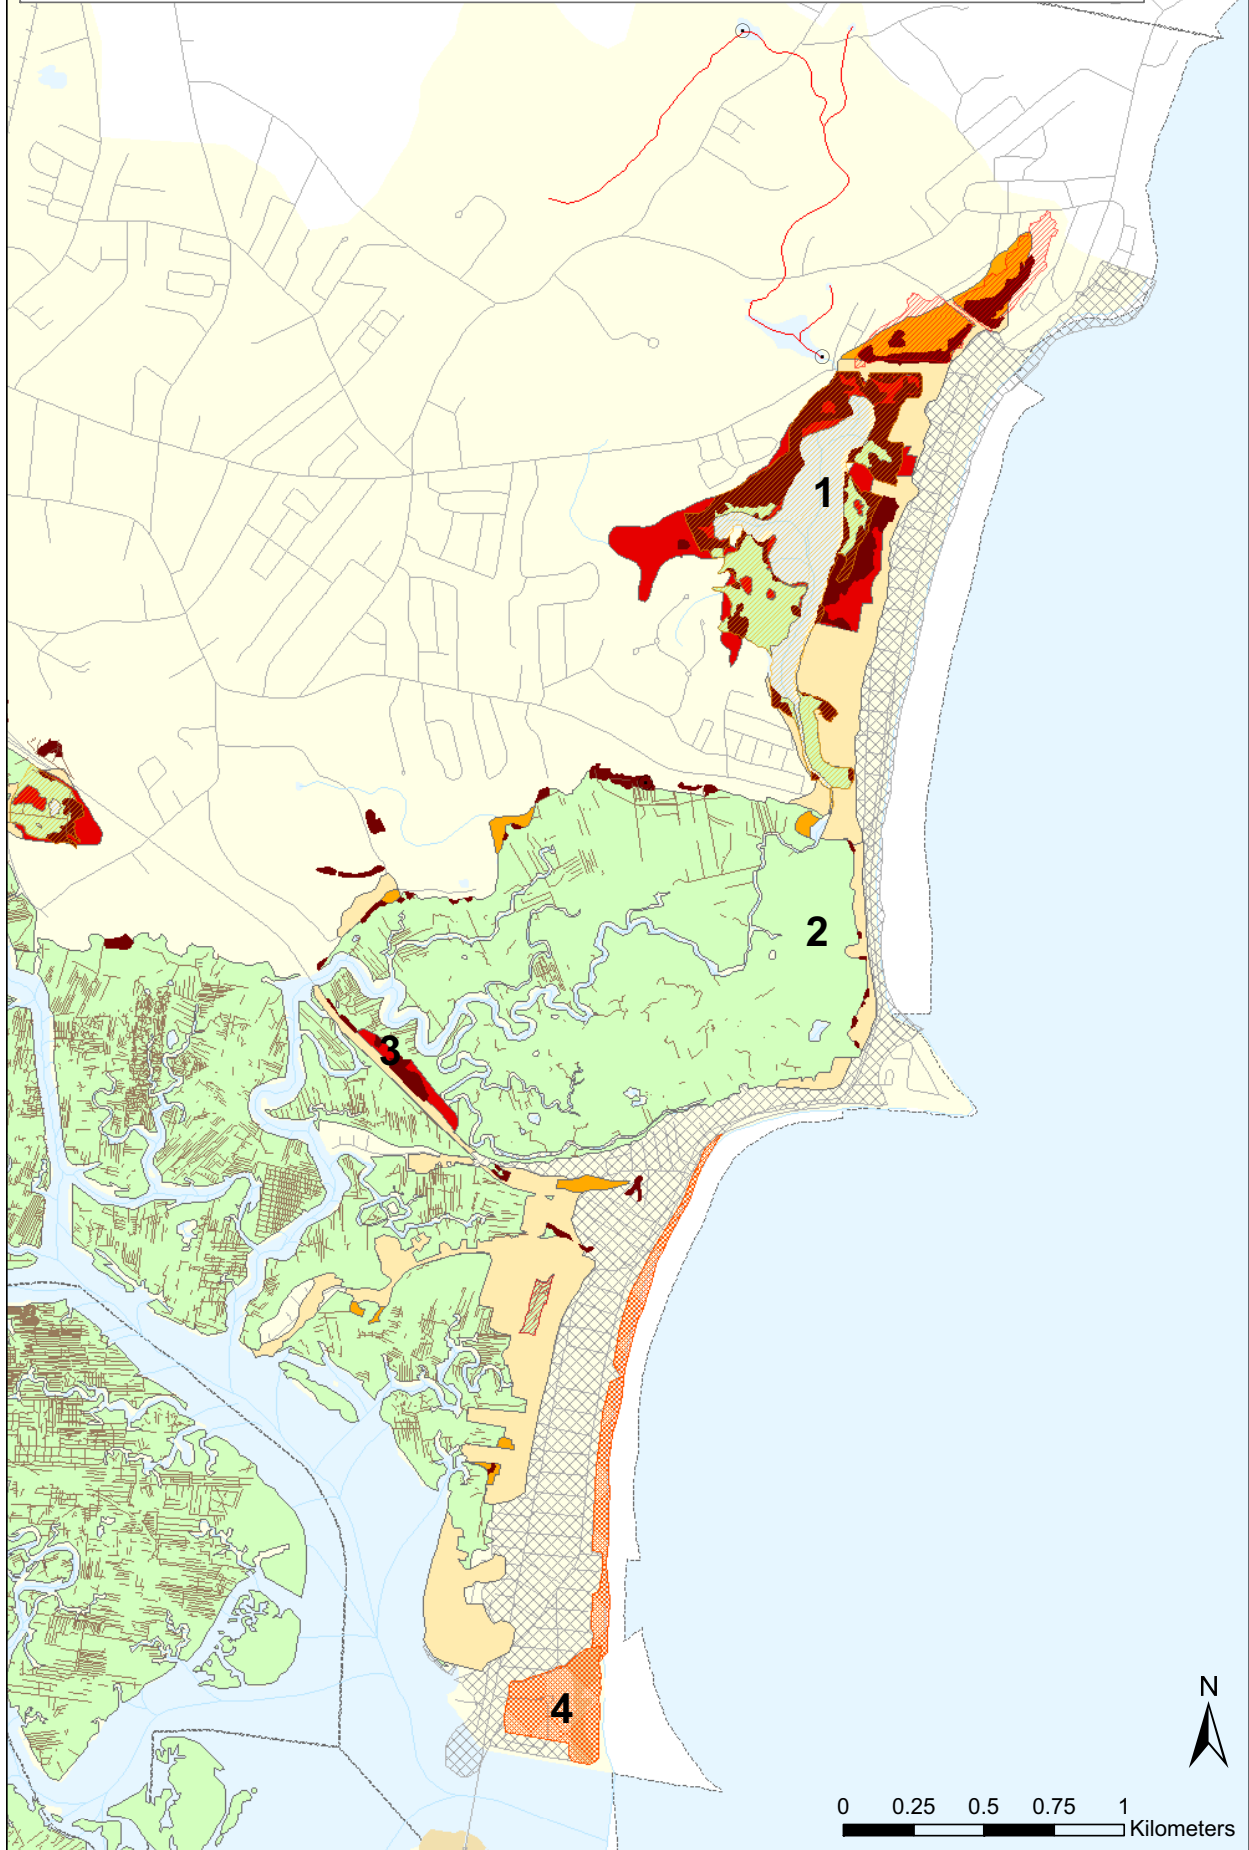
**Figure 18. Hampton-Seabrook Estuary Restoration Opportunities
Tide Mill Creek - Meadow Pond**

Numbers on the map correspond to restoration opportunities highlighted in the text.

2. Marsh upstream of route 101– Unlike the majority of the Estuary, the salt marsh habitat in this region is characterized by very little ditching. Due to the high habitat and research value of this area of marsh, it is recommended that conservation efforts be focused here. Further, the NH Audubon Society identified this area as a conservation priority due to the high density of saltmarsh sharp-tailed sparrows as well as evidence of breeding willets (McKinley and Hunt 2008).

4. Hampton Beach State Park – Dunes located at this site have eroded and are subject to trampling due to the high use of this area. Revegetation of the areas impacted by humans is recommended. Furthermore, due to the high use of this area in the summer, it is recommended that dunes be protected from further impacts with fencing and signs. A large dune system formerly occupied this site prior to it being developed. Opportunities to remove fill from the area and restore a larger dune system should be explored, particularly because it is state owned land. The high visibility of this area warrants a large outreach campaign to inform park patrons of the value of dunes, the threats facing them, and what they can do to avoid impacting dunes.

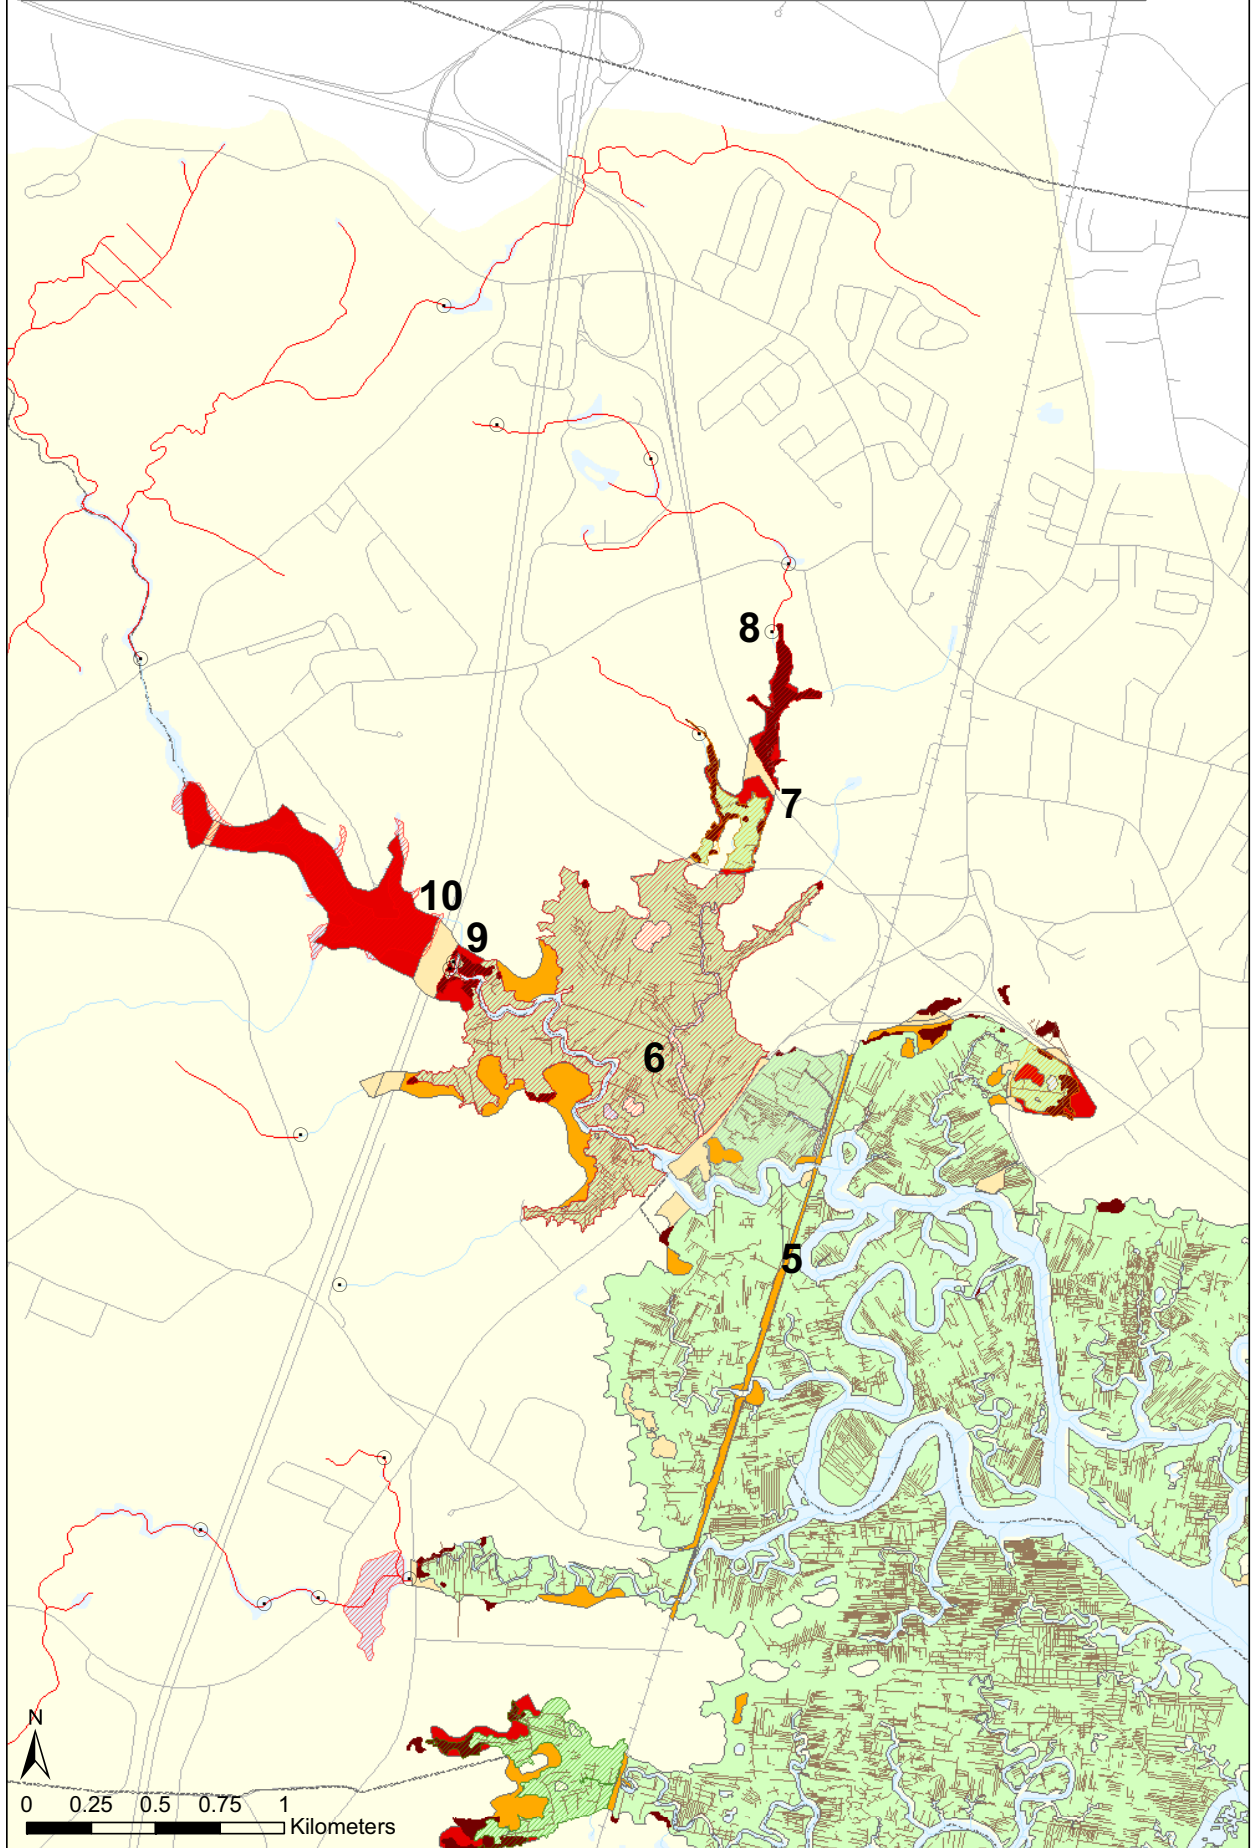
Figure 19. Hampton-Seabrook Estuary Restoration Opportunities Taylor River-Drake's River

Numbers on the map correspond to restoration opportunities highlighted in the text.

6. Taylor River upstream of route 1 – An undersized culvert under route 1 restricts tidal flow to this region of the marsh. Restoration of this area of marsh was listed as a secondary priority by the Rockingham County Conservation Commission (RCCD 2005) due to the potentially high cost of restoring this site. Although some conservation land does exist in this region, further efforts to protect this area, as well as the surrounding upland buffer, should be pursued due to the relative lack of ditches. This region was noted as a conservation priority for bird habitat due to the concentration of saltmarsh sharptailed sparrows in the region, the presence of conservation land, as well as the relatively undeveloped upland buffer (McKinley and Hunt 2008).

7. Drakeside Road – A tidal restriction under Drakeside road was replaced in 1996 after the previous culvert was washed out in a storm. The current 4' x 8' box culvert is likely not providing adequate tidal flow to upstream areas, as evidenced by the prevalence of *Phragmites* upstream as well as observations of restricted tidal flow by the Rockingham County Conservation District. This site is listed in a RCCD (2005) document as a restoration priority. They recommend removal of rip rap to increase tidal flow, and possible installation of a second culvert to the west of the current one. An additional option is to replace the existing culvert with a larger one. This site was also identified as an important area for salt marsh sharp-tailed sparrows (McKinley and Hunt 2008); the impacts of improved tidal flushing on bird use should be considered prior to beginning restoration activities.

8. Towle Farm Dam – A small earthen dam on the Drakes River blocks fish access to upstream waters that could provide potential river herring habitat.
9. Downstream of the Taylor River Dam - Removal of *Phragmites* immediately downstream of the Taylor River Dam is recommended to enhance fish habitat. This area is subject to increased runoff from the NH State Liquor store on the northbound side of route 1. If left untreated, *Phragmites* may raise the marsh elevation and as a result, exclude anadromous and resident fish from the marsh adjacent to the river.

10. Taylor River Dam – Although the first dam on the Taylor River has a fish ladder to provide fish passage, it has deteriorated and in recent years it is not passing many fish. Furthermore, water quality issues in the impoundment upstream of the dam limit opportunities for fish use and access to upstream habitat. The upstream areas of this river system provide excellent fish habitat opportunities; in fact, the upstream region of the Taylor River is listed as a conservation focus area by The Nature Conservancy. A feasibility study is currently underway to evaluate restoration alternatives for the dam at this site.

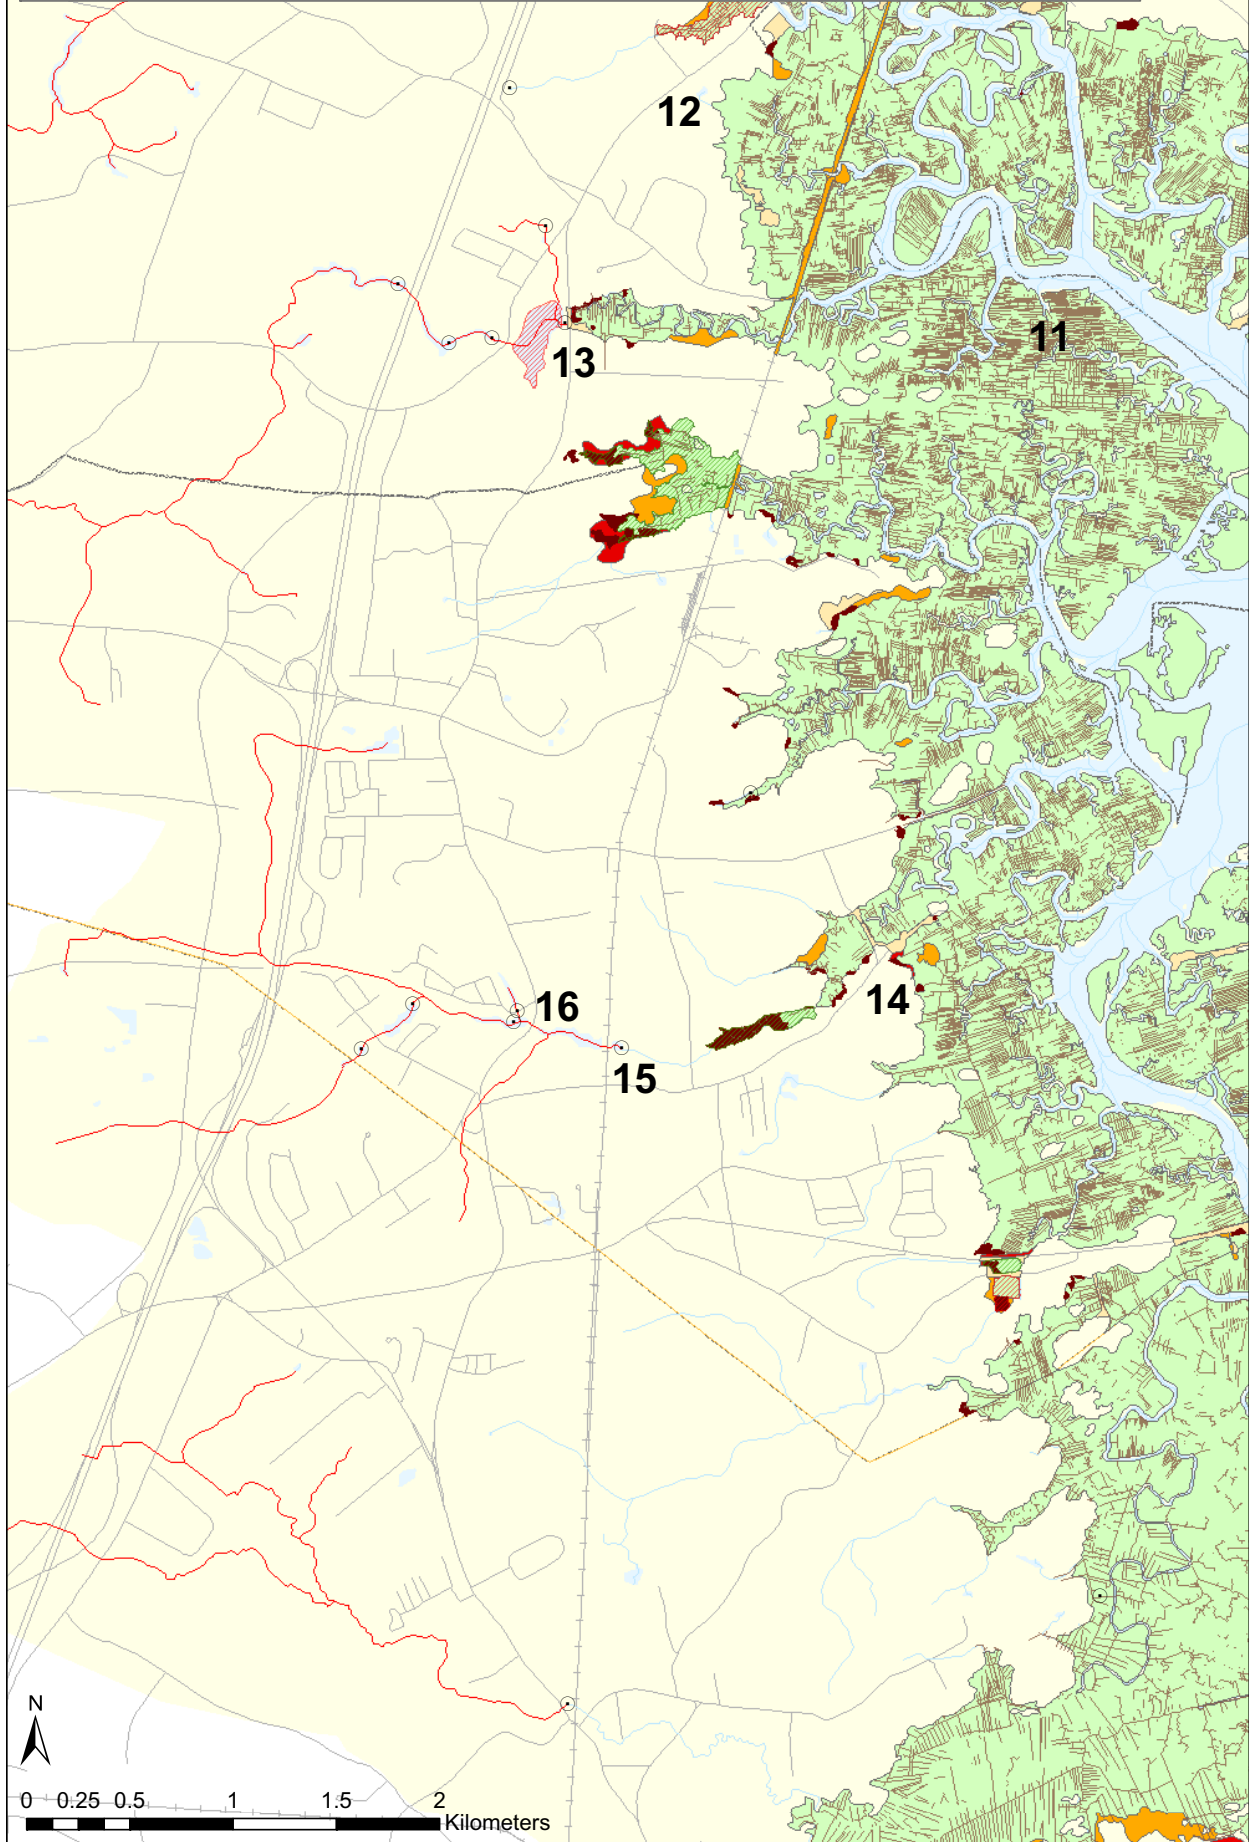
Figure 20. Hampton-Seabrook Estuary Restoration Opportunities Hampton Falls River-Browns River-Cains Brook

Numbers on the map correspond to restoration opportunities highlighted in the text.

13. Hampton Falls River – A dam currently exists on the Hampton Falls River at the route 1 crossing. High quality habitat exists upstream; therefore, exploration of opportunities for dam removal or installation of fish passage is recommended. Due to the abundance of dams along the main stem of this system, evaluation of the feasibility of restoring fish passage to the upstream reaches is also recommended.

14. Mill Creek – The salt marsh-upland border around the tidal portion of Cains Brook (i.e., Mill Creek) contains multiple stands of *Phragmites*. Current research at the University of New Hampshire is evaluating *Phragmites* removal techniques in this area. Based on the conclusions of the research, it is recommended that the stands of *Phragmites* at this site be removed to improve the habitat value of the site and prevent the further spread of *Phragmites*.

15. Noyes Pond Dam – The Noyes Pond Dam and the Cains Brook Dam are recommended for removal to restore hydrologic connectivity and access to upstream fish habitat in this system. To increase success of fish use, measures to mediate water quality are also recommended. It should be noted that varying perspectives exist regarding the management of these dams and that the recommendation to remove the Noyes Pond Dam is contrary to those outlined in the watershed management plan prepared by the town of Seabrook (Waterfront Engineers and Appledore Engineering 2006).

16. Cains Brook near Home Depot/Lafayette Road, Seabrook – To combat erosion at this site and improve riparian habitat, planting efforts and shoreline stabilization are recommended along the banks of Cains Brook to restore the riparian buffer.
