Hampton-Seabrook Estuary Habitat Restoration Compendium

Alyson L. Eberhardt and David M. Burdick
University of New Hampshire

Cite as: Eberhardt, A.L. and D.M. Burdick. 2009. Hampton-Seabrook Estuary Habitat Restoration Compendium. Report to the Piscataqua Region Estuaries Partnership and the New Hampshire Coastal Program, Durham and Portsmouth, NH.

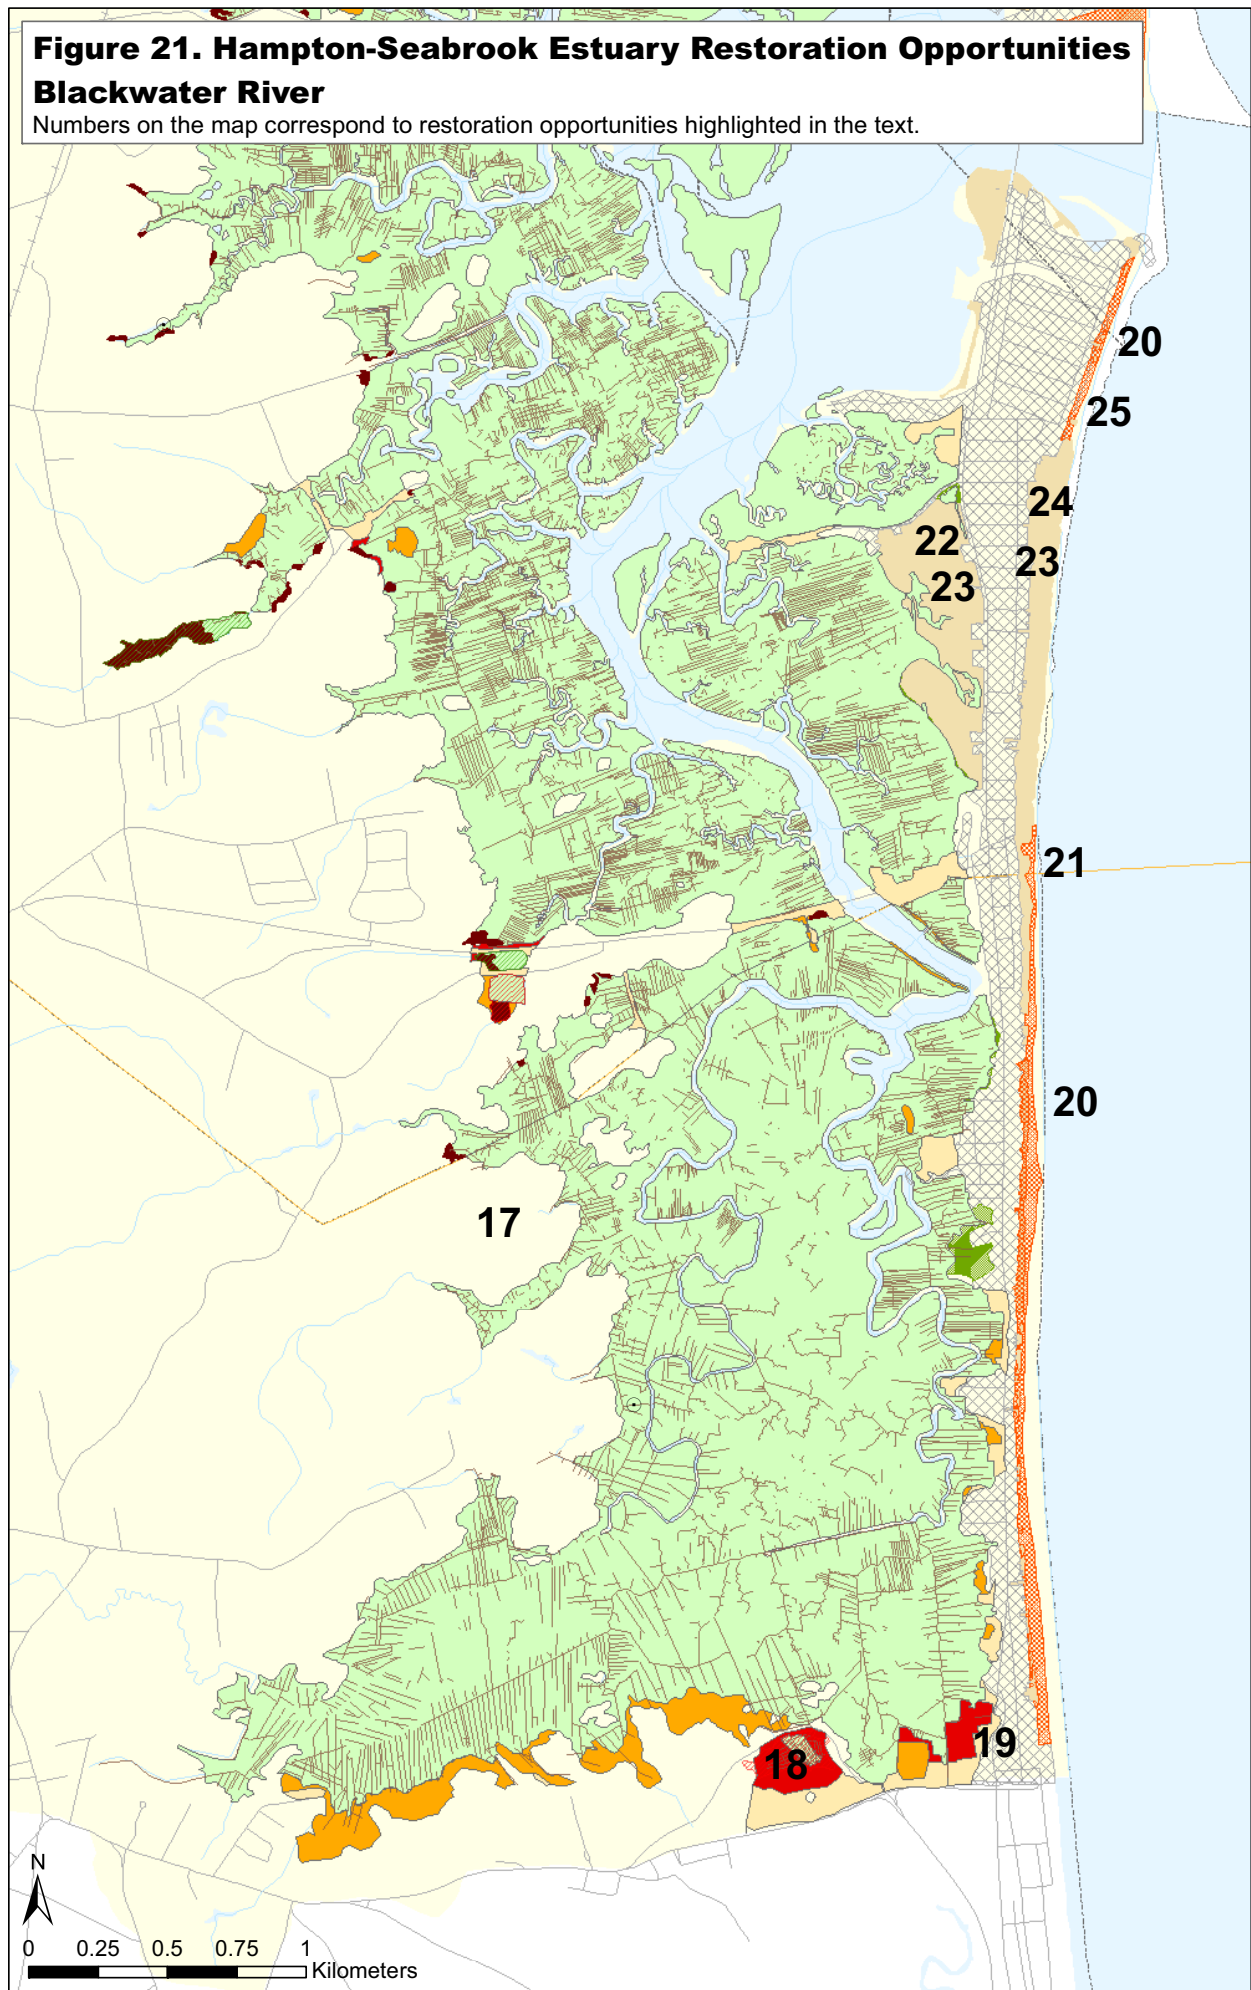
Figure 21. Hampton-Seabrook Estuary Restoration Opportunities Blackwater River

Numbers on the map correspond to restoration opportunities highlighted in the text.

17. Sea level rise protection - Protective measures are recommended for the area landward of the salt marsh west of Worthley Ave., Seabrook, NH and Seabrook Road, Salisbury, MA due to the potential adaptive benefits as a result of sea level rise. This expanse of vegetated upland is recommended for protection to provide a buffer and to allow for natural marsh expansion with sea level rise.
18. Old County Road, Salisbury, MA – Several small culverts under Old County Road restrict tidal flow to the marsh upstream which is currently dominated by *Phragmites*. It is recommended that the existing culverts be replaced with a larger culvert. In addition to culvert replacement, the area upstream of the degraded marsh is former salt marsh that was filled; this area is recommended for fill removal to lower the elevation to mean high tide. More details on this site are available in MA

19. Parking lot at intersection of Northern Blvd and Beach Road, Salisbury, MA. -This site includes an area of fill adjacent to a stand of *Phragmites*. Excavation of fill and *Phragmites* at this site is recommended to increase tidal inundation to the area and return it to salt marsh. (MA CZM 2008; site 8*)
