STATE OF UTAH MSE WALL INSPECTION FORM

Compiled As Part of Research By The Utah Department of Transportation

Region	4	Identifying Road/Intersection	SR-9, Hurricane

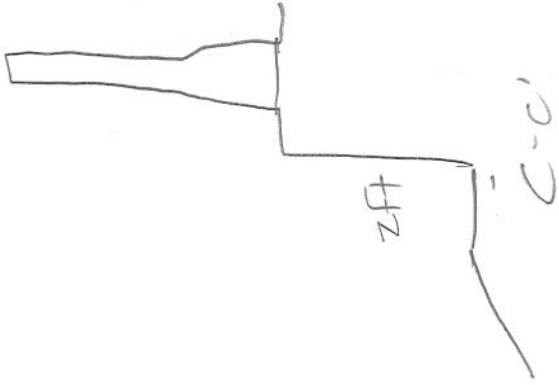
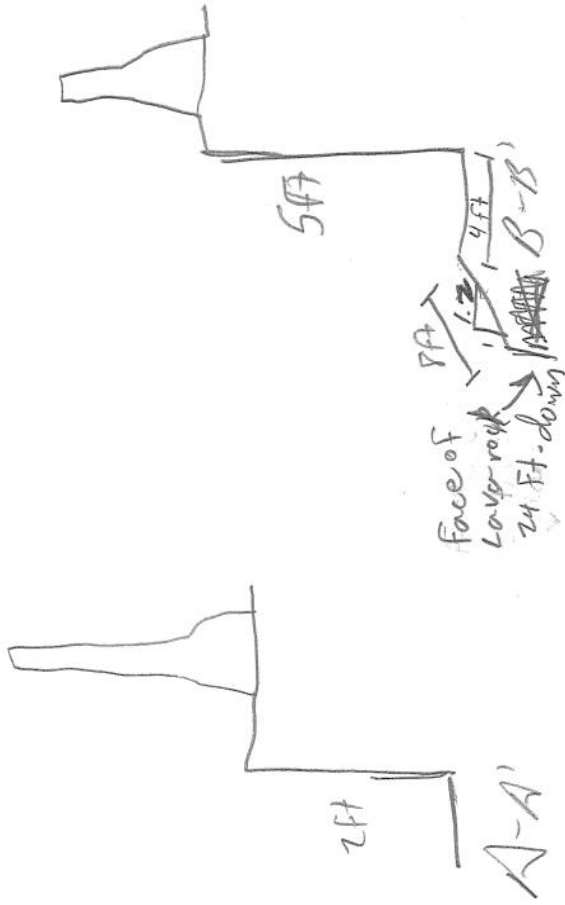
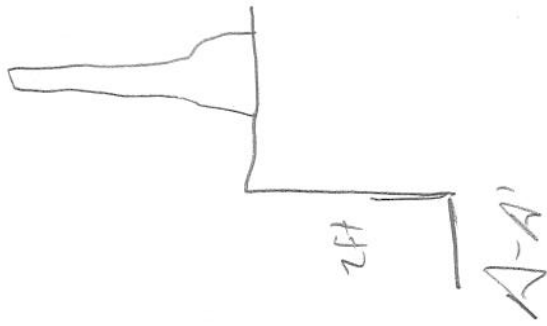
Cross Sections:

soil slopes off to a lava rock drop-off
 wall condition looks good
 drains on west end, soil erosion on west end
