STATE OF UTAH MSE WALL INSPECTION FORM

Compiled As Part of Research By The Utah Department of Transportation

Inspection Date	7/25/07	Names Of Inspectors	Ryan Maw, Holly Griffin
Region	1	Identifying Road/Intersection	SR-91

MSE Wall at Bridge	Y <input checked="" type="radio"/> N	Bridge Number if applicable:	N/A	Wall Number	R-281
Surrounding Structures	N/A		Maximum Height of Wall (ft)	30'	
Distance to Each Structure	N/A		One Stage, Two Stage or Block Wall	one stage	
State Route Number	SR 91/89		Estimated Max Length of Wall Abutment:	110 paces x 2.17 ft	
Approximate Mile Marker	6		Max Slope of Ground in front of wall:	22" x 3'	
GPS Datum	WGS/84, NAD/83, or NAD/27		Max Height of wall burial line above surrounding level ground:	30'	
MSE Wall GPS Coordinates (Location of Measurement shown on plan view)	N 41° 29.827		Please draw rough layout of panel with approximate dimensions in space provided below:		
	W 111° 57.426				
If known, Panel or System Manufacturer	VSL		8x64

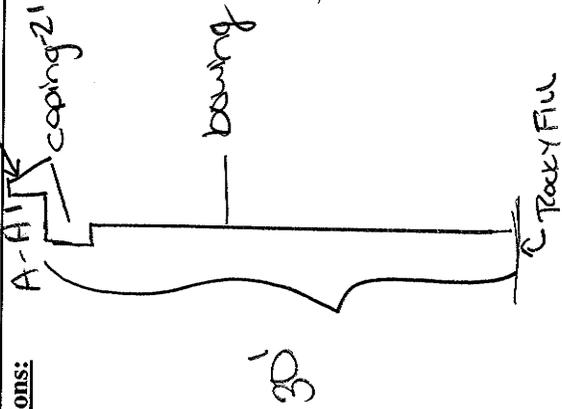
Cross Sections:

creek eroding wall
 creek in contact w/wall
 bowing present in center of wall
 leaking observed - likely due to blocked drain
