STATE OF UTAH MSE WALL INSPECTION FORM

Inspection Date	7/18/07	Names Of Inspectors	Holly Griffin, Ryan Maw
Region	1	Identifying Road/Intersection	I-215 and California

MSE Wall at Bridge	(Y) N	Bridge Number if applicable:		Wall Number	R-146
Surrounding Structures	none			Maximum Height of Wall (ft)	25
Distance to Each Structure				One Stage, Two Stage or Block Wall	one
State Route Number	I-215			Estimated Max Length of Wall Abutment:	650 ft
Approximate Mile Marker				Max Slope of Ground in front of wall:	2:1
GPS Datum	WGS/84, NAD/83, or NAD/27			Max Height of wall burial line above surrounding level ground:	0
MSE Wall GPS Coordinates (Location of Measurement shown on plan view)	N 40° 44.484'	Please draw rough layout of panel with approximate dimensions in space provided below.

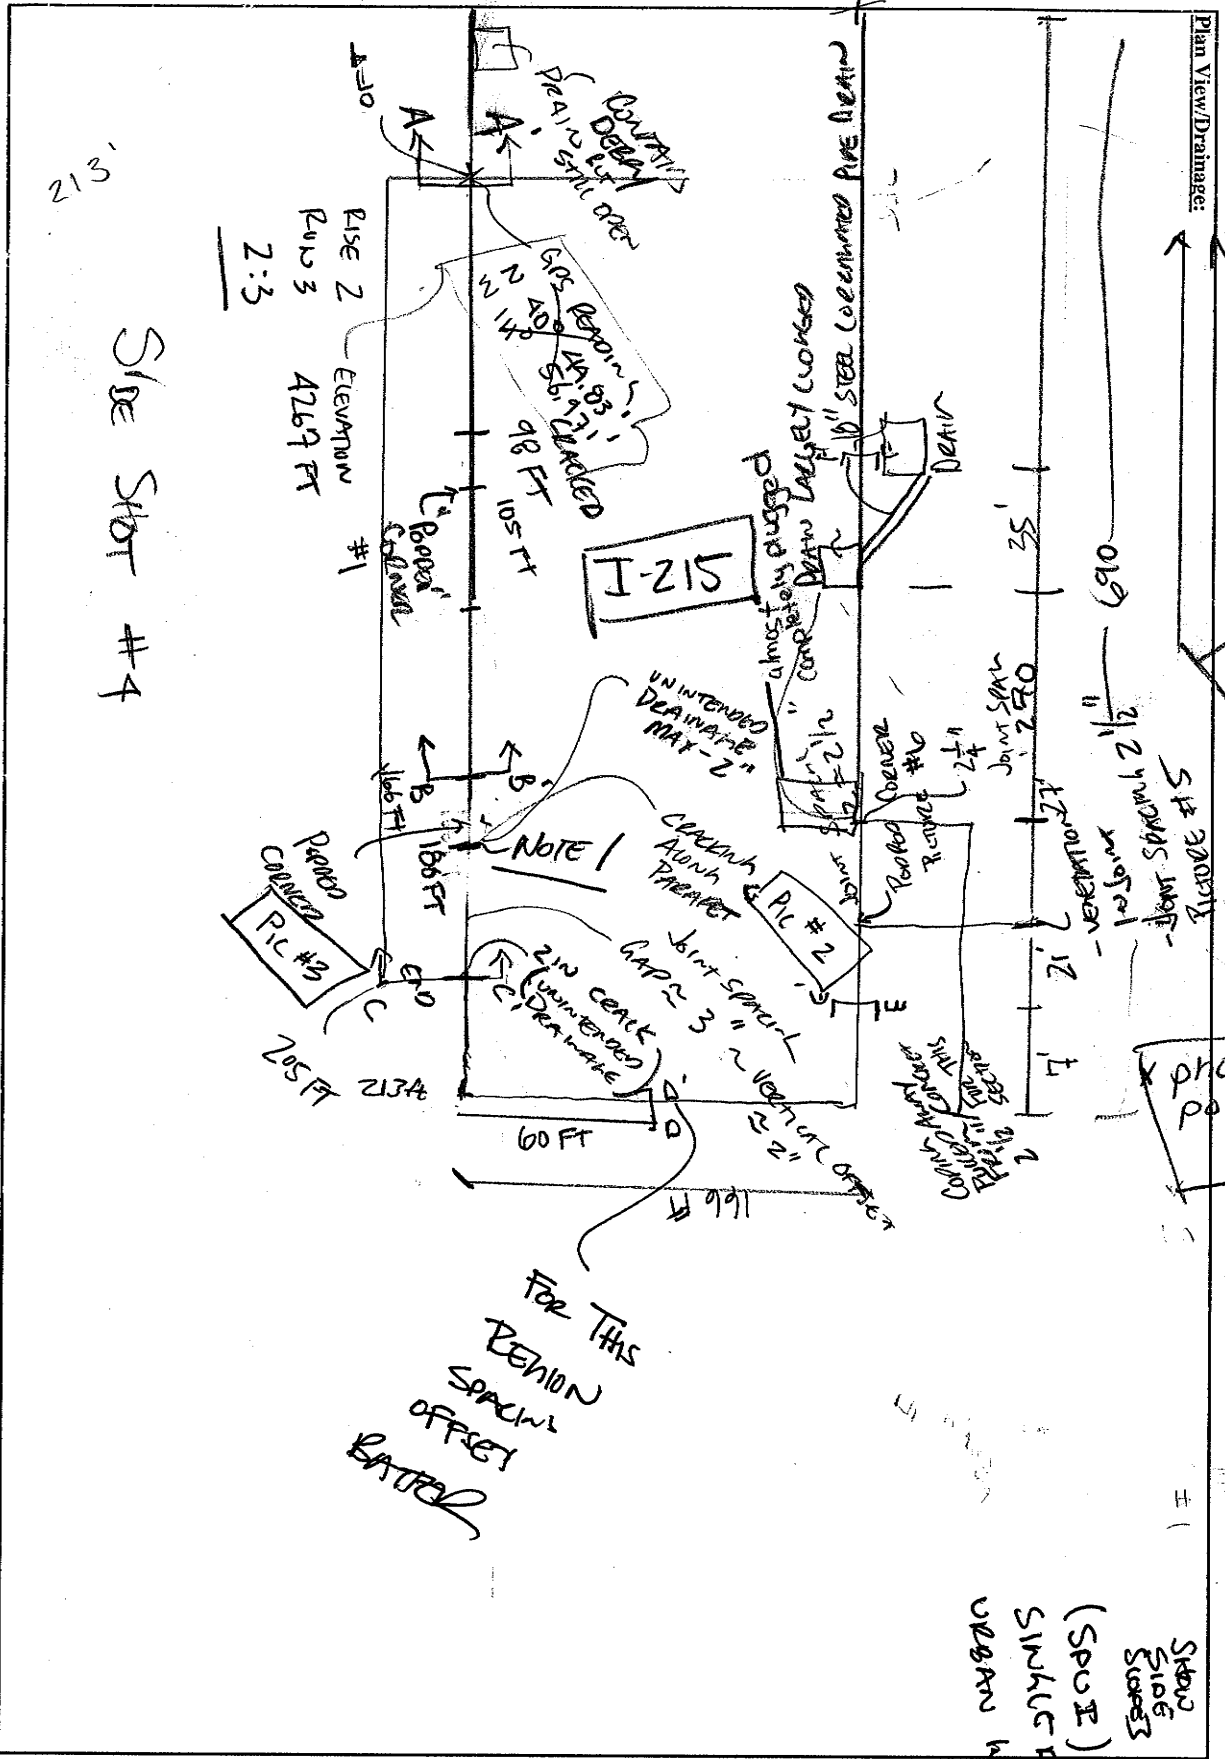
Side Shot #4

SPACING OF PANELS 1 TO 1.5" HORIZONTAL DISPLACEMENT 0-0.75"

NOTE 1: AS WALL APPROACHES BRIDGE ACCESS, WENTER HORIZONTAL DISPLACEMENT EXISTS BETWEEN PANELS (BOUNDARY OF PANELS).
