STATE OF UTAH MSE WALL INSPECTION FORM

Compiled As Part of Research By The Utah Department of Transportation

| Region | <u>3</u> | Identifying Road/Intersection | <u>I-15 & Univ. Parks exit West side</u> |

| MSE Wall at Bridge | <input checked="" type="radio"/> Y <input type="radio"/> N | Bridge Number if applicable: | Wall Number | <u>R-367A</u> |

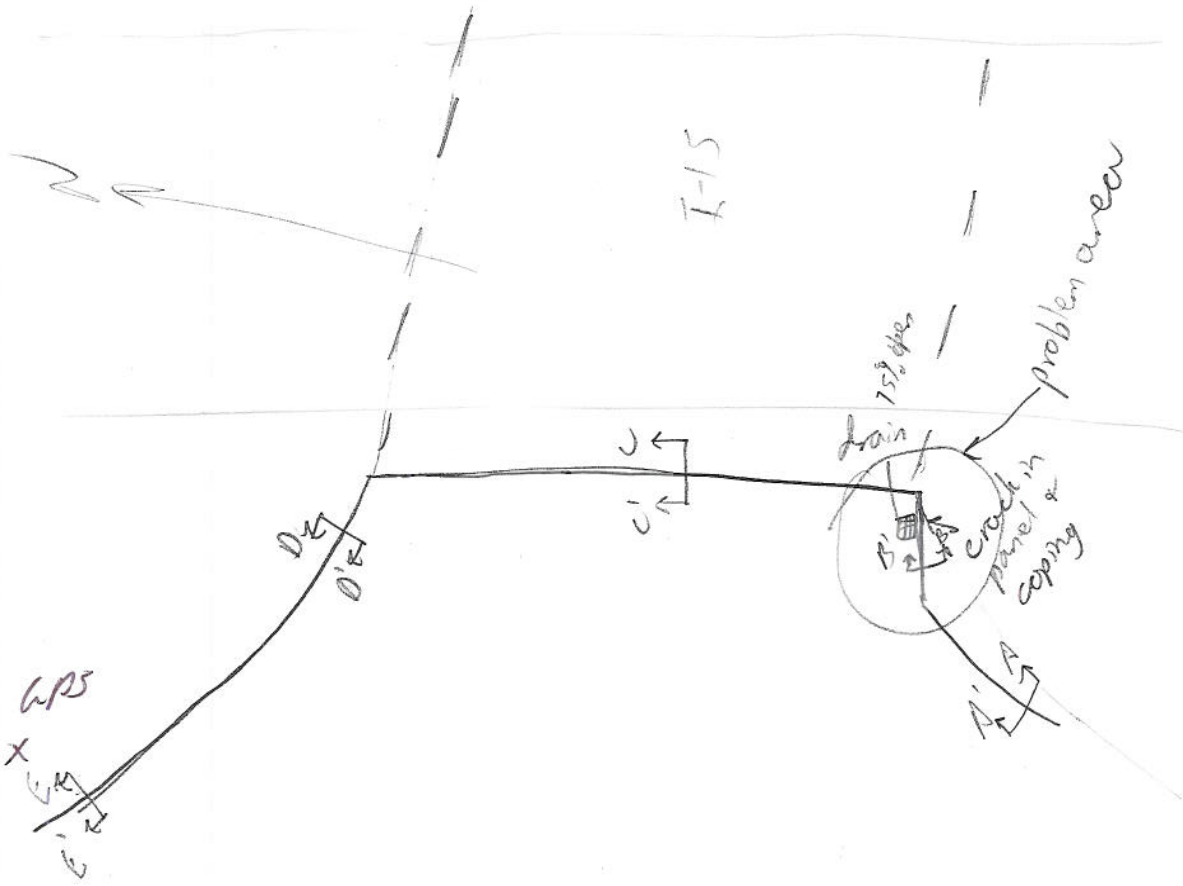
Plan View/Drainage:

- 4- Indicate Layout of MSE Wall in respect to major intersections, roadways, potential hazards, irrigation, vegetation, locations of conditions for which 'Yes' was marked, etc. in space provided below. Also Indicate approximate GPS Coordinates of Site of Interest in space provided below
